# Preparing the SVT for Future Operations

Tim Nelson - **SLAC**

*HPS Collaboration Meeting*

*JLab - May 15, 2020*

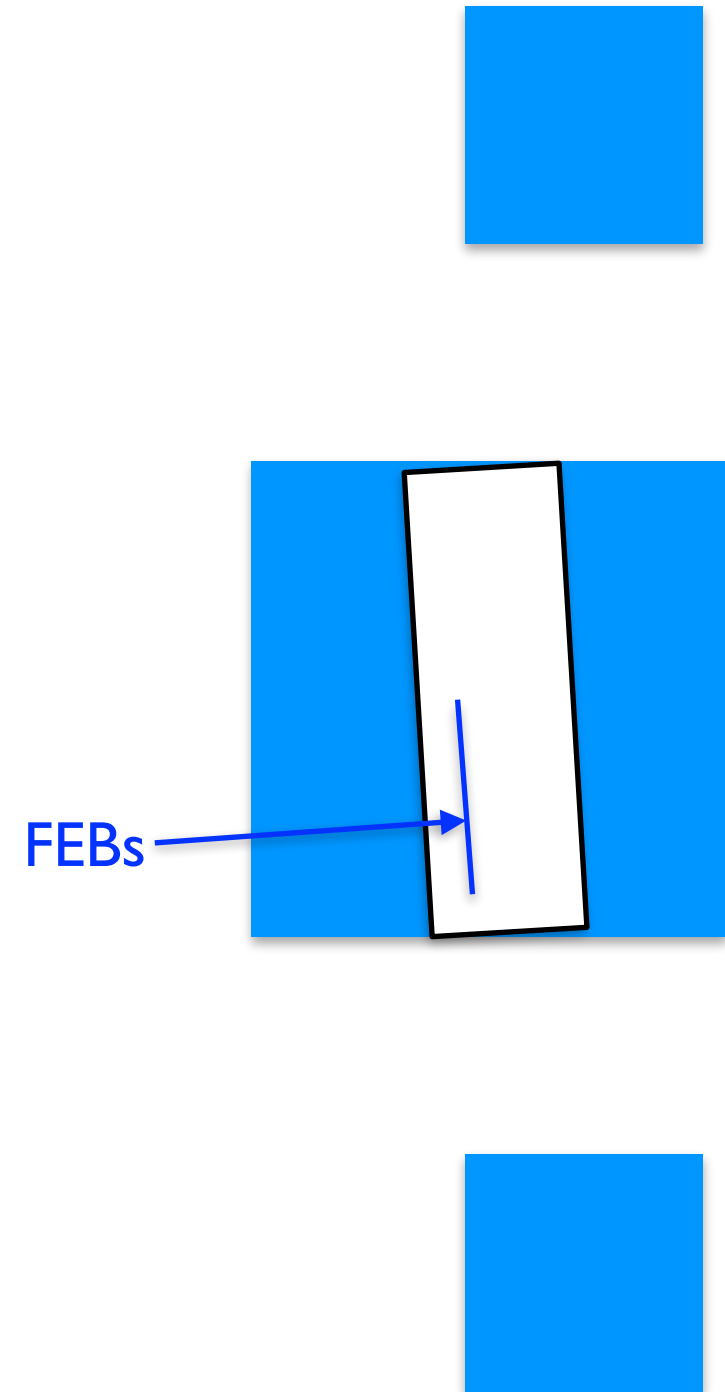
*FEB degradation manifests as drooping 5V / 500 mA regulator, which supplies:*

*No current monitoring, so mechanism unclear, but lowering temperatures improved overhead.*

- With only 3/10 symptomatic, geographically diverse, numerology favors problem w/ current draw.
- Temperature sensitivity favors a regulator problem. (known susceptibility of LDO control/monitoring).

*Damage meant loss of L7T and one hybrid in L5B.*

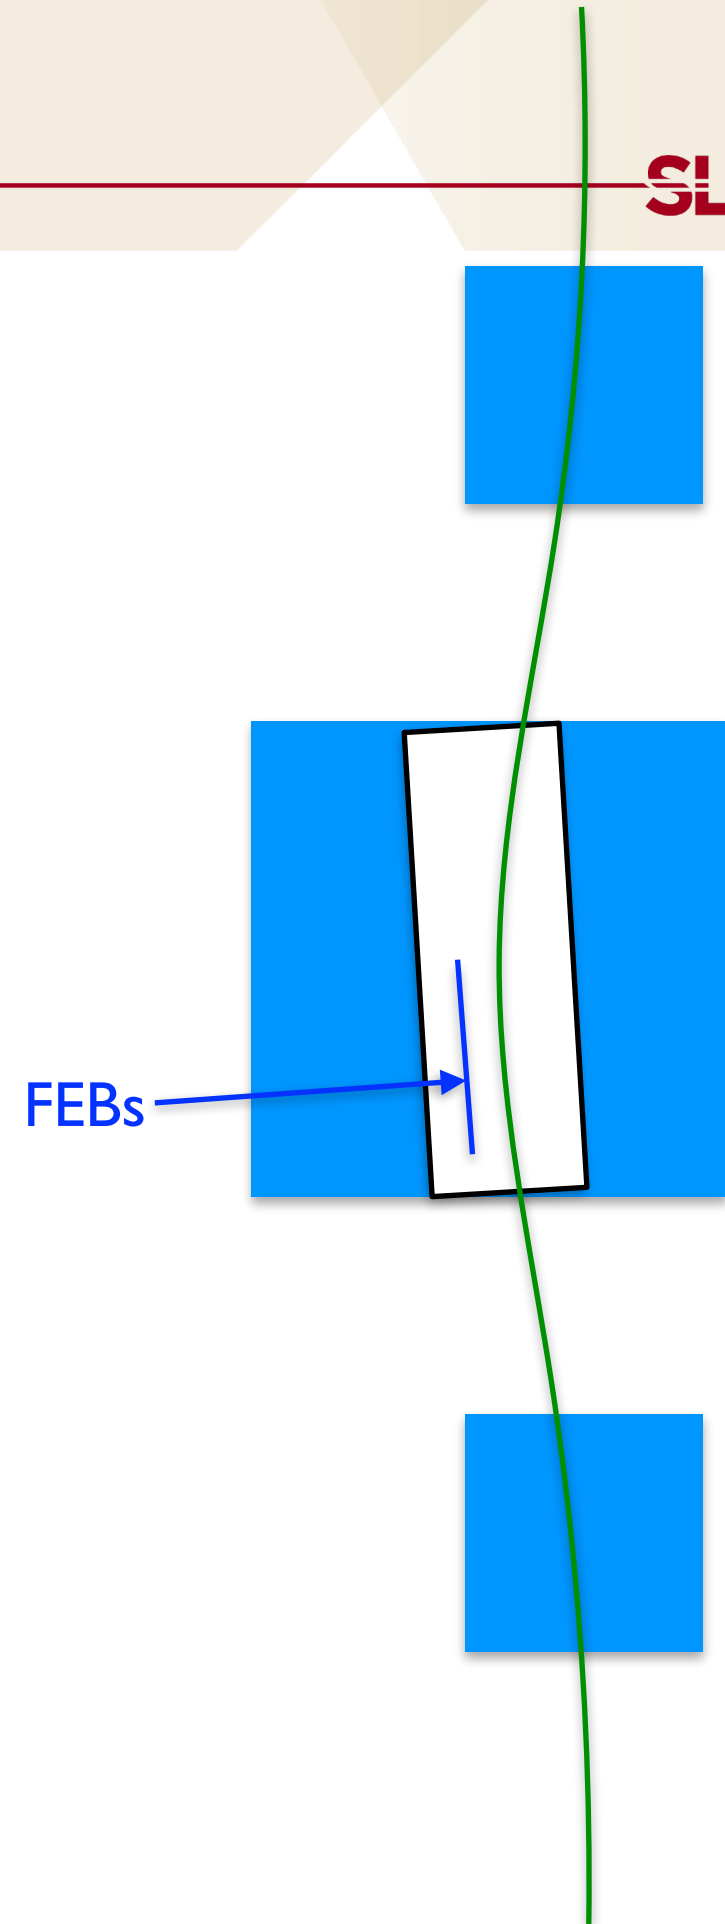
*FEB degradation manifests as drooping 5V / 500 mA regulator, which supplies:*

*No current monitoring, so mechanism unclear, but lowering temperatures improved overhead.*

- With only 3/10 symptomatic, geographically diverse, numerology favors problem w/ current draw.
- Temperature sensitivity favors a regulator problem. (known susceptibility of LDO control/monitoring).

*Damage meant loss of L7T and one hybrid in L5B.*

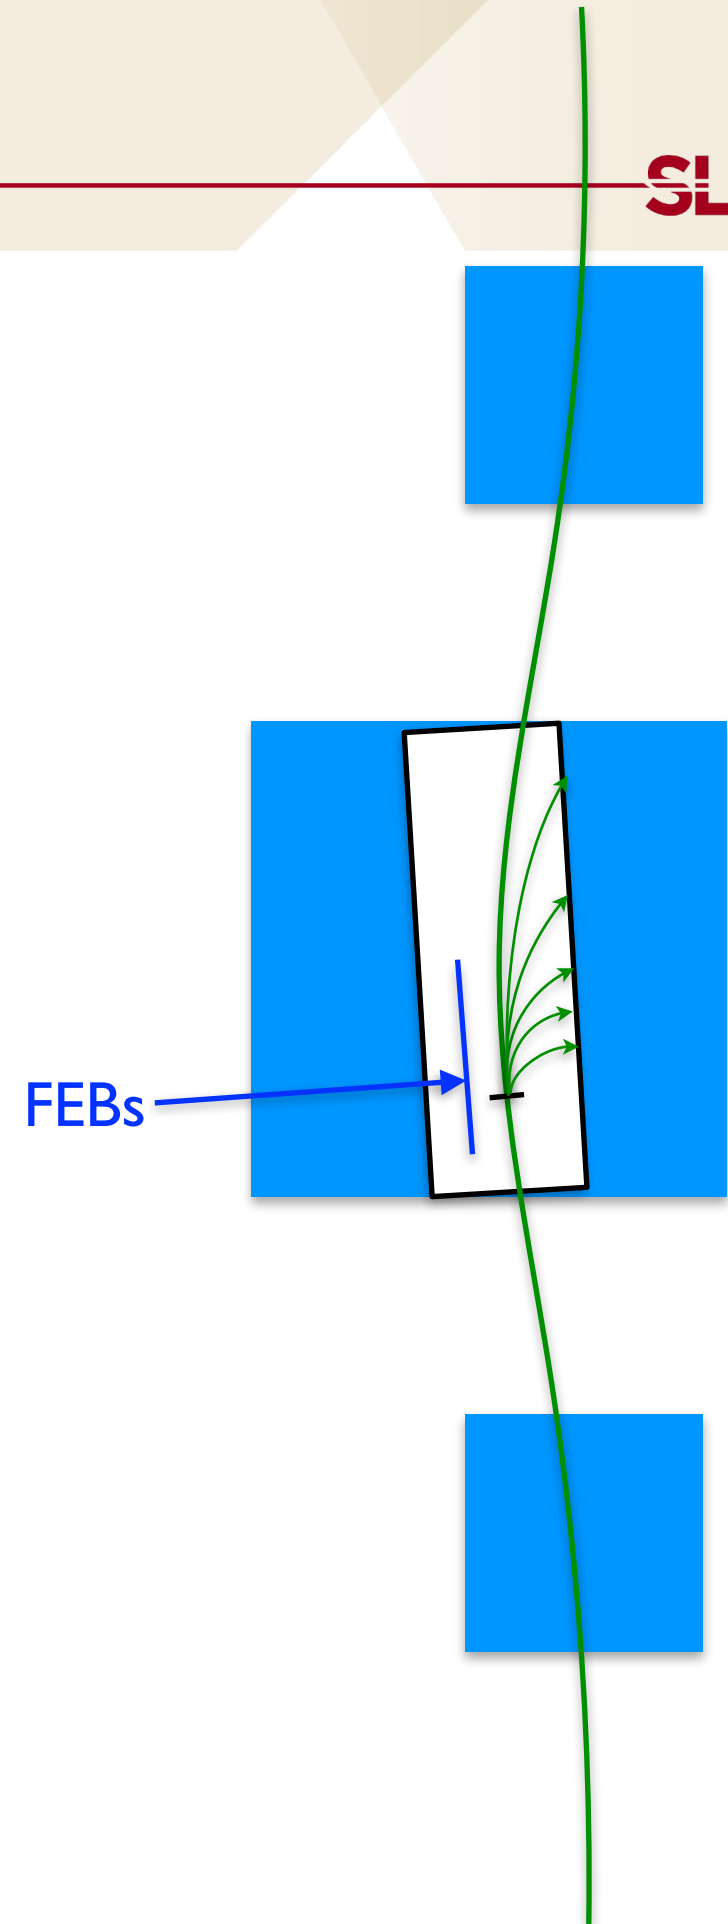
*FEB degradation manifests as drooping 5V / 500 mA regulator, which supplies:*

*No current monitoring, so mechanism unclear, but lowering temperatures improved overhead.*

- With only 3/10 symptomatic, geographically diverse, numerology favors problem w/ current draw.
- Temperature sensitivity favors a regulator problem. (known susceptibility of LDO control/monitoring).

*Damage meant loss of L7T and one hybrid in L5B.*

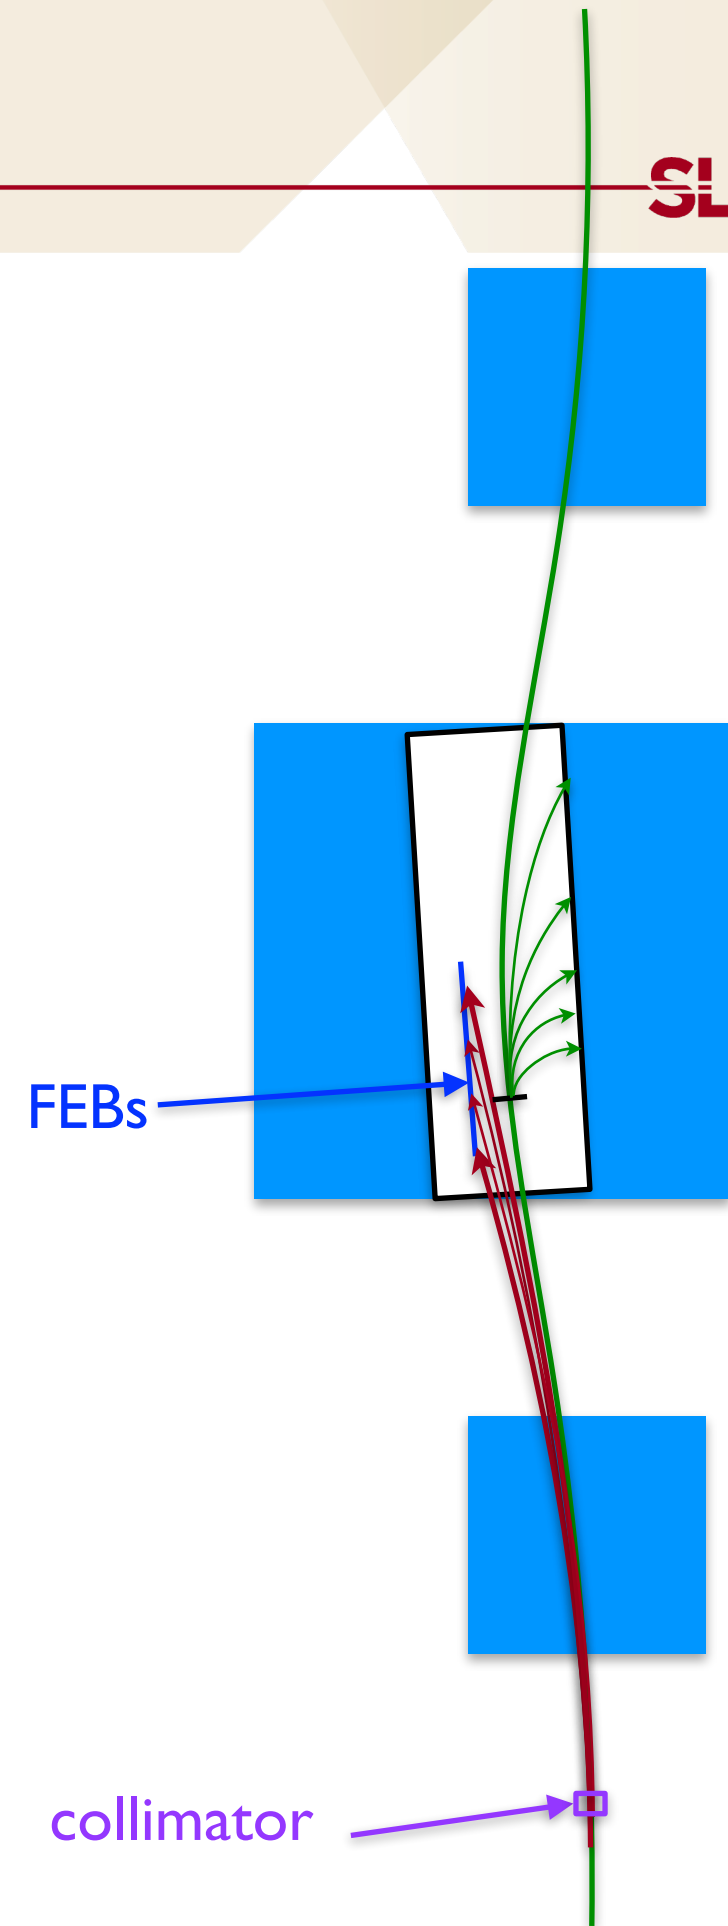
*FEB degradation manifests as drooping 5V / 500 mA regulator, which supplies:*

*No current monitoring, so mechanism unclear, but lowering temperatures improved overhead.*

- With only 3/10 symptomatic, geographically diverse, numerology favors problem w/ current draw.
- Temperature sensitivity favors a regulator problem. (known susceptibility of LDO control/monitoring).

*Damage meant loss of L7T and one hybrid in L5B.*

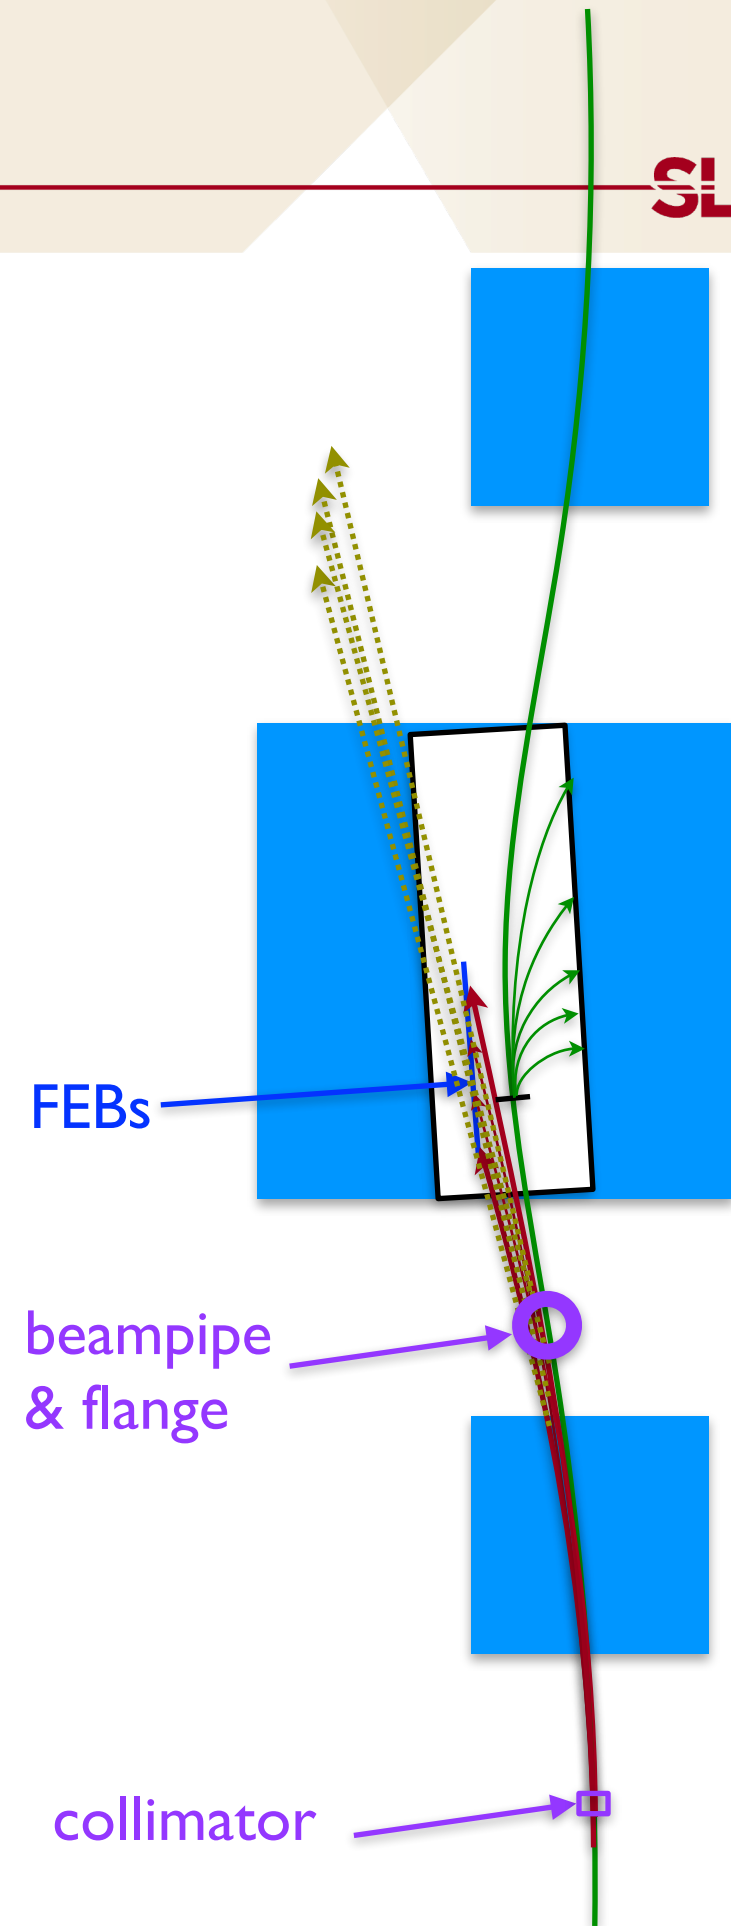
*FEB degradation manifests as drooping 5V / 500 mA regulator, which supplies:*

*No current monitoring, so mechanism unclear, but lowering temperatures improved overhead.*

- With only 3/10 symptomatic, geographically diverse, numerology favors problem w/ current draw.
- Temperature sensitivity favors a regulator problem. (known susceptibility of LDO control/monitoring).

*Damage meant loss of L7T and one hybrid in L5B.*

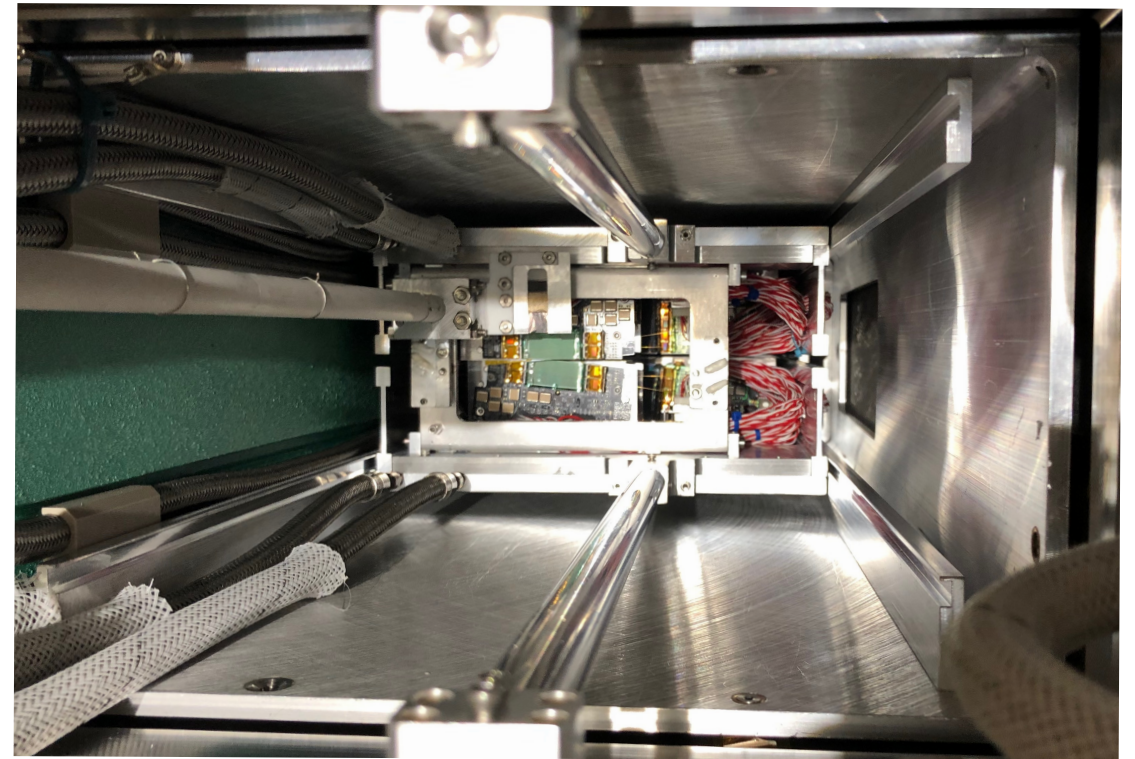
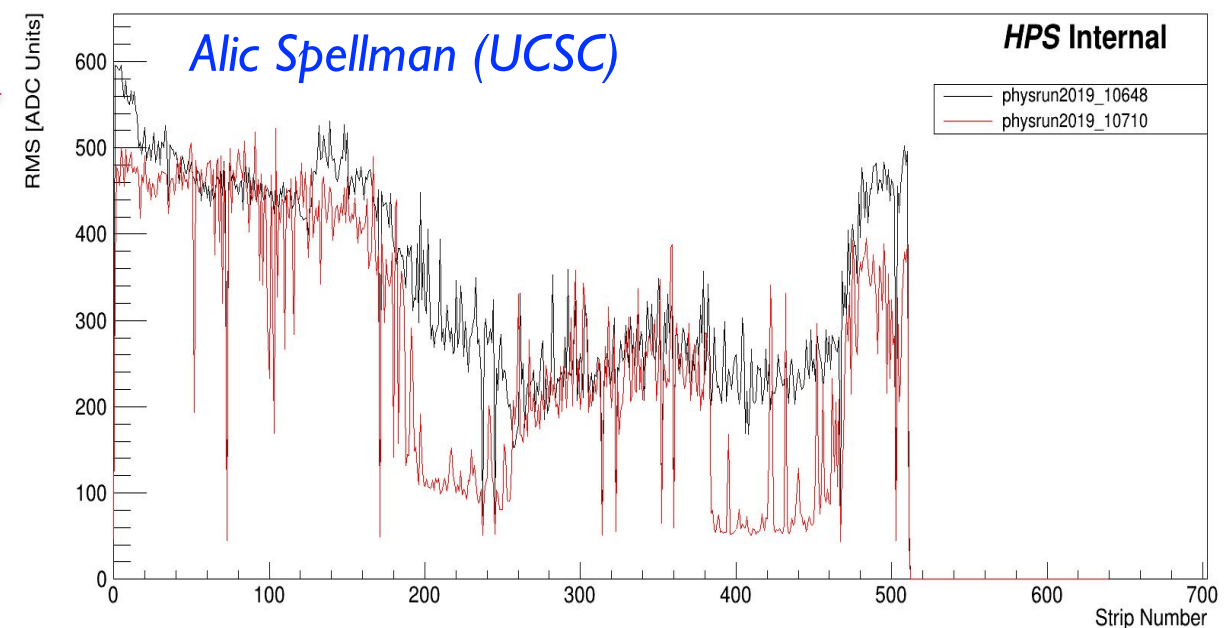
raw\_hits\_L1T\_axial\_timesample\_0\_physrun2019\_10648

*HV trips in the SVT were rare in previous runs, but much more common in 2019.*

- On a few specific days, experienced a large number of HV trips in Layers 1/2.
- No obvious problems with beam, but there was unusual activity /tuning for other halls
- On one occasion, a section of channels damaged in Layer 1, mostly outside acceptance.
- Late in the run (during straight-throughs?), a Layer 2 sensor severely damaged.

*Layer 1/2 sensors no longer hold bias voltages required for operation to much higher doses.*

*Will need access to modules to study these issues further and explore mitigations.*

*More modules will be needed to run again.*
