# ECAL Maintenance & Repairs

HPS Collaboration Meeting

May 2020

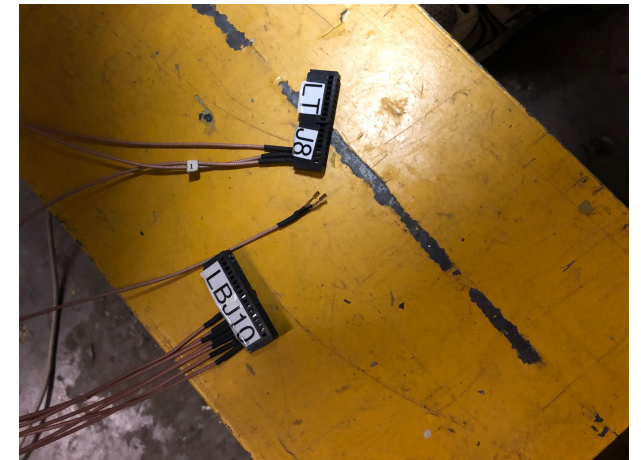
- Probably 3 bad ones, 2 of which went during the run, 1 shortly prior on electron side
- 3 more candidate signal issues, some developed during the run, could be preamps
- We have a ~dozen good, spare preamps, ideally get more

- (-9,2) low amplitude
- (7,-3) low amplitude
- (-7,-2) large amplitude
- (-15,-2) dead
- (5,-2) dead
- (-1,1) dead

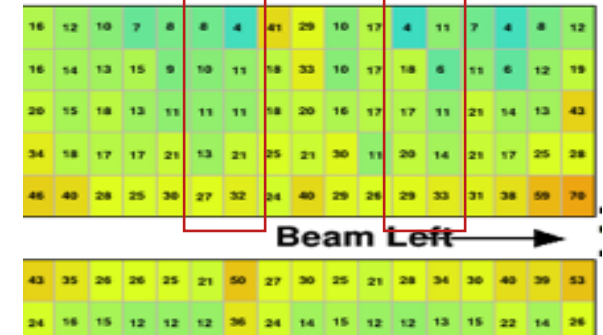
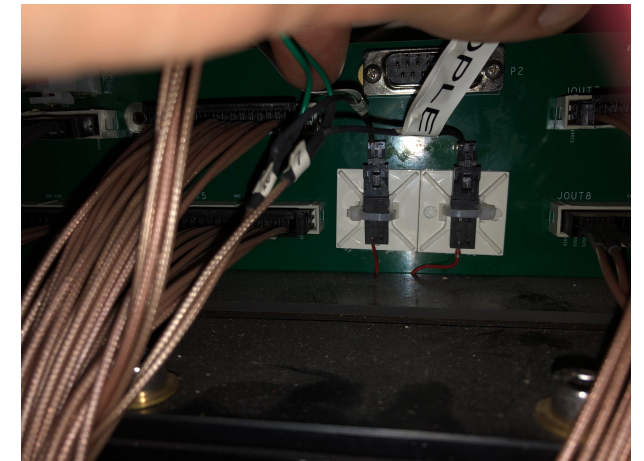
HV LT7 and LT10

- One HV group's current draw (gains) varied during the 2019 run for a few days
  - possibly due to a single preamp
  - this was a bigger problem during the 2015 engineering run too, before sticker removal on all preamps
- Another HV group was problematic
  - holding voltage for many weeks prior to the 2019 run, and then all of a sudden unable to without tripping
  - it's one of the 2 groups that has motherboard bypass
  - fixed during the beam commissioning phase, didn't really impact the run much, fortunately
    - cut soldered pigtail, switched to terminal block to ease swapping preamps (soldered HV)
    - pulled preamps until finding the culprit and replaced it
  - should we preemptively do the same terminal block "fix" for the other HV group with motherboard bypass?
- They're both on the same half of the same motherboard ....

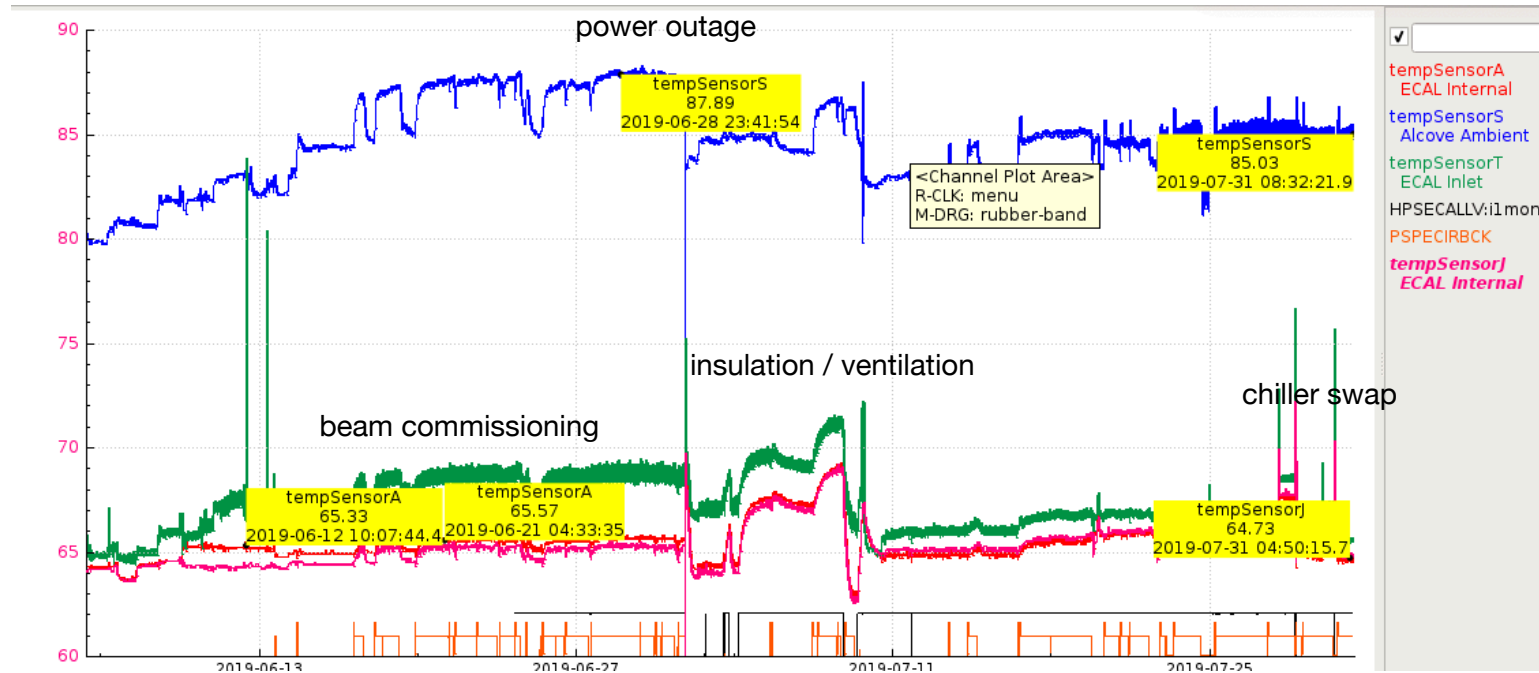
- Chiller issues during the 2019 run, exacerbated by changing alcove environment, led to gain variations in ~20% of the production runs that had to be calibrated out offline
- Maintain the improved insulation and alcove ventilation that was installed during the 2019 run
- Keep a spare chiller on standby (we did have one in 2019, but not immediately accessible)
- Be more judicious on chiller stability requirements and replacement
