Updates from the Lab: Some Testing with MHTestB

Some Preliminary Observations & Measurements

SLAC MAGIS Group Meeting

Jun. 24th, 2021

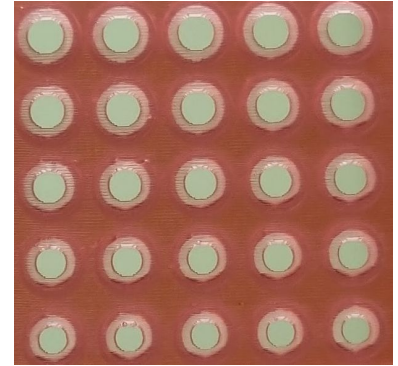
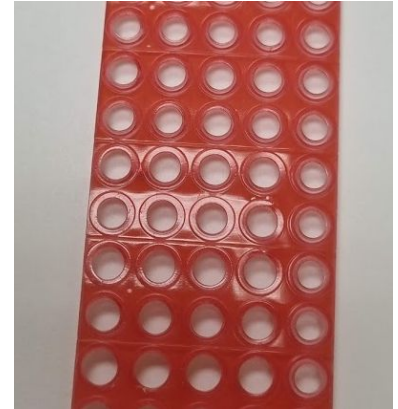
MHTestB: Printing Direction

- Local supports are printed vertically
- Front boards are printed horizontally
 - Huge difference in overall smoothness & hole inner diameter
 - 5.3mm and 5.4mm both feel very loose
- This was done at the company's discretion; perhaps worth specifying printing direction next time
- What do we expect from the final “dome” shape?
How would the diagonally printed holes look like?

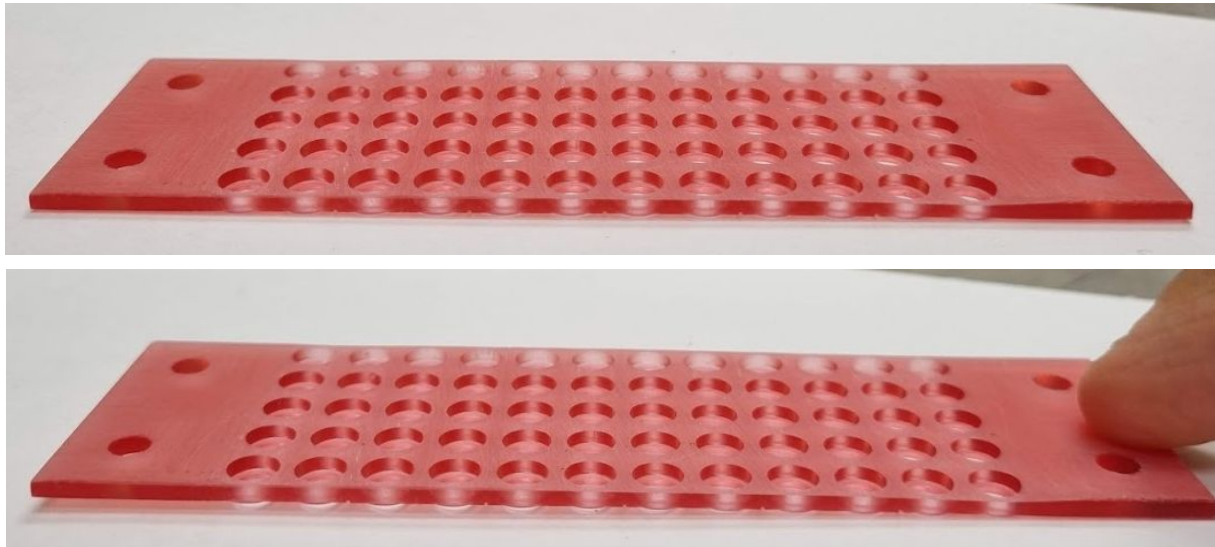
MHTestB: Flex in Front Boards

- Front boards are convex to the front side
 - Similar behavior all across the 4 boards
- Makes it difficult for the mirrors in the central region to be pushed properly

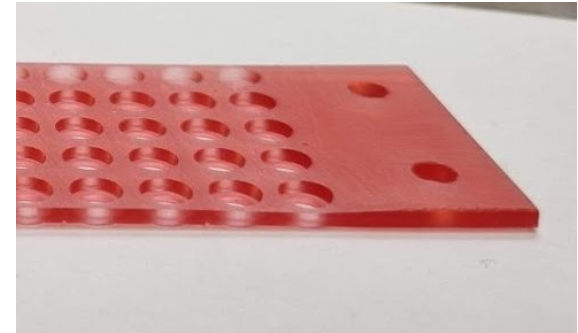
MHTestB: Non-uniformity in Front Boards

- Front boards have non-uniform thicknesses
 - Was designed to be uniform at {1.8, 1.9, 2.0, 2.1} mm
 - 0.3mm - 0.4mm thicker in the bottom & top regions (visible amount!)
- Digital caliper measurements

Board Type	Thickness [mm] @ bottom region	Thickness [mm] @ center region	Thickness [mm] @ top region
1.8mm	2.24	1.86	2.13
1.9mm	2.33	1.91	2.31
2.0mm	2.44	2.03	2.40
2.1mm	2.37	2.06	2.44

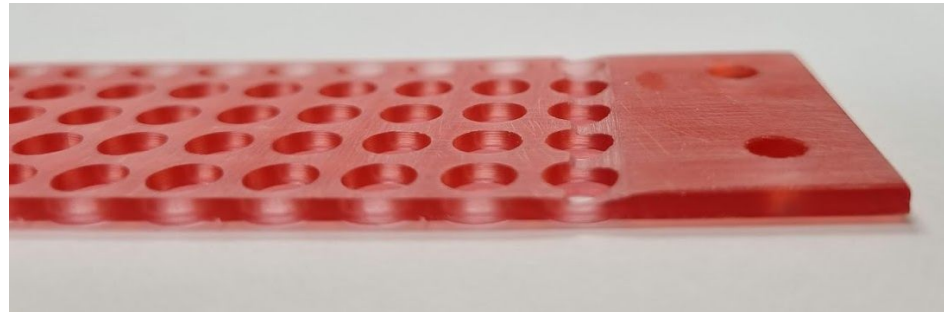
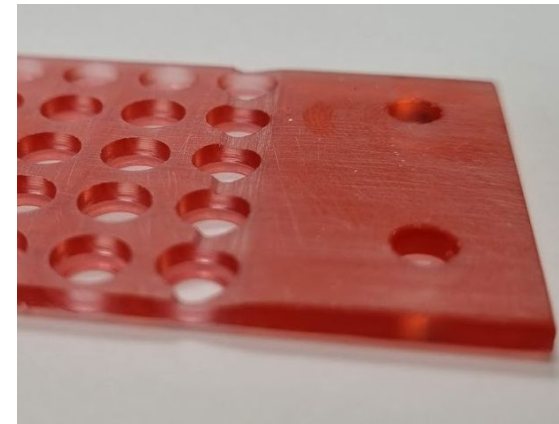
MHTestB: Damage on 1.9mm Board

- The very bottom row of 1.9mm front board has significant damage
- What caused it?
 - Printing process...?
 - Unlikely, considering the printing direction
 - Handling process @ company
 - Delivery

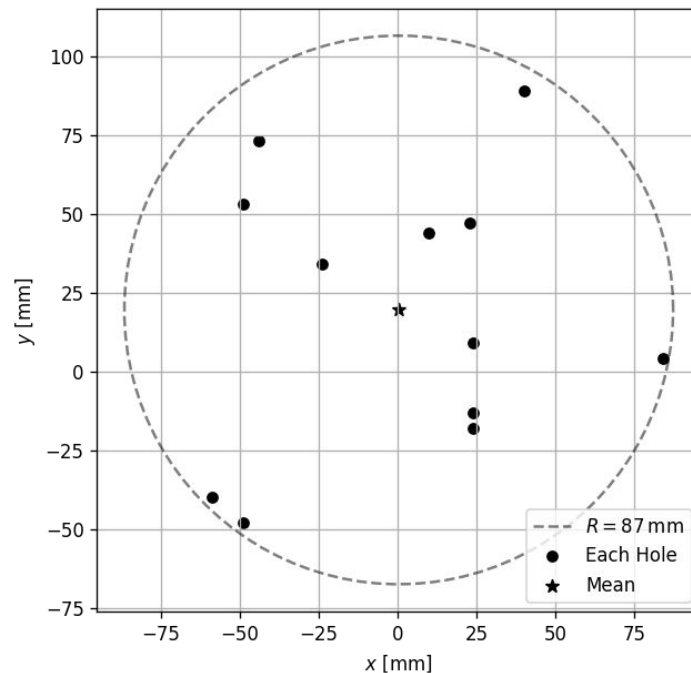
MHTestB 1.8mm Board with 1/64" Rubber Sheet
Control column (5.4mm, 0.8mm)

- 1.8mm front board, “control” column
 - 12 identical holes
 - 5.4mm diameter, 0.8mm overlap radius
 - Repeated across different front boards
- Full result with 1/64” rubber sheet
 - All beamspots **within 87mm radius** from mean, corresponding to **$\pm 0.64\text{deg}$**
 - No obvious trend within the column
- Quick test (no data recorded)
 - A similar (perhaps slightly worse) result was observed with the same 1.8mm board without rubber sheet
 - No visible damage to mirrors

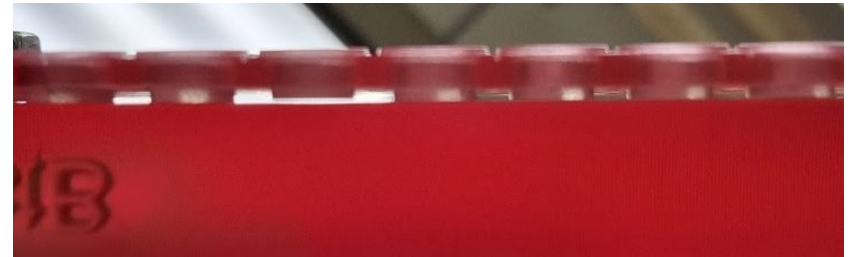
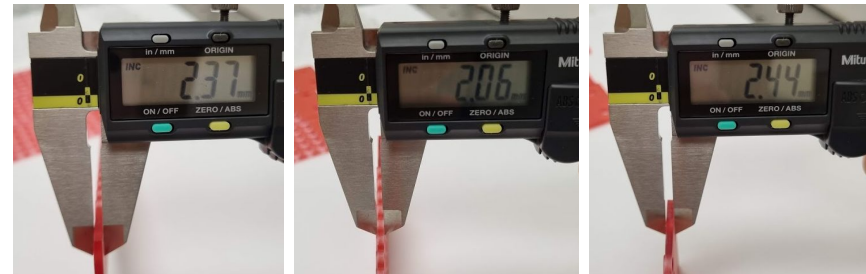
Issues with the Front Board Thicknesses...

- Noticed **significantly larger span** with and without rubber
 - ~120mm radius, ~0.88deg
- Then, upon closer visual inspection, it was noticed that **the mirrors were not properly pushed in by the local support**
 - Bottom/top are significantly thicker than the mirrors
 - The front board is bent
 - Too much pressure from the screws can further bend the board

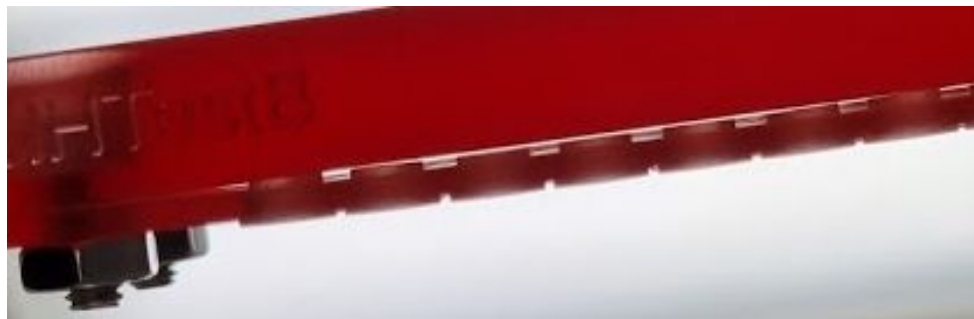
Wait... Re-visiting the 1.8mm Board

- 1.8mm board edges also slightly thicker (2.24mm, 2.13mm)
- Along with bending effect, our mirrors could again be floating
- Was this happening in the no-mirror run?

- Yes, indeed!
 - But there is very little room, maybe 0.1mm
 - That corresponds to $\sim 1.15^\circ$
 - Not terrible, but not good enough \Rightarrow 2.13mm, 2.24mm edges are no good

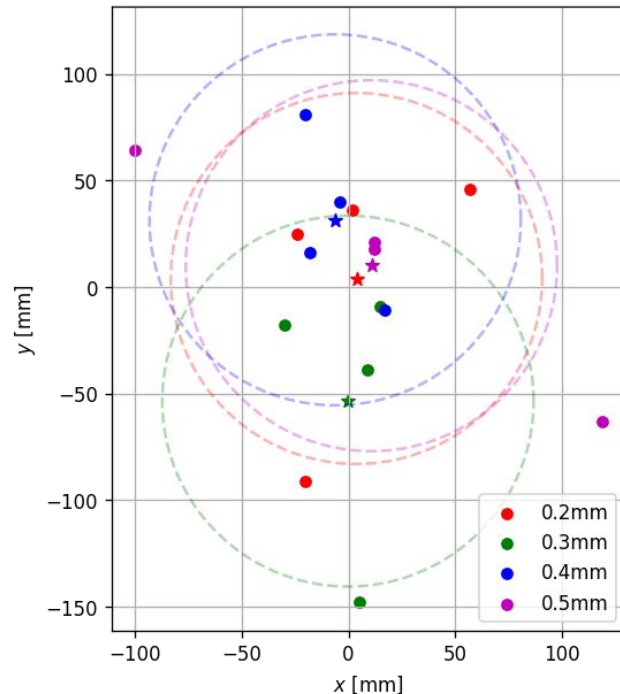
MHTestB 1.8mm Board with 1/32" Rubber Sheet
5.4mm holes with different overlaps

- 1.8mm front board + 1/32" rubber sheet
 - 5.4mm diameter holes
 - Front-stop overlap: {0.2, 0.3, 0.4, 0.5} mm
 - 4 holes per parameter
- Overall, quite a bit worse than 87mm
 - More like 130mm, 0.95deg
 - Possibly due to bending of front board
 - Need to fine-tune screw strength
- No noticeable trend
 - Larger overlaps no more stable than smaller ones
 - This is worth decreasing, if possible
