Safety Measures Taken in High-Gradient Accelerating-Structure Test Facility at KEK

Tetsuo ABE

KEK / Accelerator Laboratory

LCWS2023

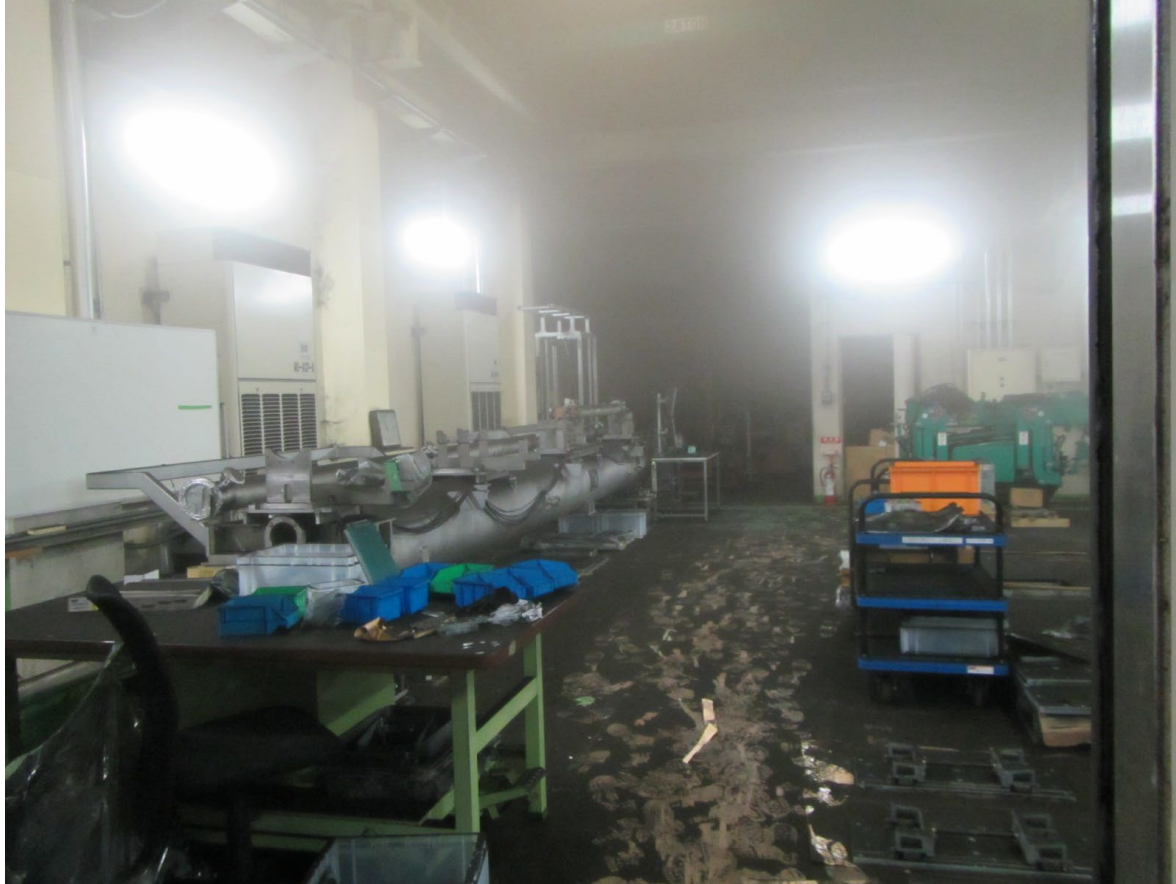
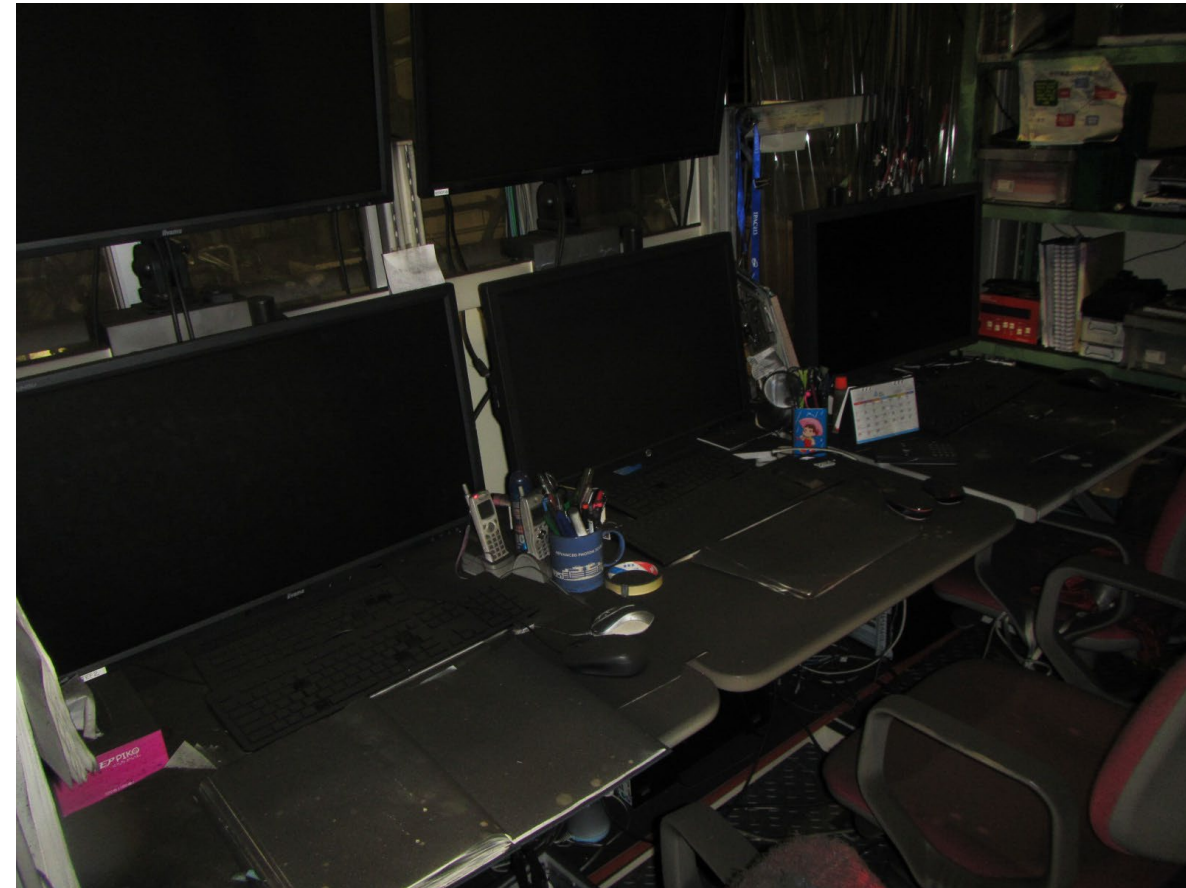
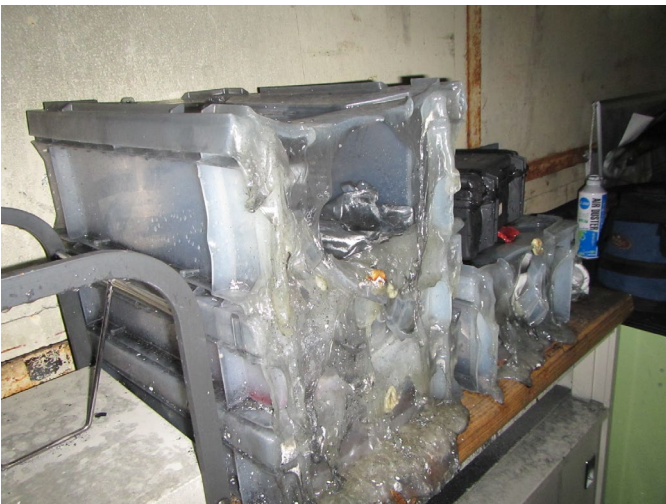
A lot of soot spatially spreaded to the injector linac building
➔ To remove the soot around Nextef, it took over a year.

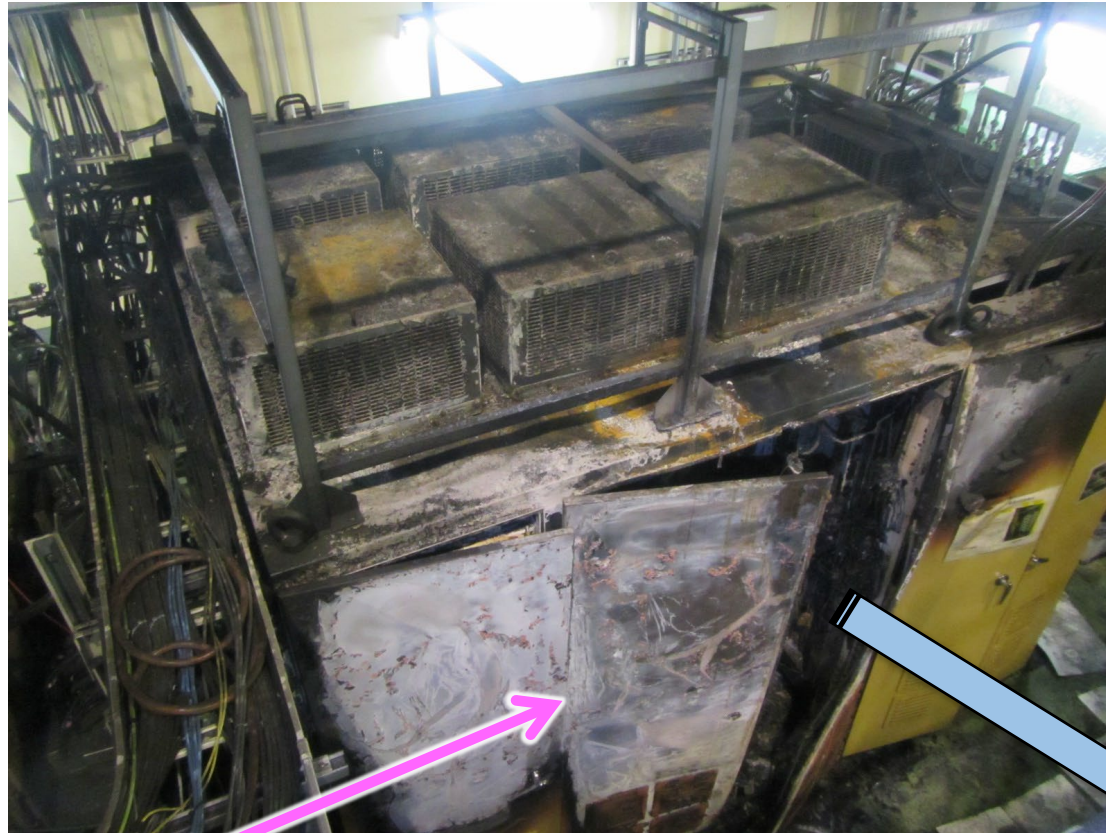
Burnt modulator

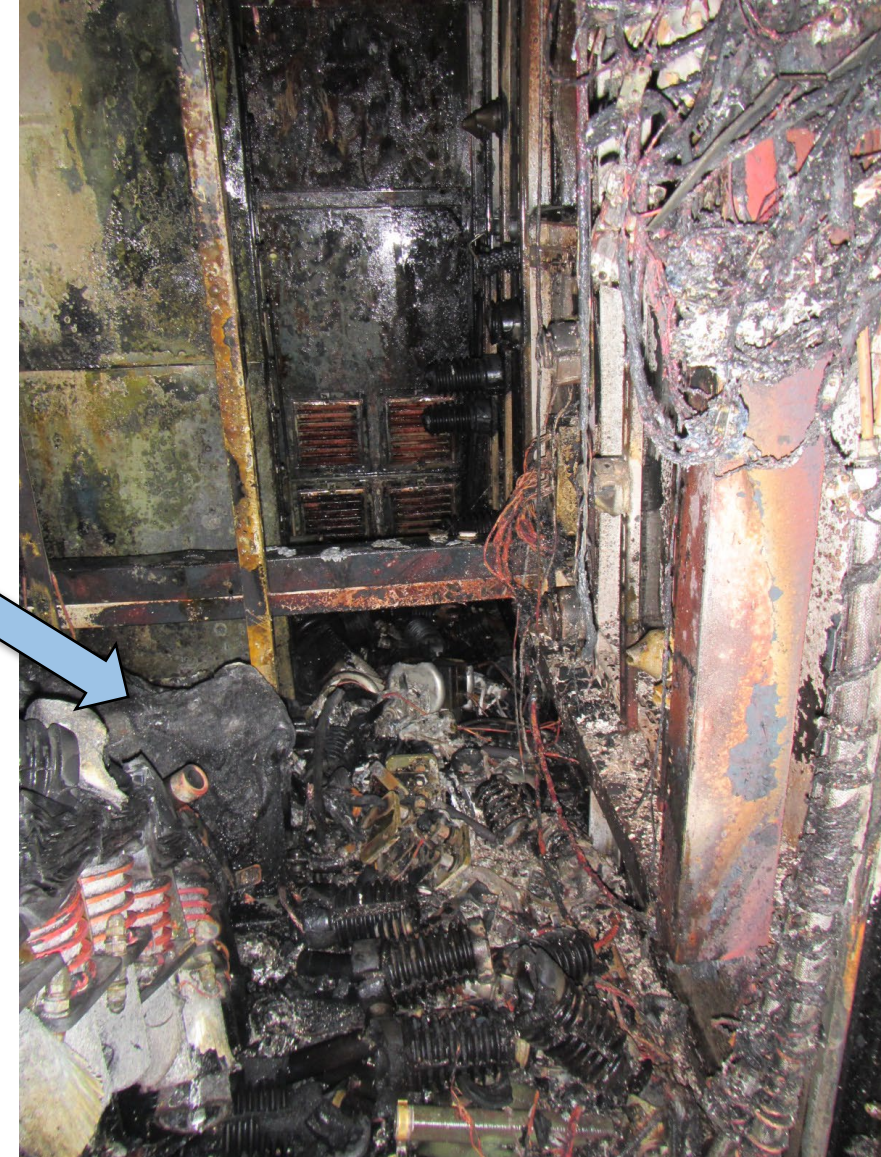
All the plastic-case capacitors meltdown

- No deterioration of the modulator performance observed
- The most likely cause is puncture of the plastic-case capacitors (although there is no direct evidence).
 - Fire occurred at other facilities using modulators with plastic-case capacitors.
 - At Nextef, such puncture occurred twice.

- Plastic → metal capacitors with a lower field
- Fire extinguisher installed in the modulator

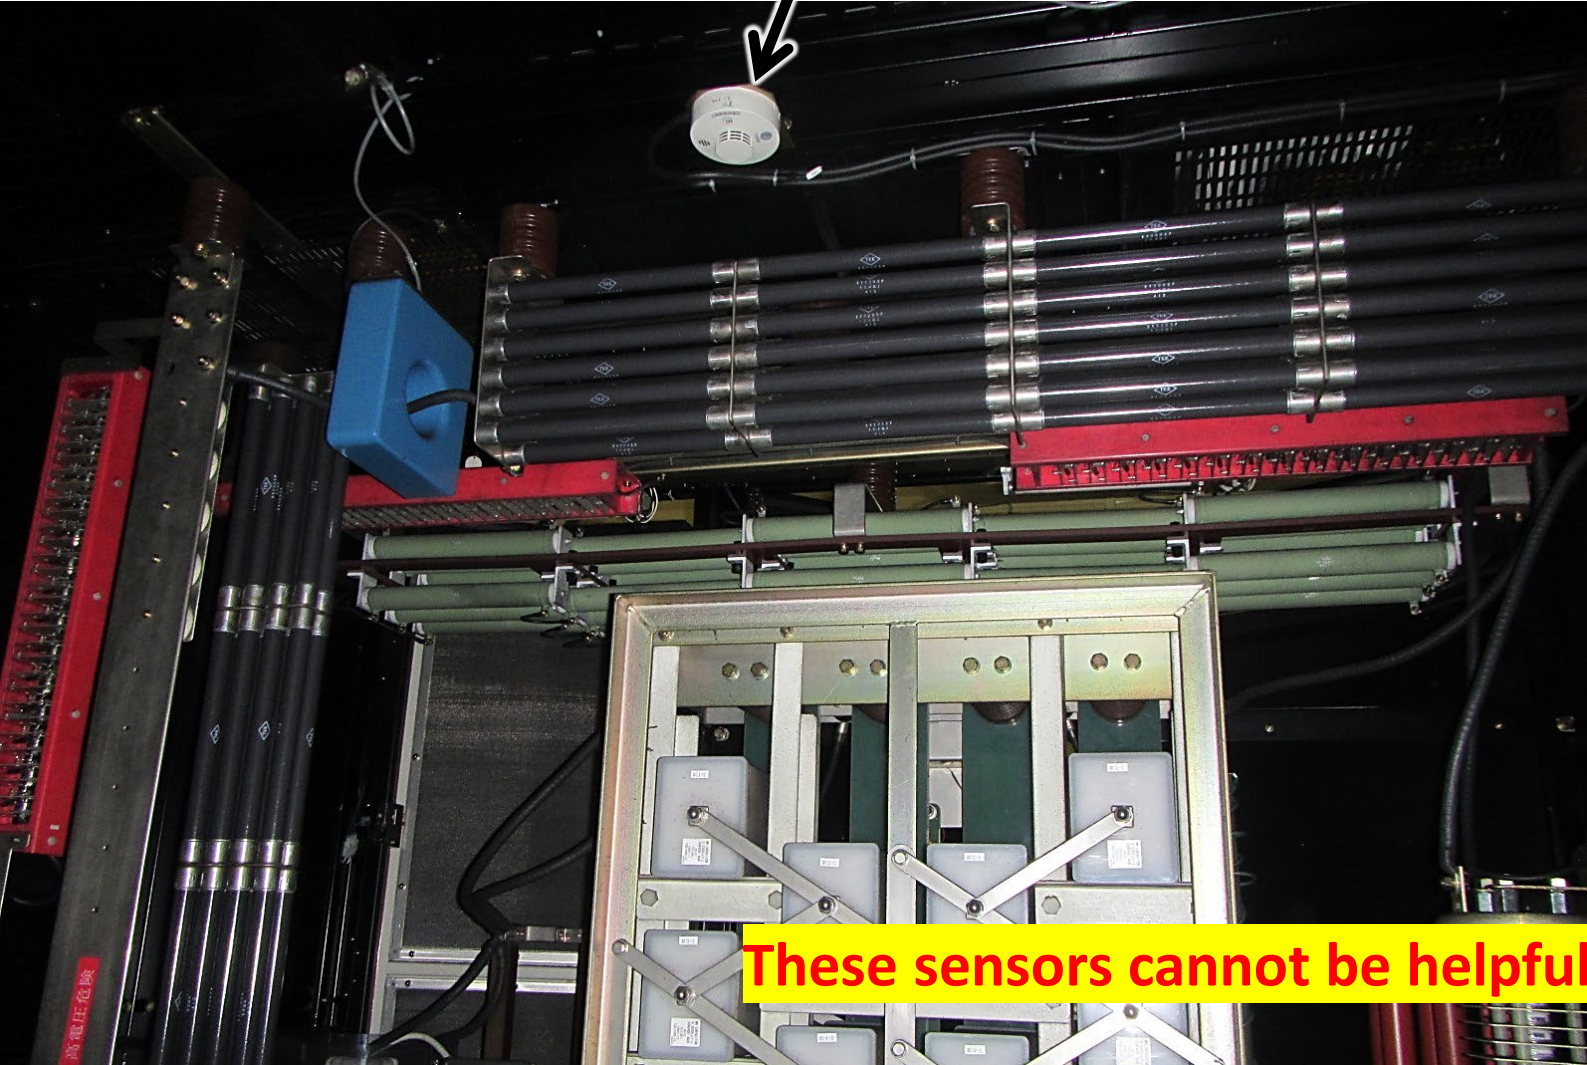
Smoke sensor
located at the center of the ceiling

These sensors cannot be helpful for fire prevention.

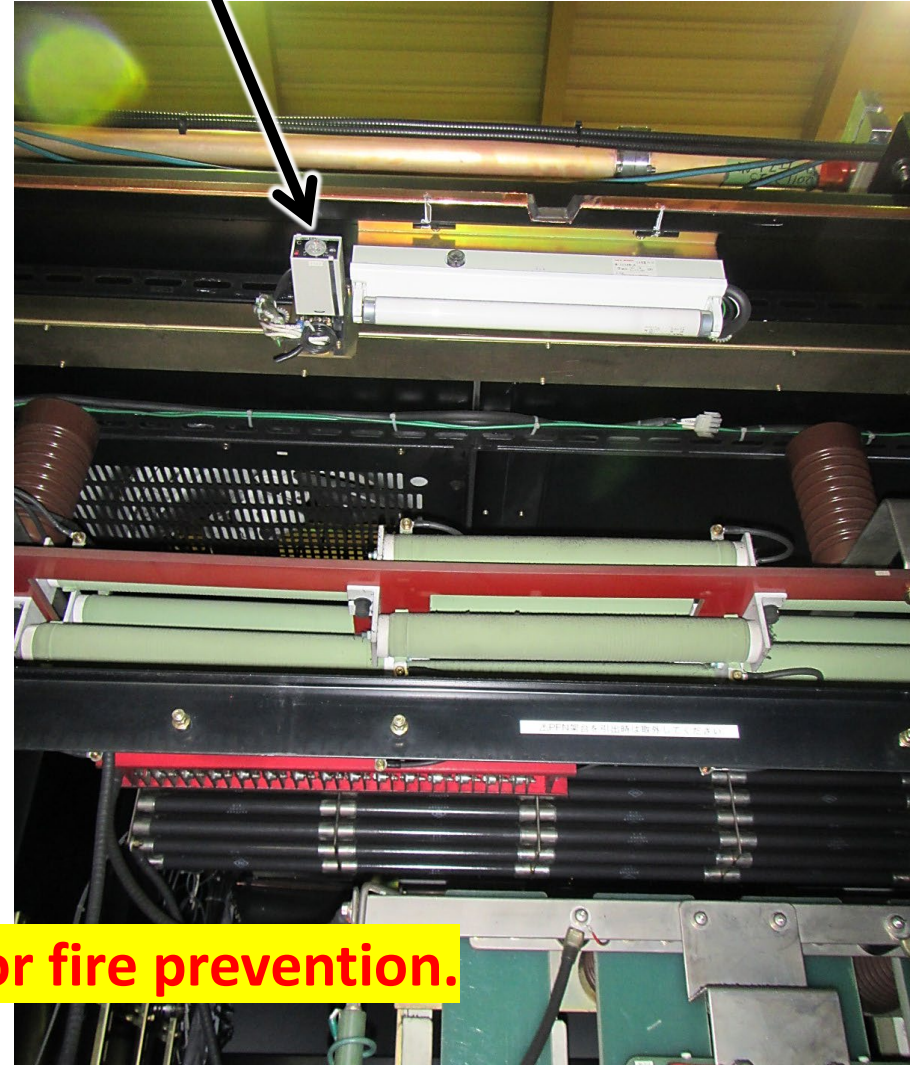
Temperature sensor (Threshold: 40 degC)
located at the edge of the ceiling

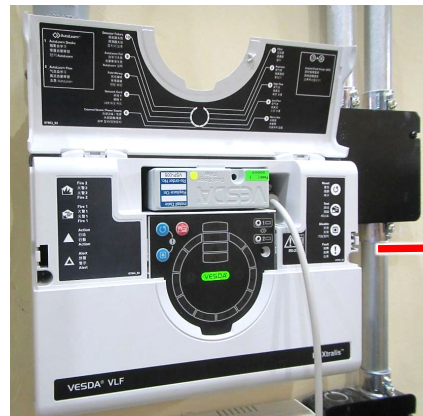
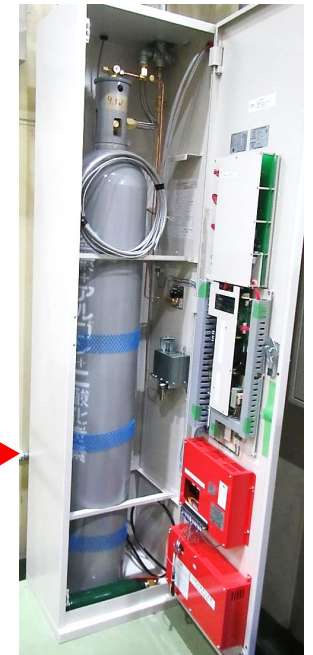
(Intake)
High-sensitivity
smoke detector
(VESDA)

> 0.1 %/m → HV OFF

> 2.0 %/m → LV OFF, Start fire exting.

PFN cover to make the smoke-detection sensitivity higher

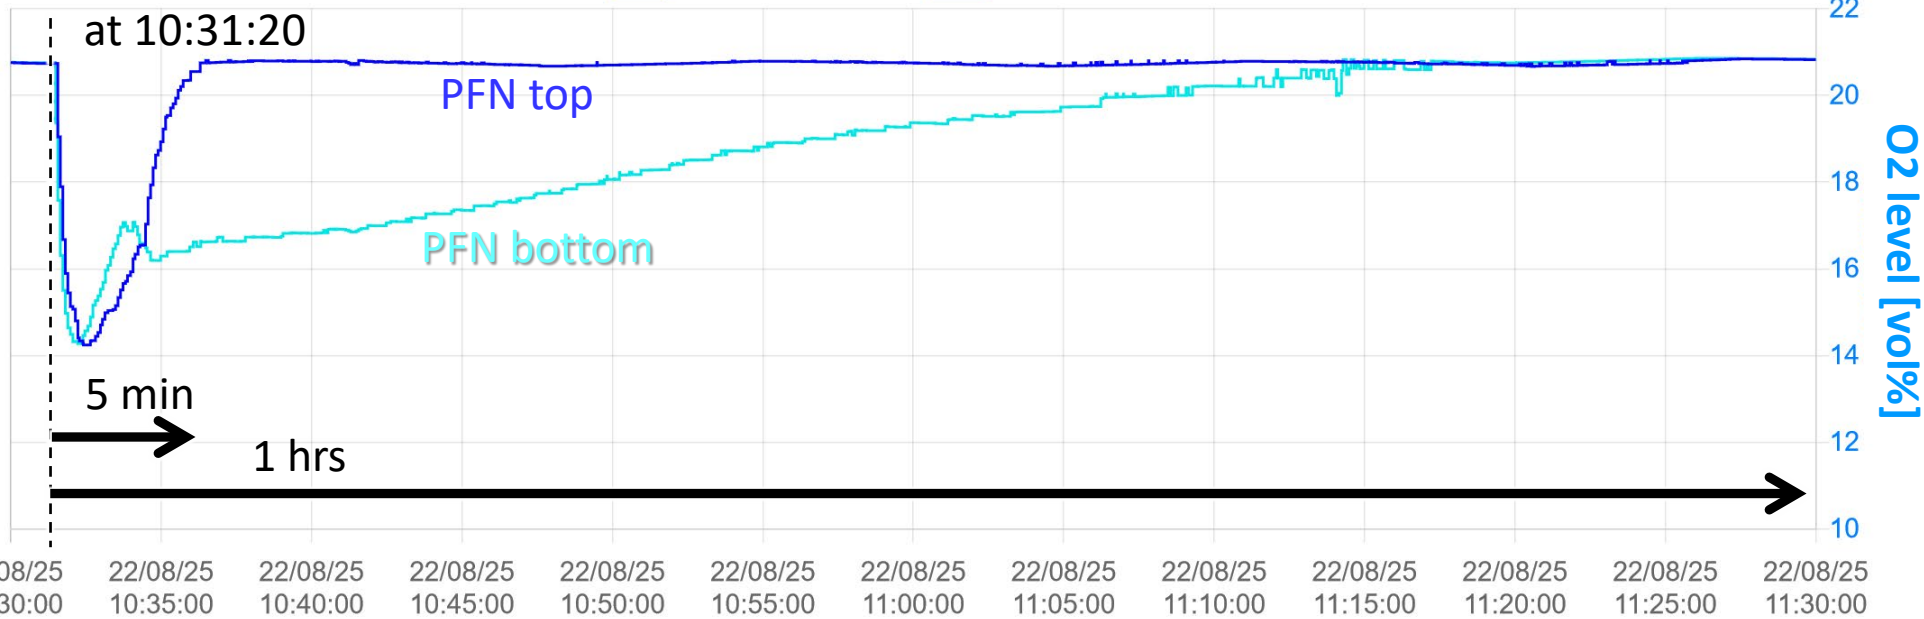
- ✓ O2 level dropped to 14.3vol% (15vol% is the threshold for fire to persist.)
- ✓ After 1 hour, the O2 levels returned to normal (20.9vol%)

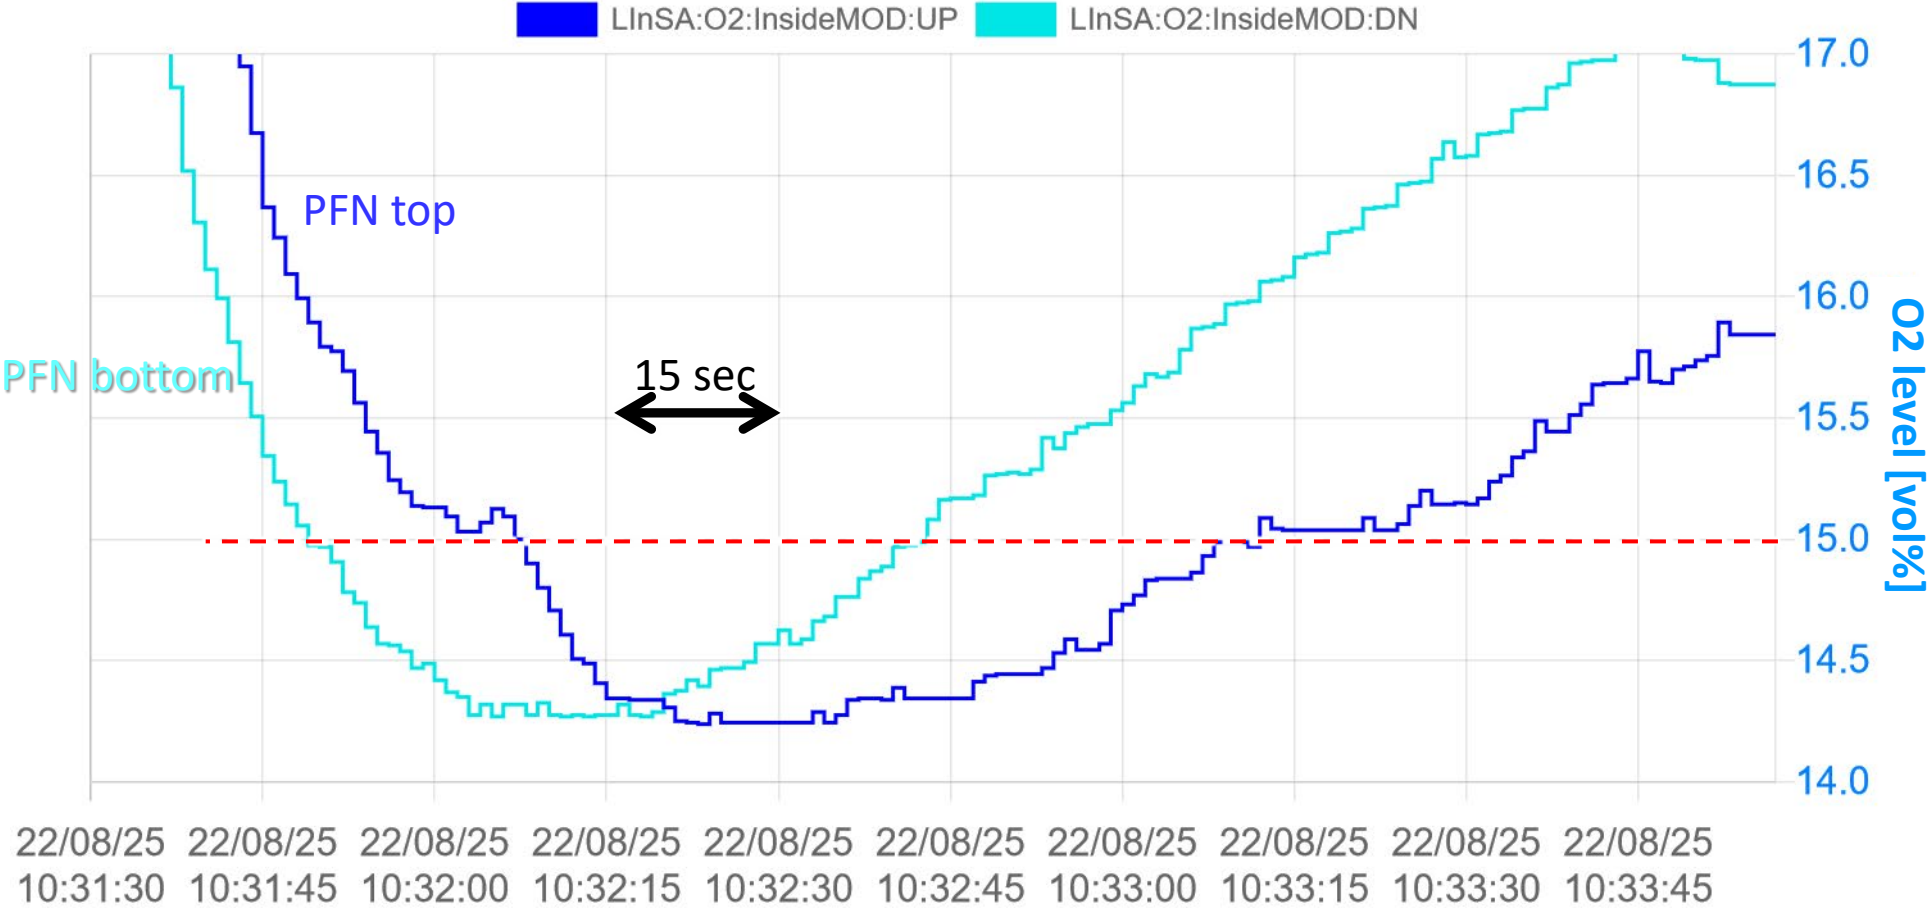
- Time during the O2 level below 15vol%
- At the PFN top : 63 sec
 - At the PFN bottom : 53 sec

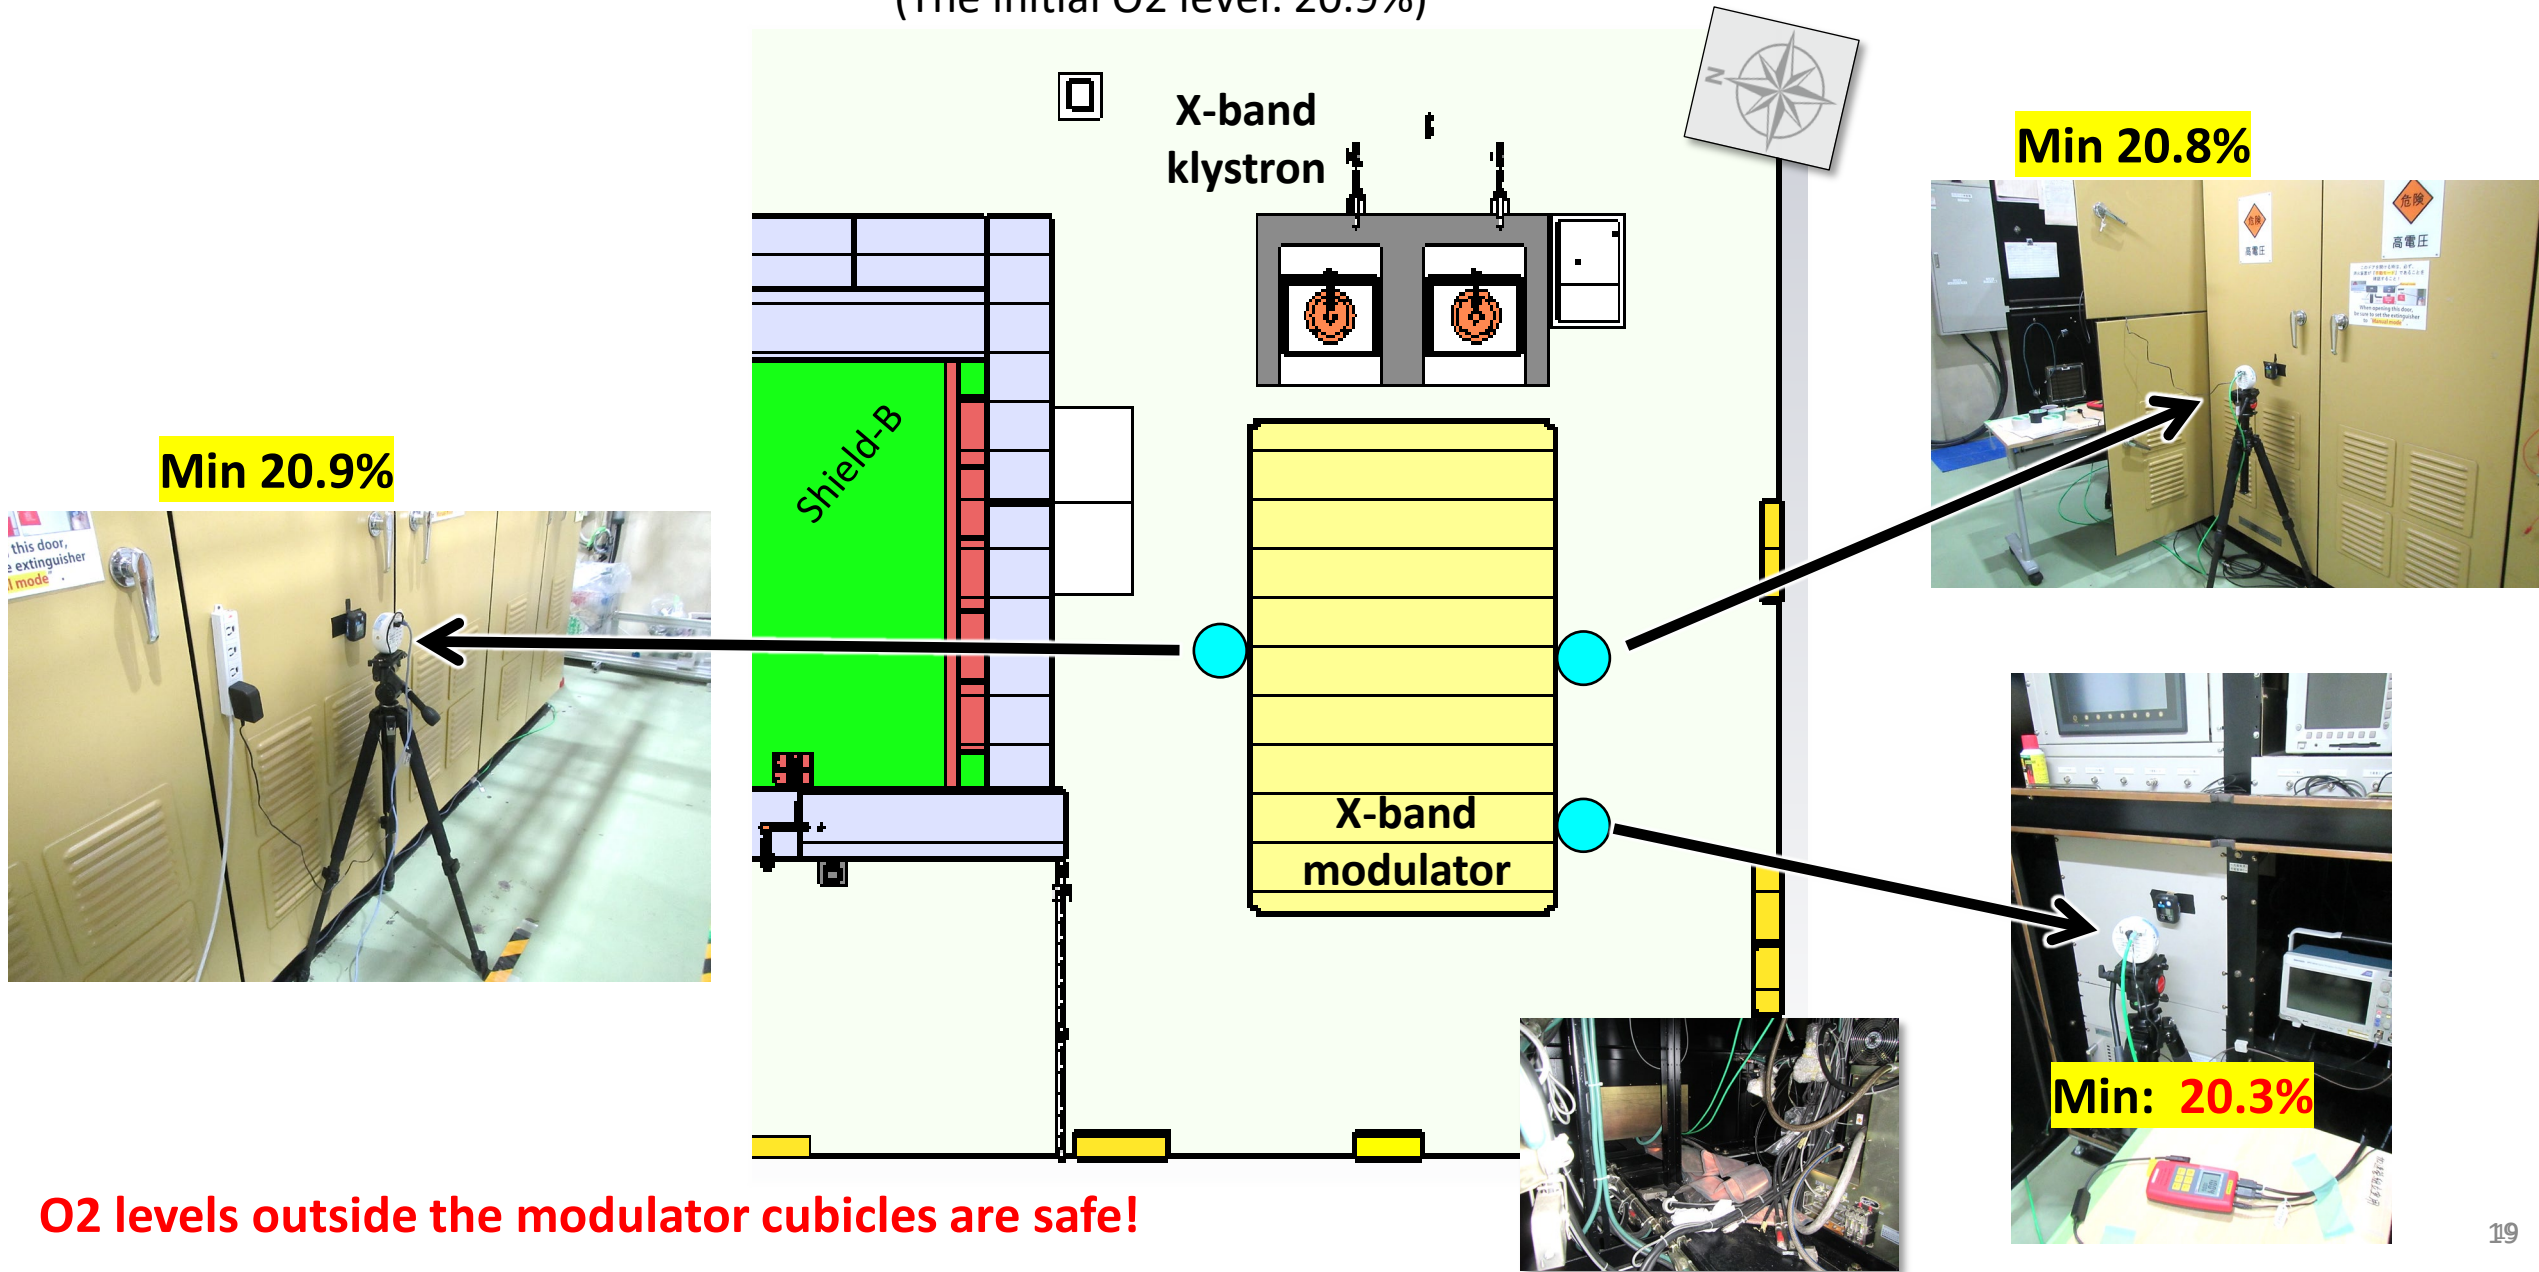
No change in the O2 level outside the modular @ at a height of 1 meter above the floor.

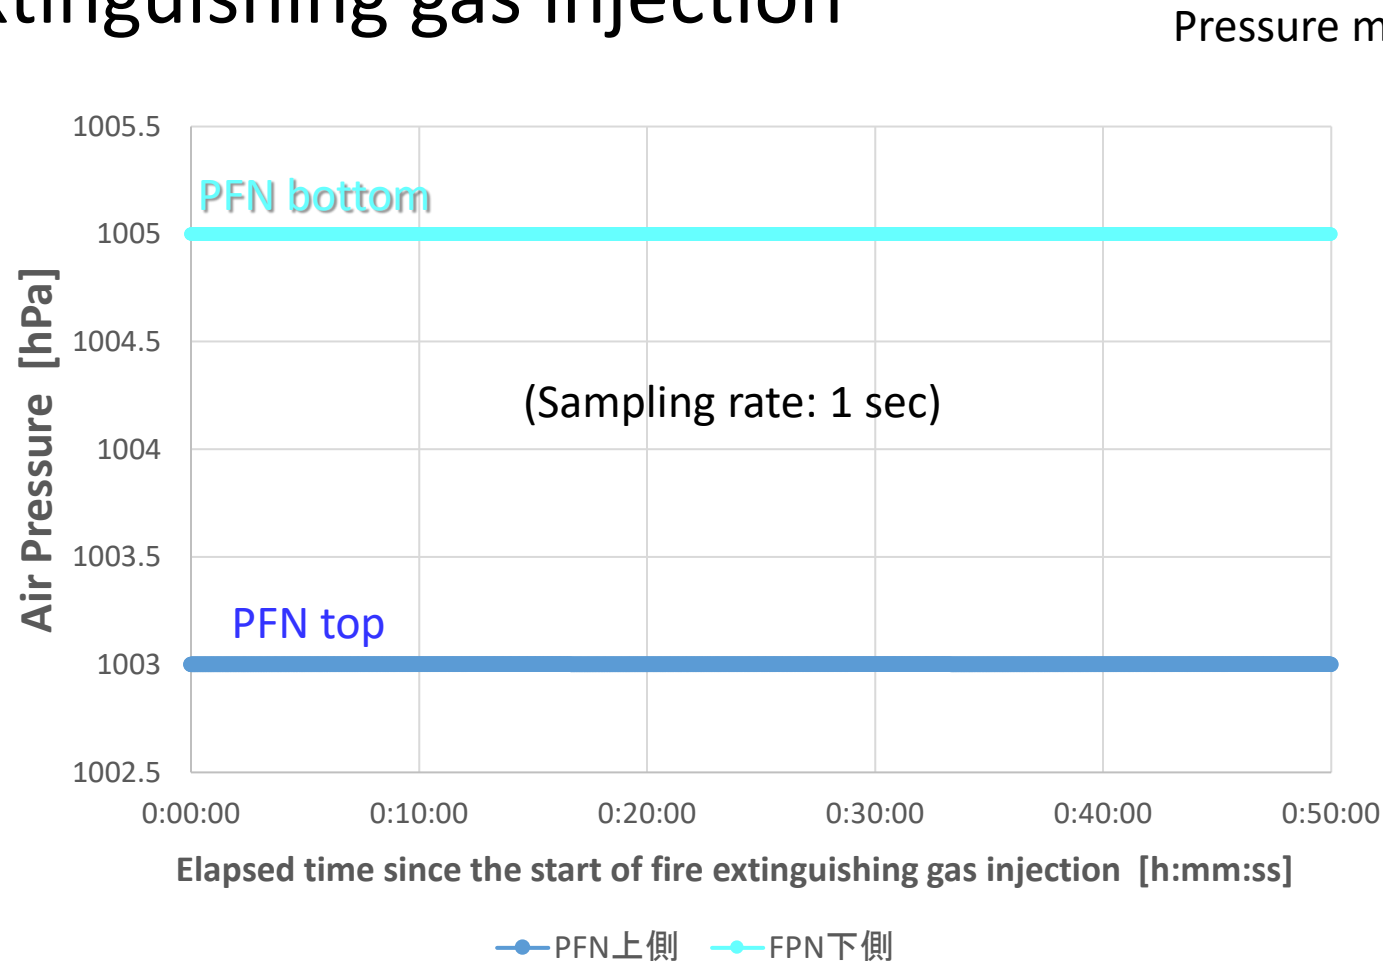
No change in gas pressure inside the modulator during/after the fire extinguishing gas injection

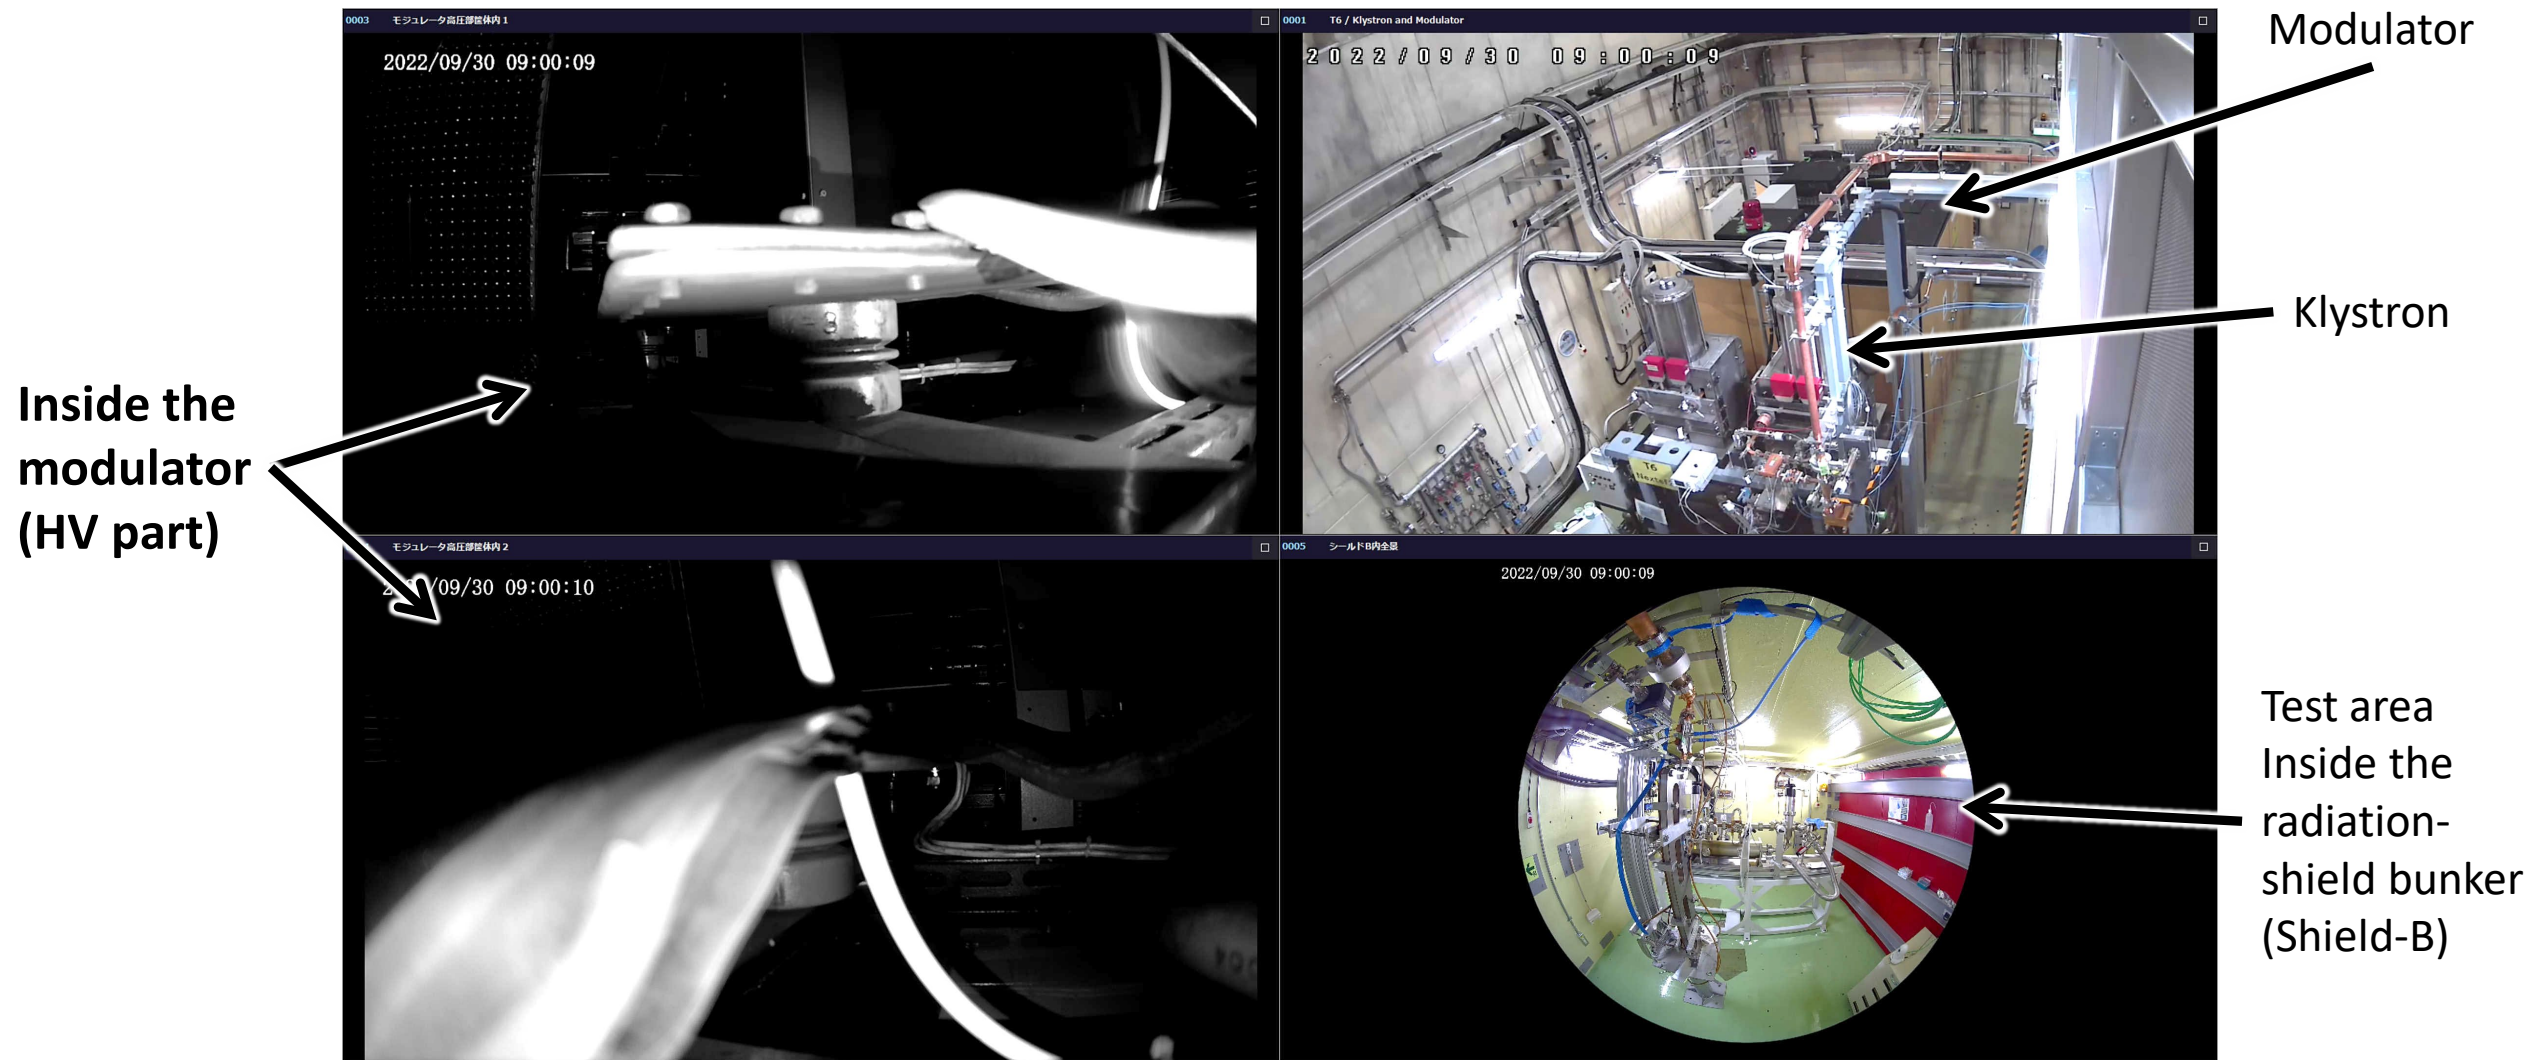
Video monitoring at Nextef2

Not only the outer appearance, but also the inside of the modulator being visually monitored

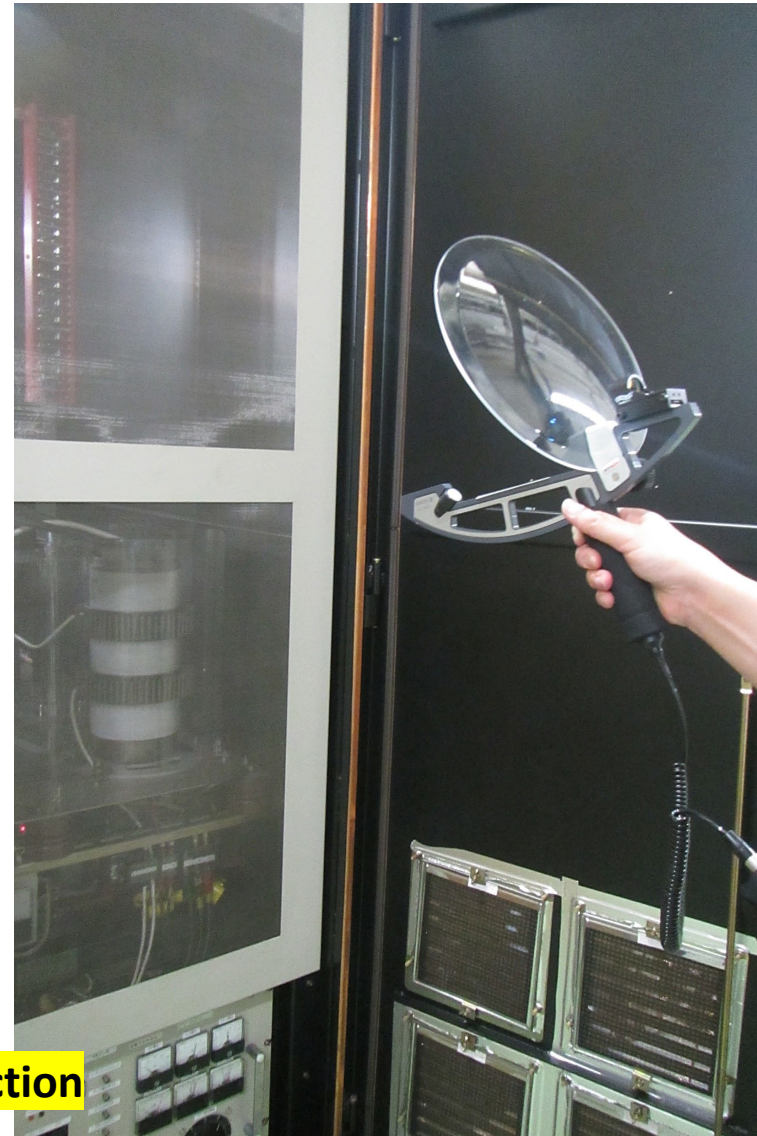
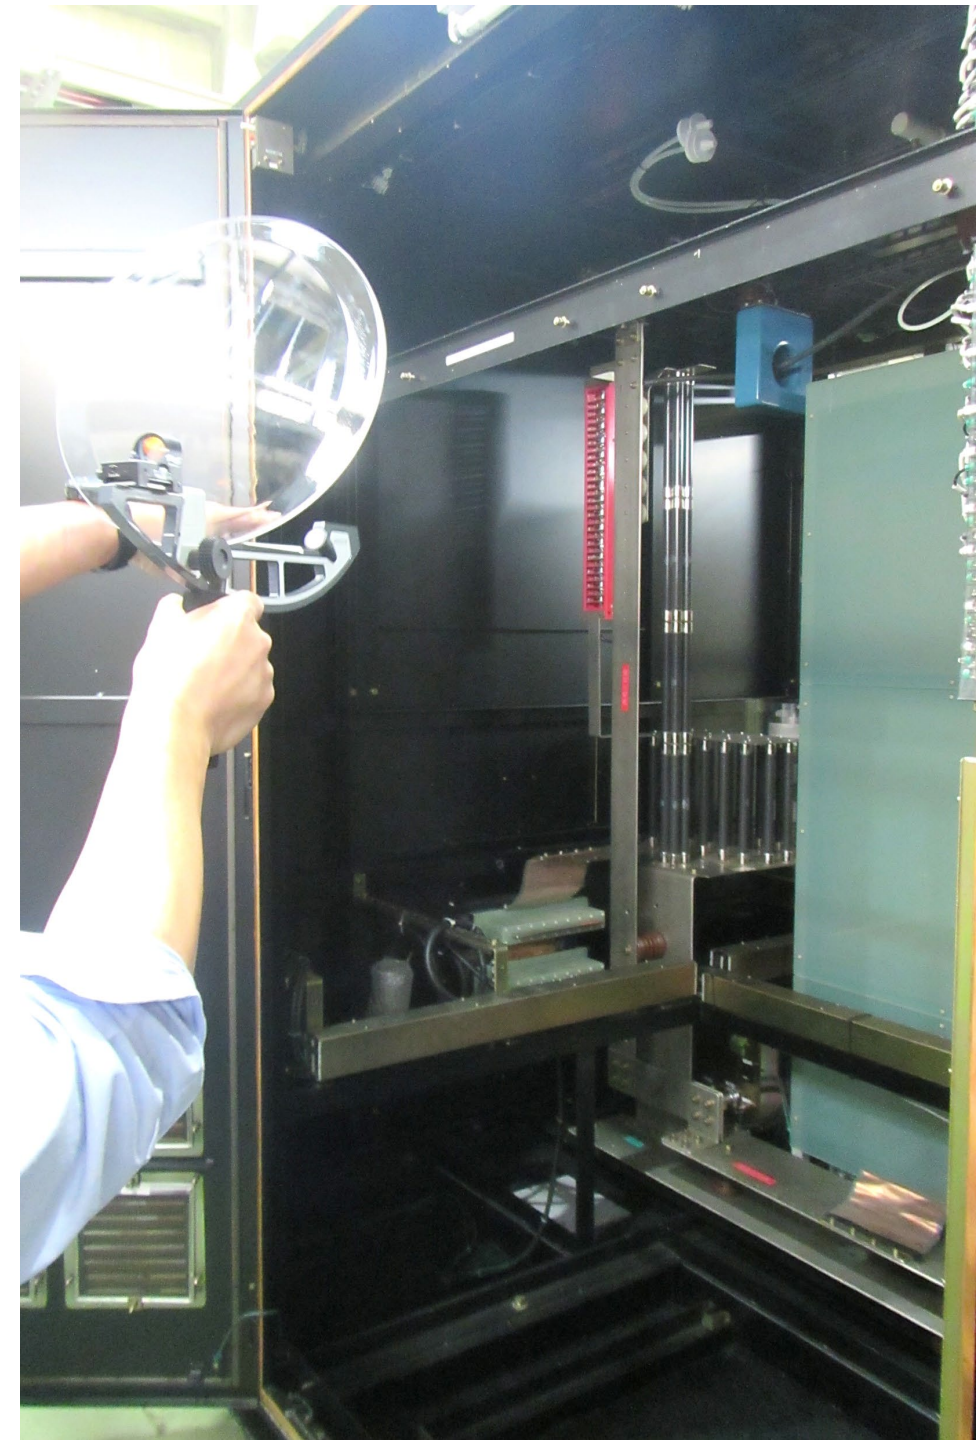
Listening to ultrasonic sounds from corona discharge

Ultrasonic leak detector made by SONOTEC Co., Ltd. (sensitive to $\sim 40\text{kHz}$)

To be incorporated in our regular inspection

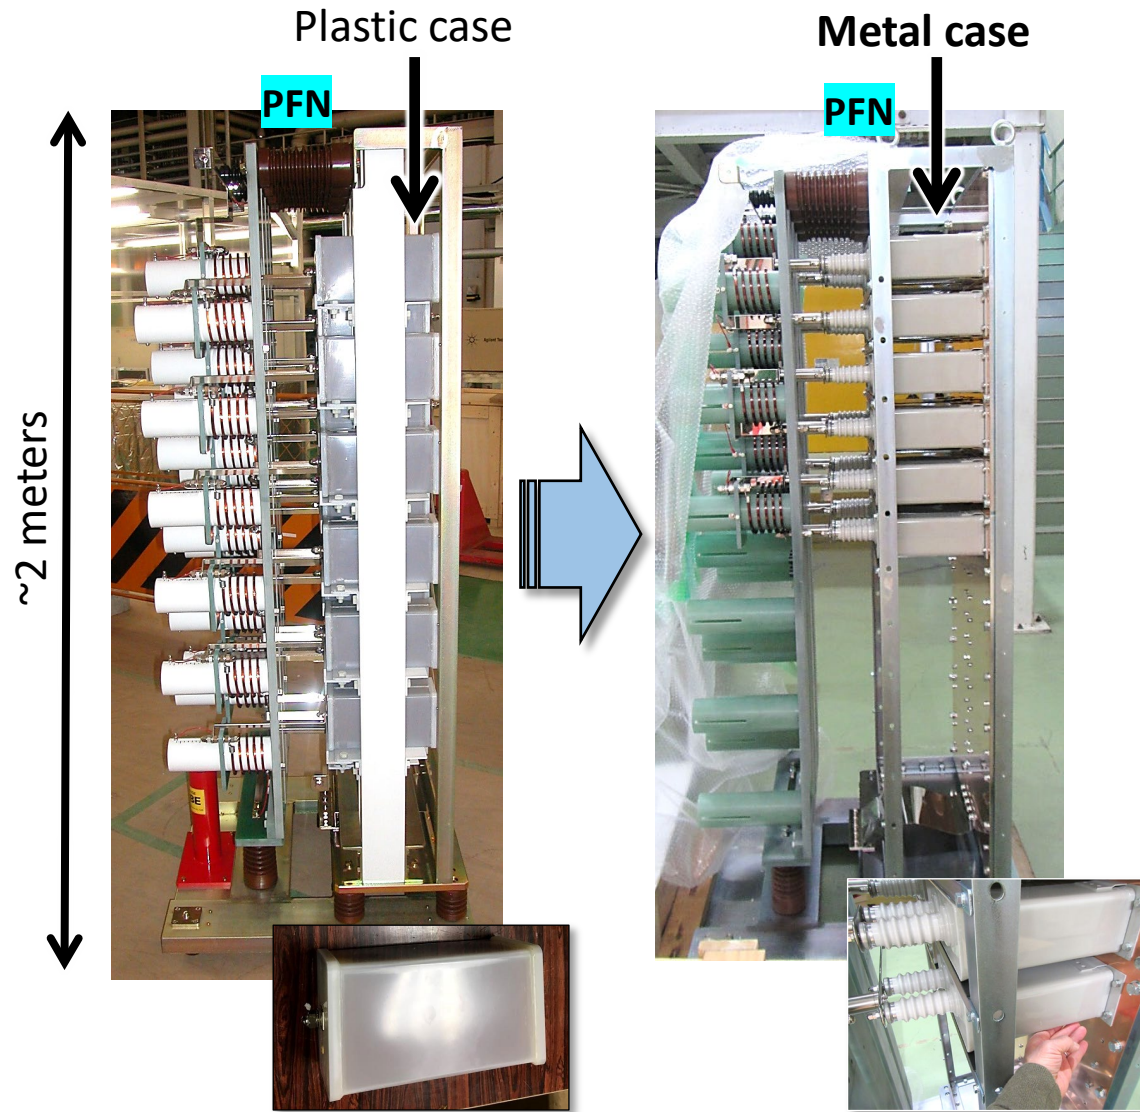
Capacitors replaced

52.8 V/ μm

49.8 V/ μm @ 38 kV
