# Experience with field emission at DESY / European XFEL

Denis Kostin, MSL/DESY, 28.01.2025

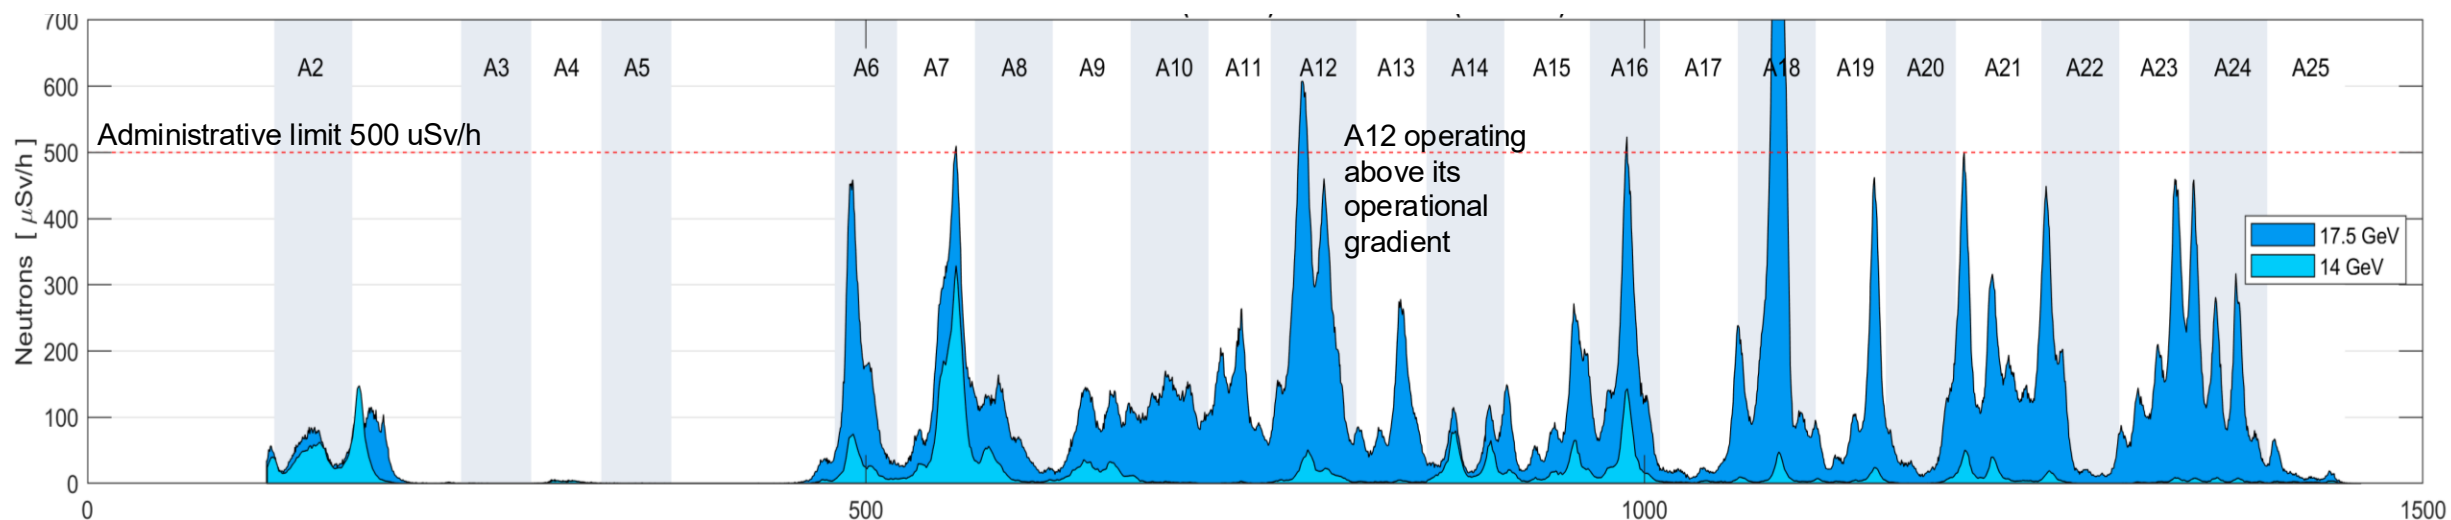
New field emitter detected

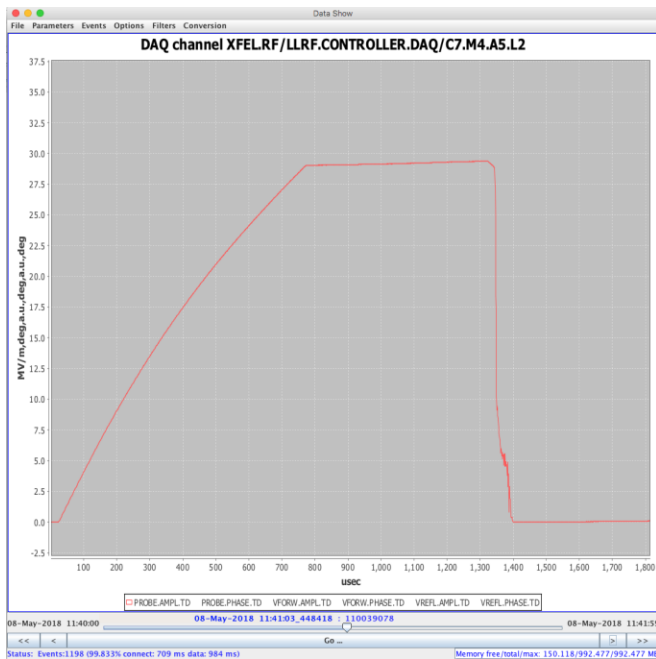
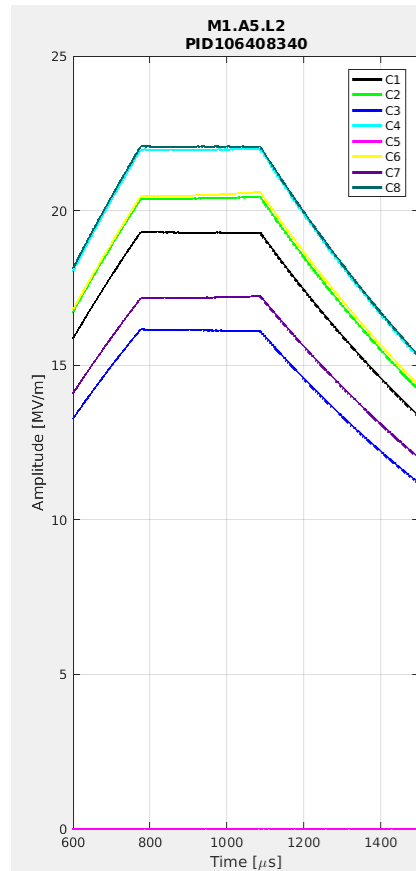
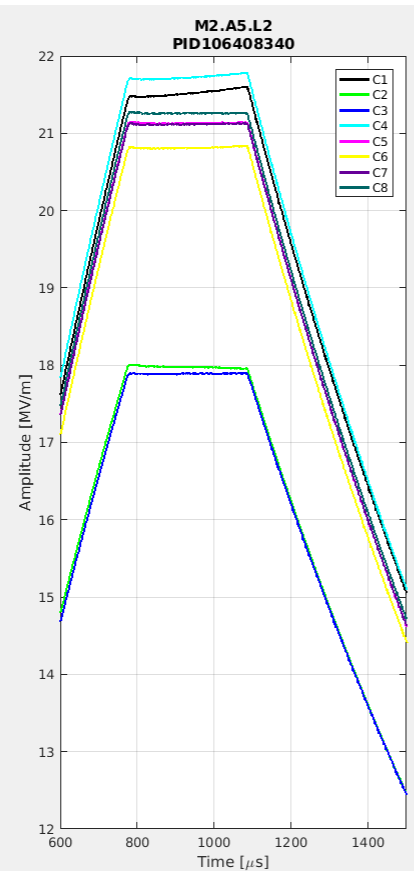
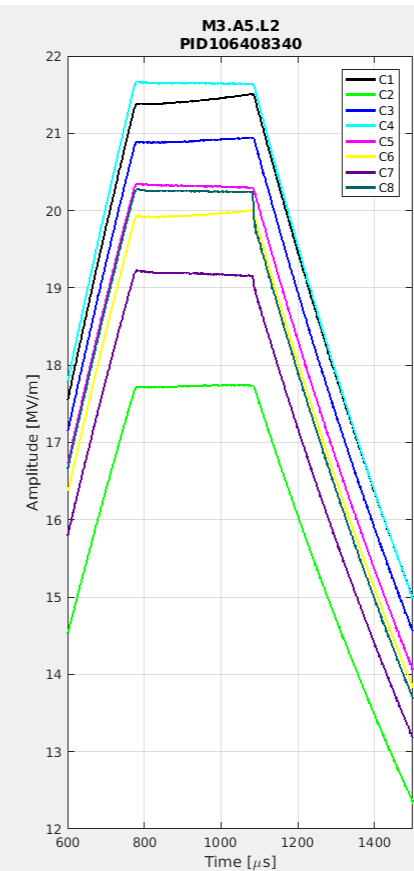
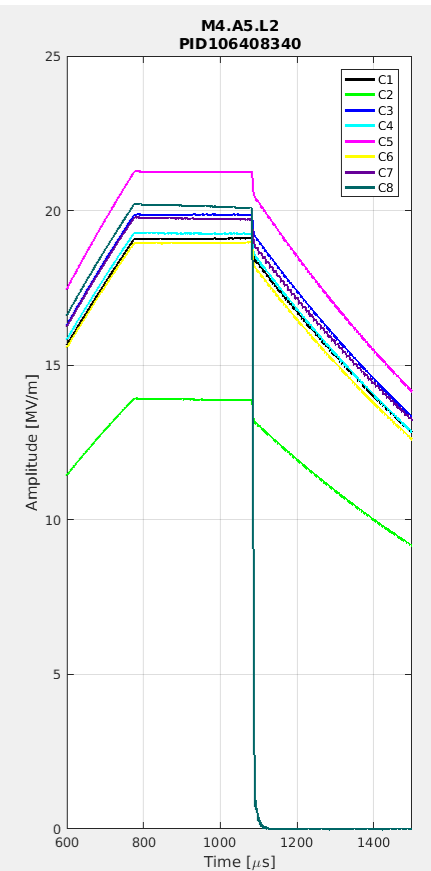
# RF station A5 event:

After shutdown in April 2018 RF power at L2 was ramped up to SP=800MV too fast after previous (year) operation at 600MV. This caused a high dark current. High dark current is most probably the source of 2 cavities degradation with high FE – C7/C8.M4.A5. Also the SC-Quads were off at the moment, which may cause some dark current transport in the linac.

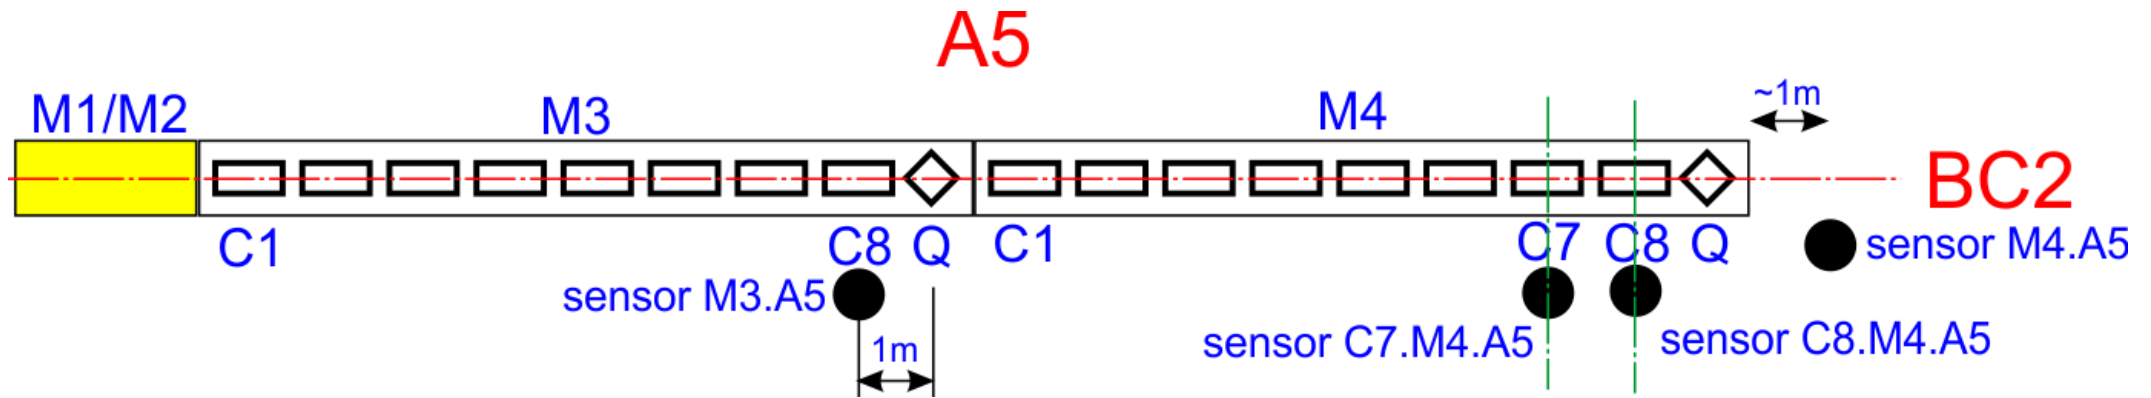
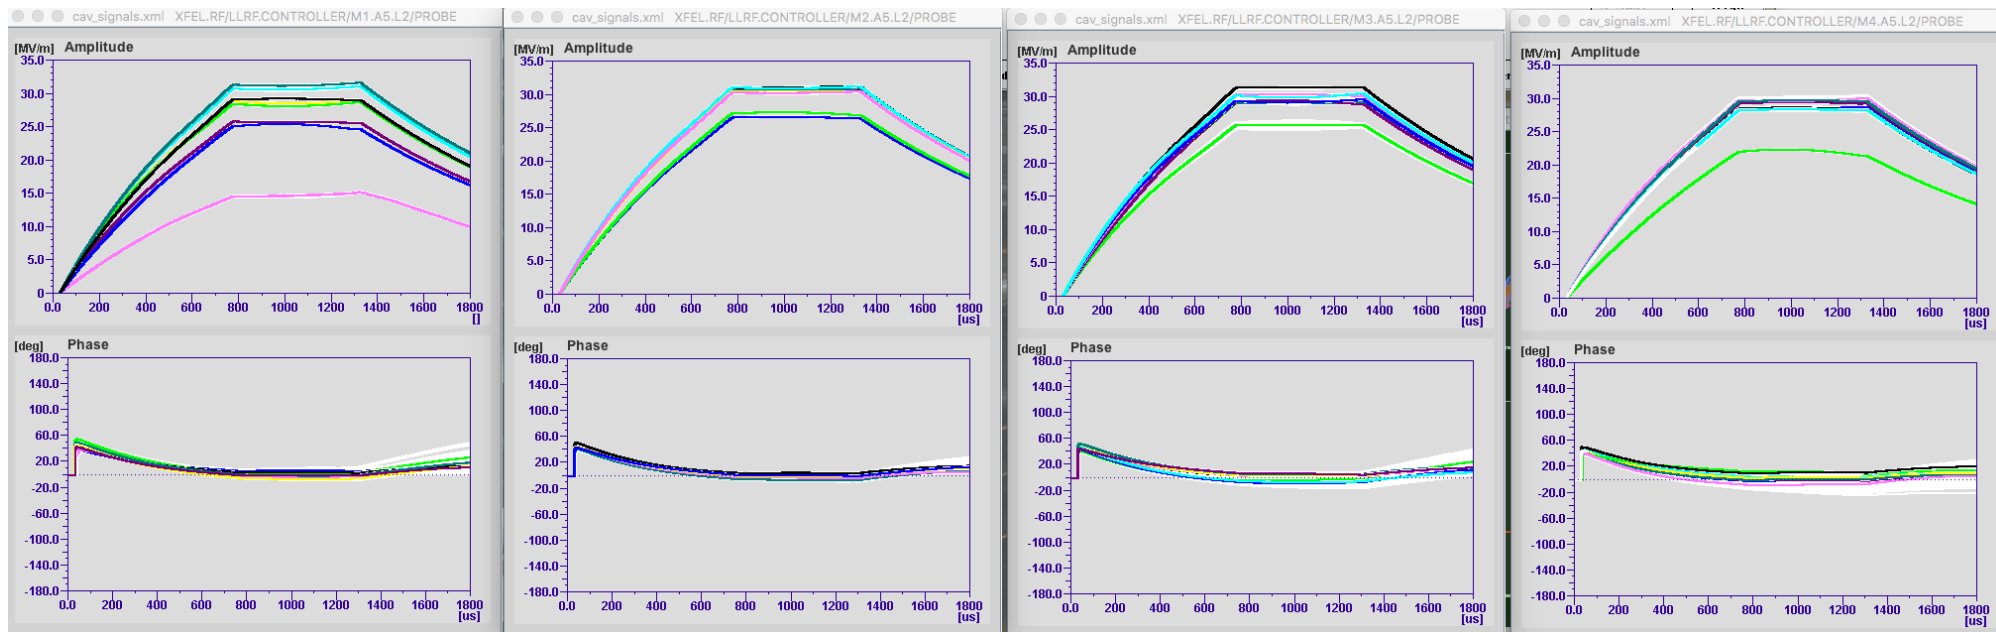
# RF station A5 conditioning:

- A5 MP conditioning with C7/C8 was done with slow increasing the gradient separately with C8 and C7;
- A5 final gradients after MP conditioning (SP = 800 MV):

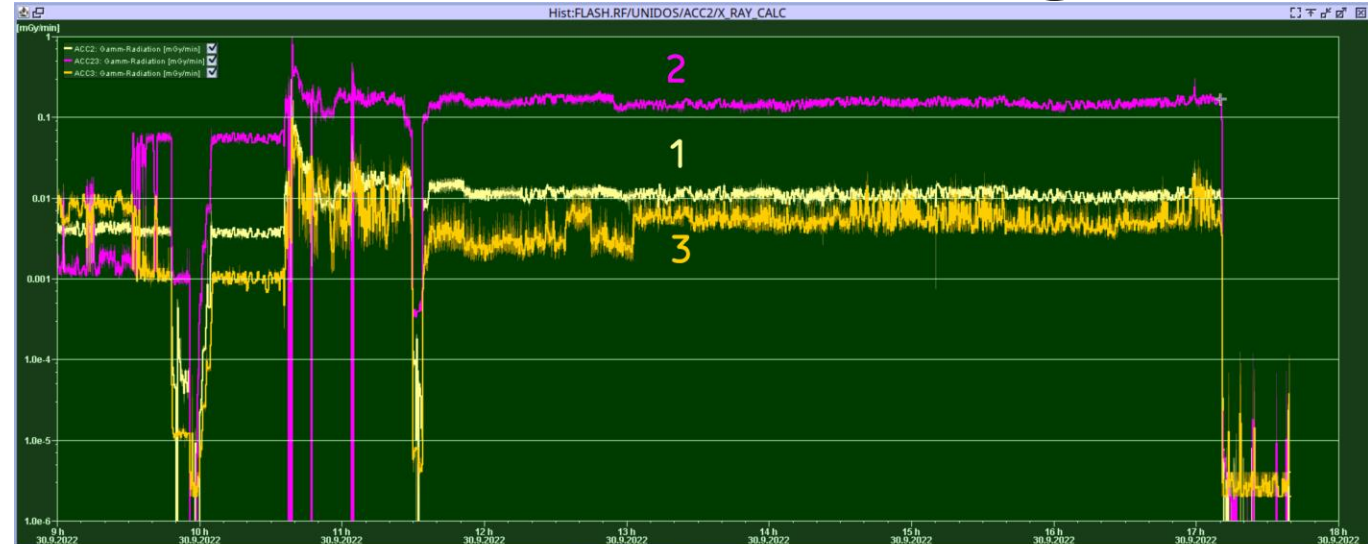
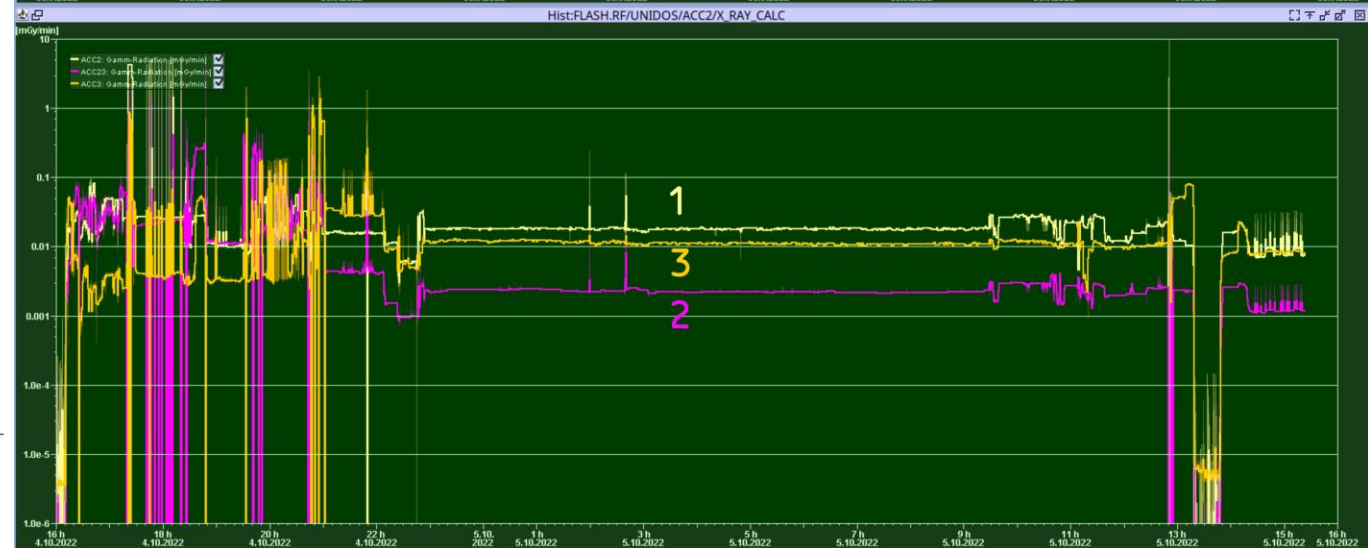
FLASH ACC2&3 gamma radiation decreased during commissioning
