Experience with Field Emission at TRIUMF

Zhongyuan Yao

RF/SRF, Accelerator, TRIUMF

CM01 Field Emission Workshop, Jan. 28-29, 2025

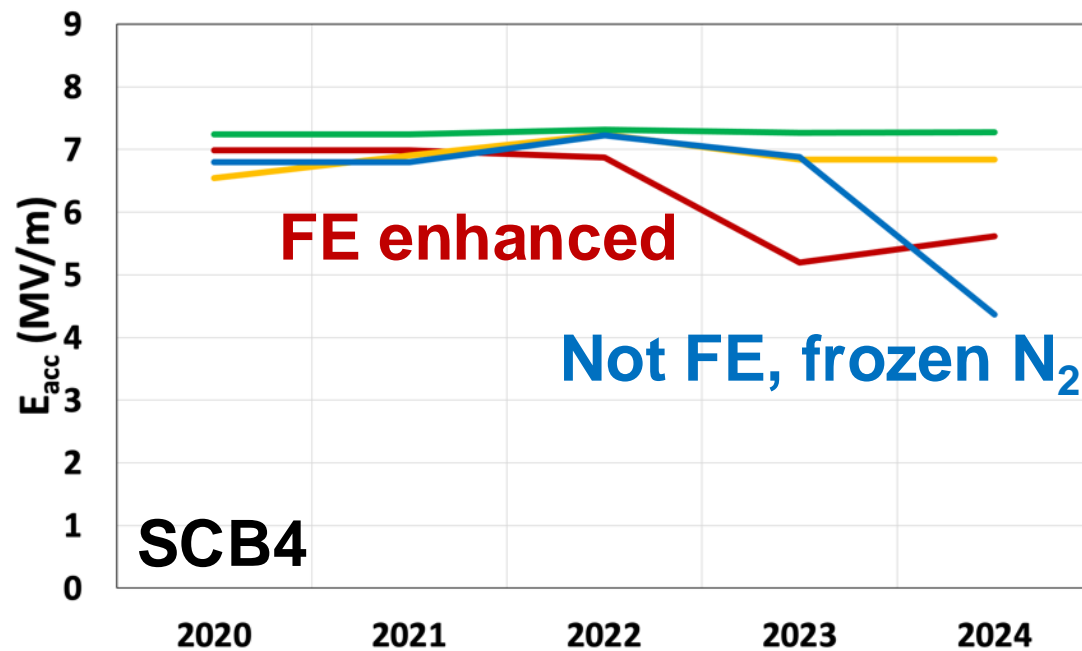
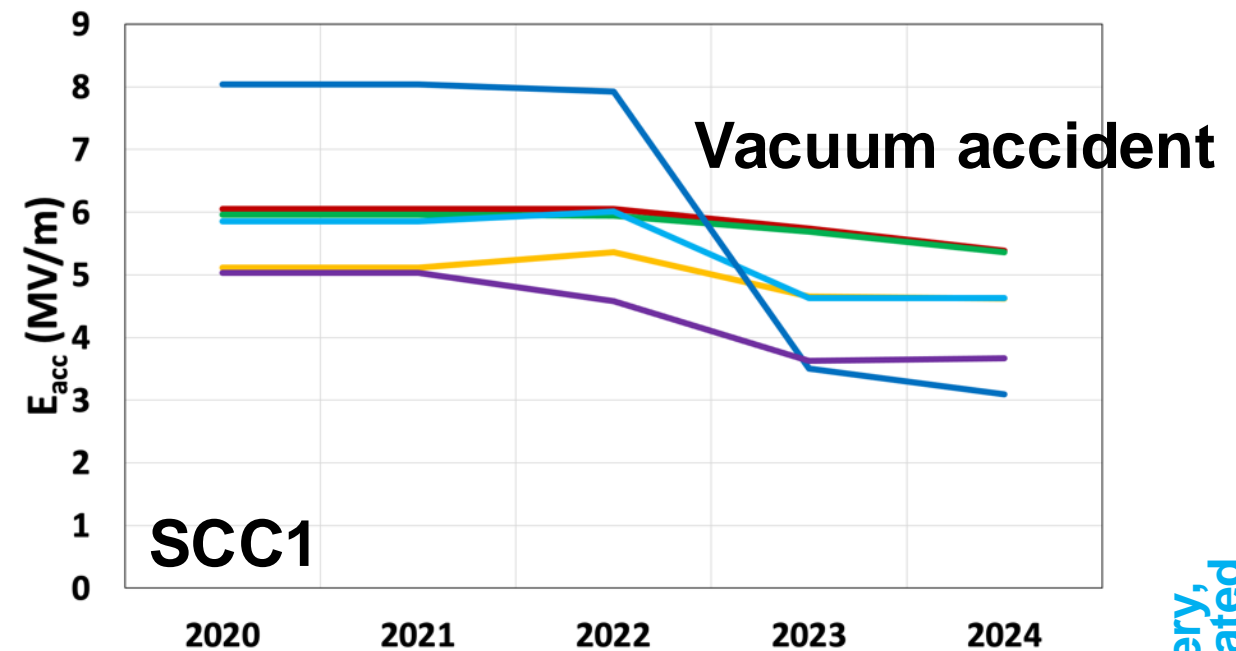
- Operating E_{acc} is generally stable over years unless known issues
- Small differences due to inconsistent pulse conditioning

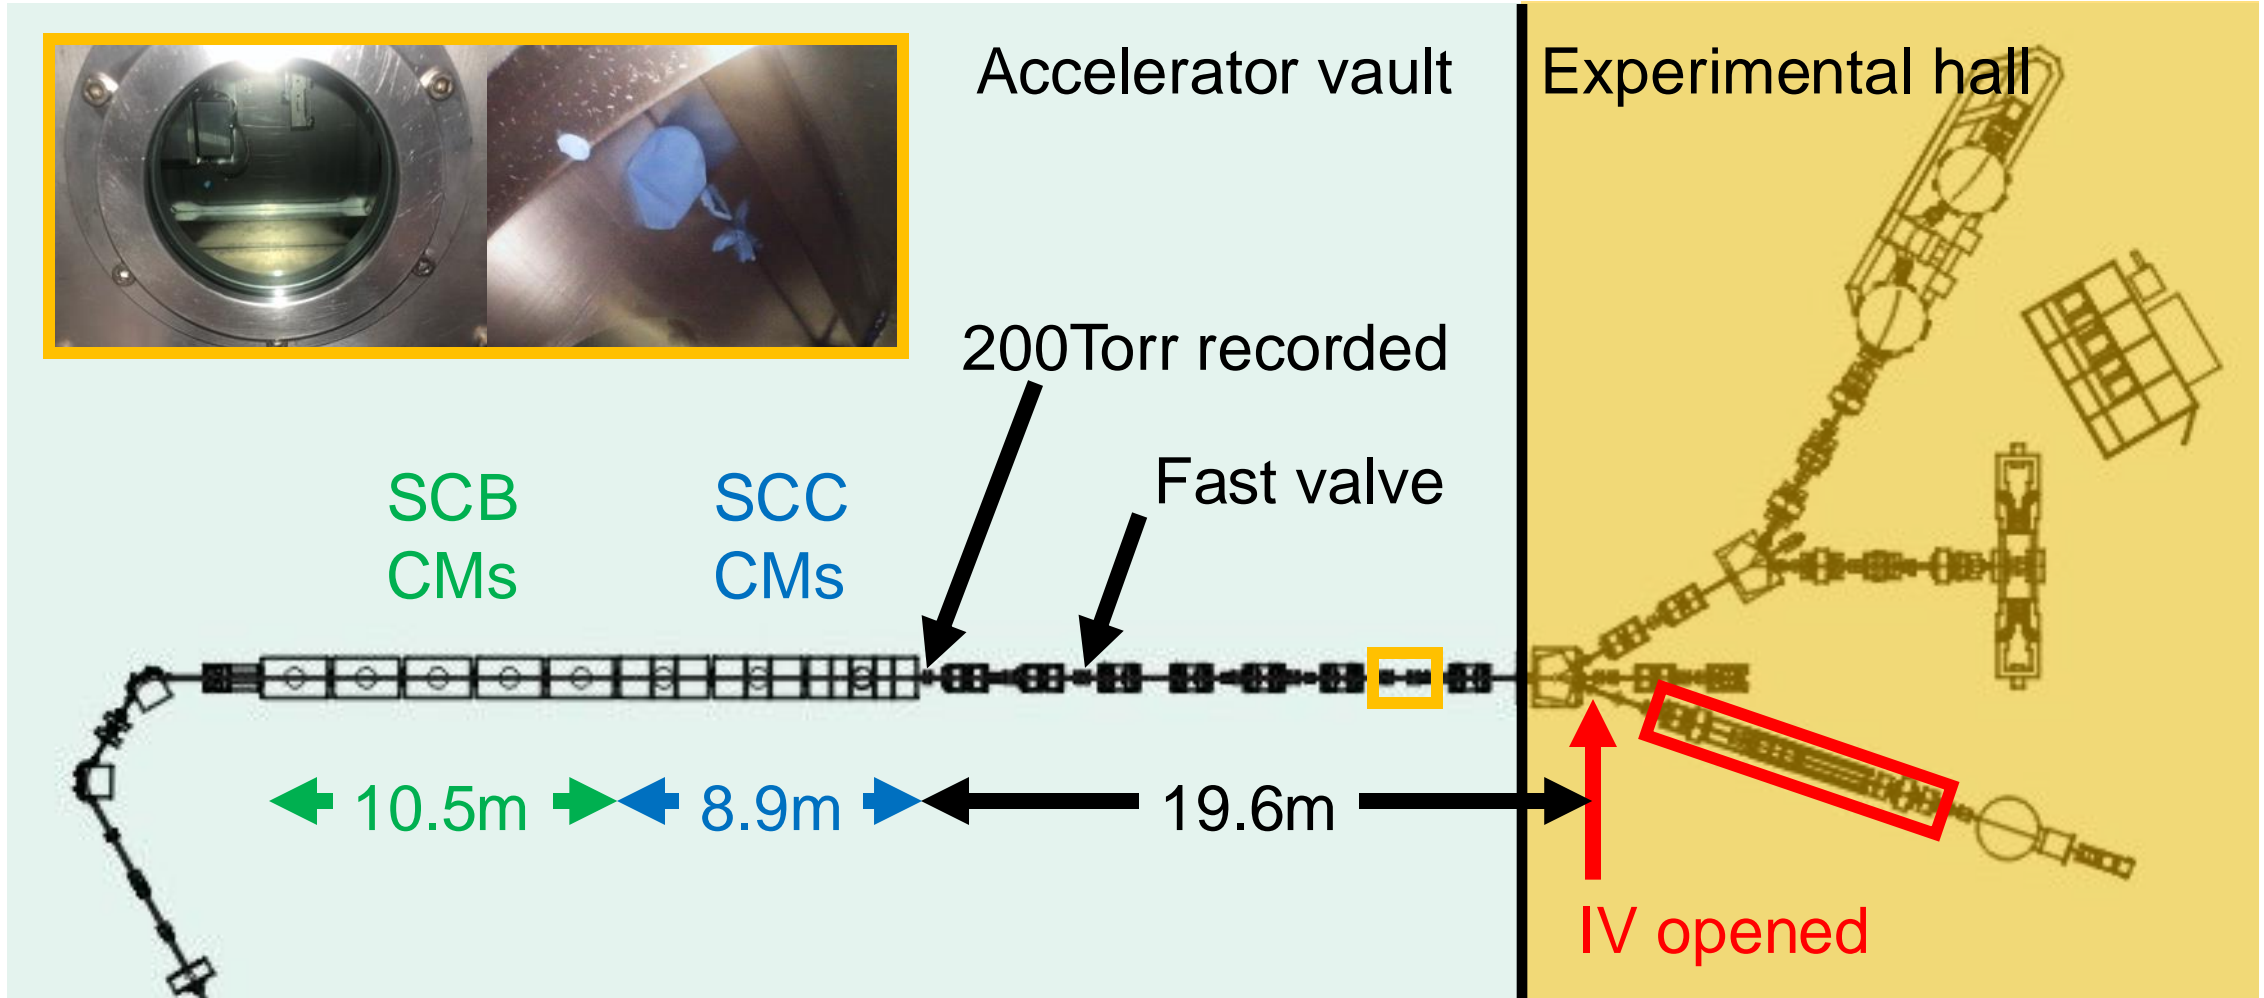
- Affected range is about 9m, includes downstream 3 CMs
- HPR required, 2 completed and performance restored

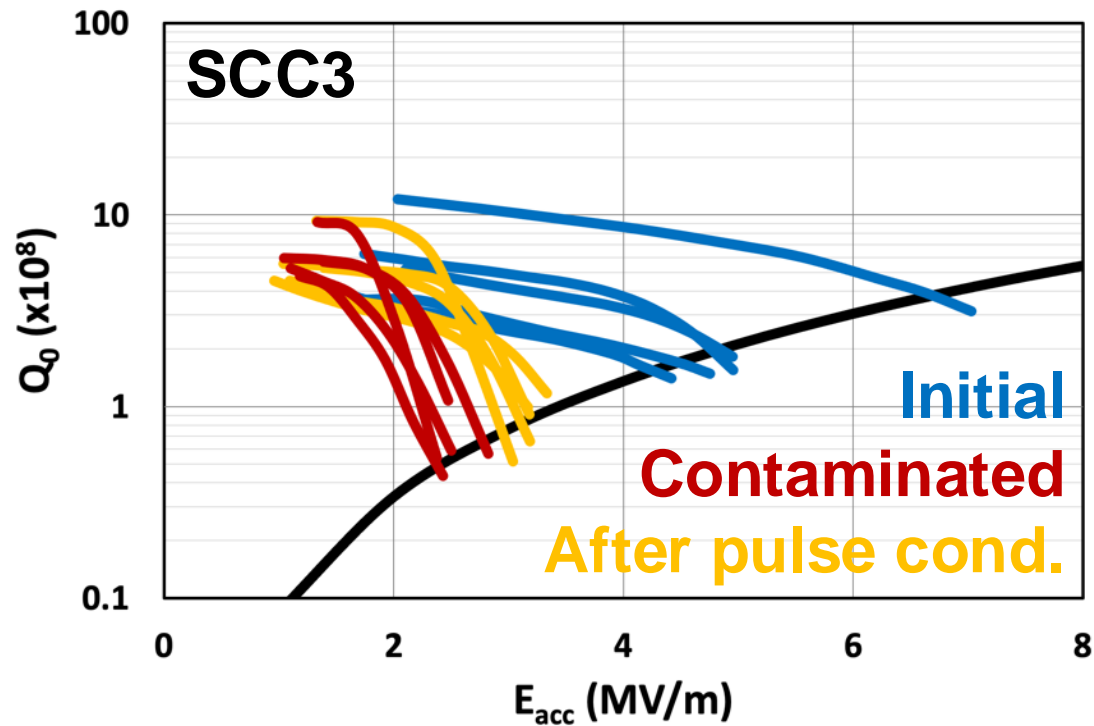
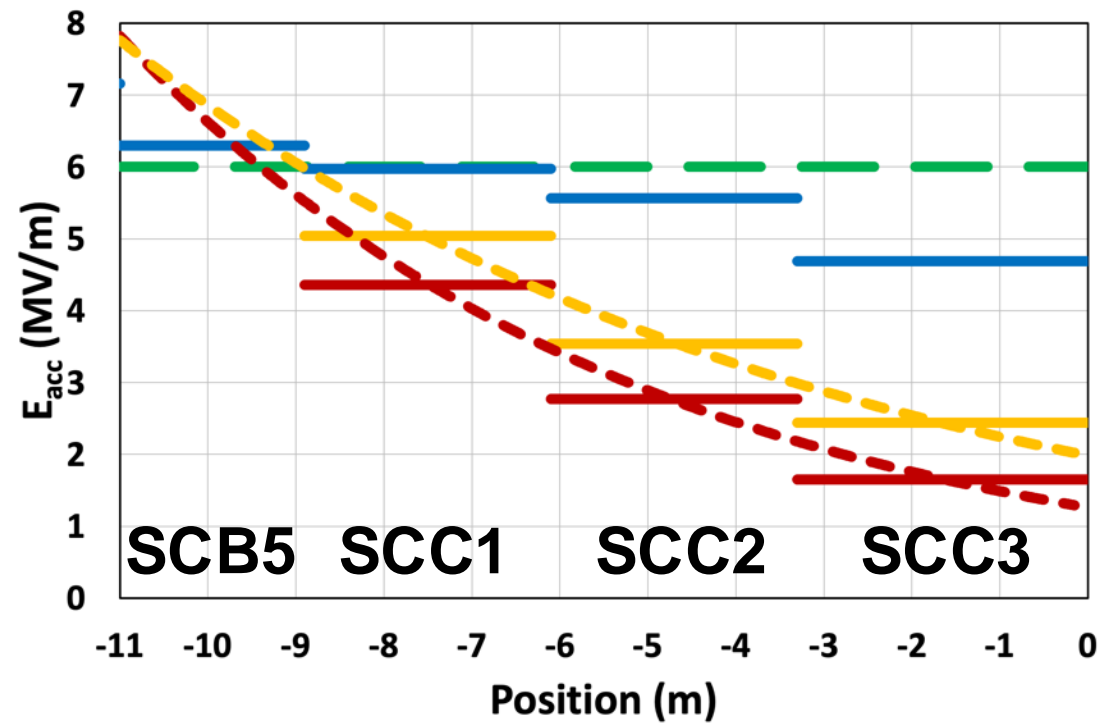
- SCC3#1 degraded after thermal cycle in shutdown
- Neighbors #2 restored after pulse conditioning
- May related to actuation of isolation valves

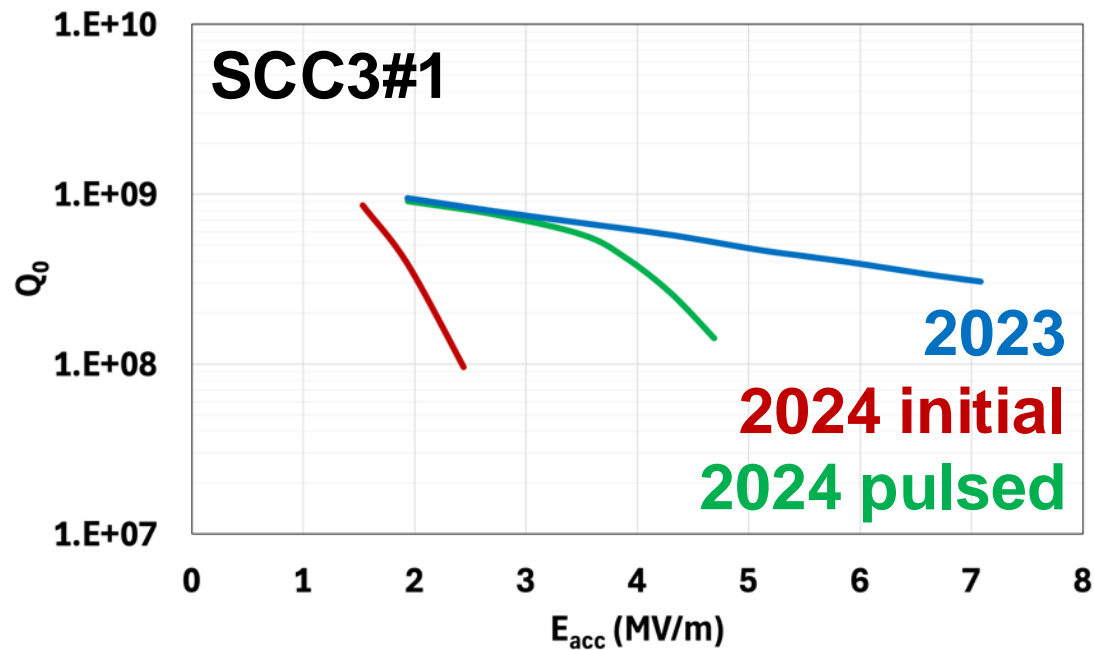
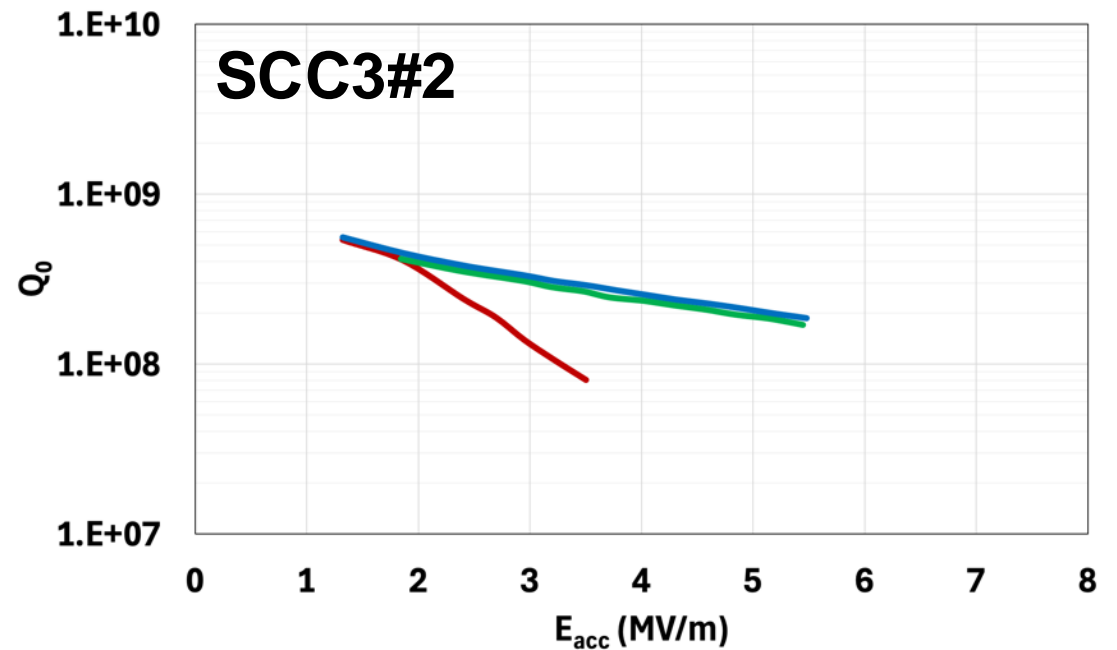
- ~50% cavities need pulse conditioning after thermal cycles, most cavities' performance can be restored

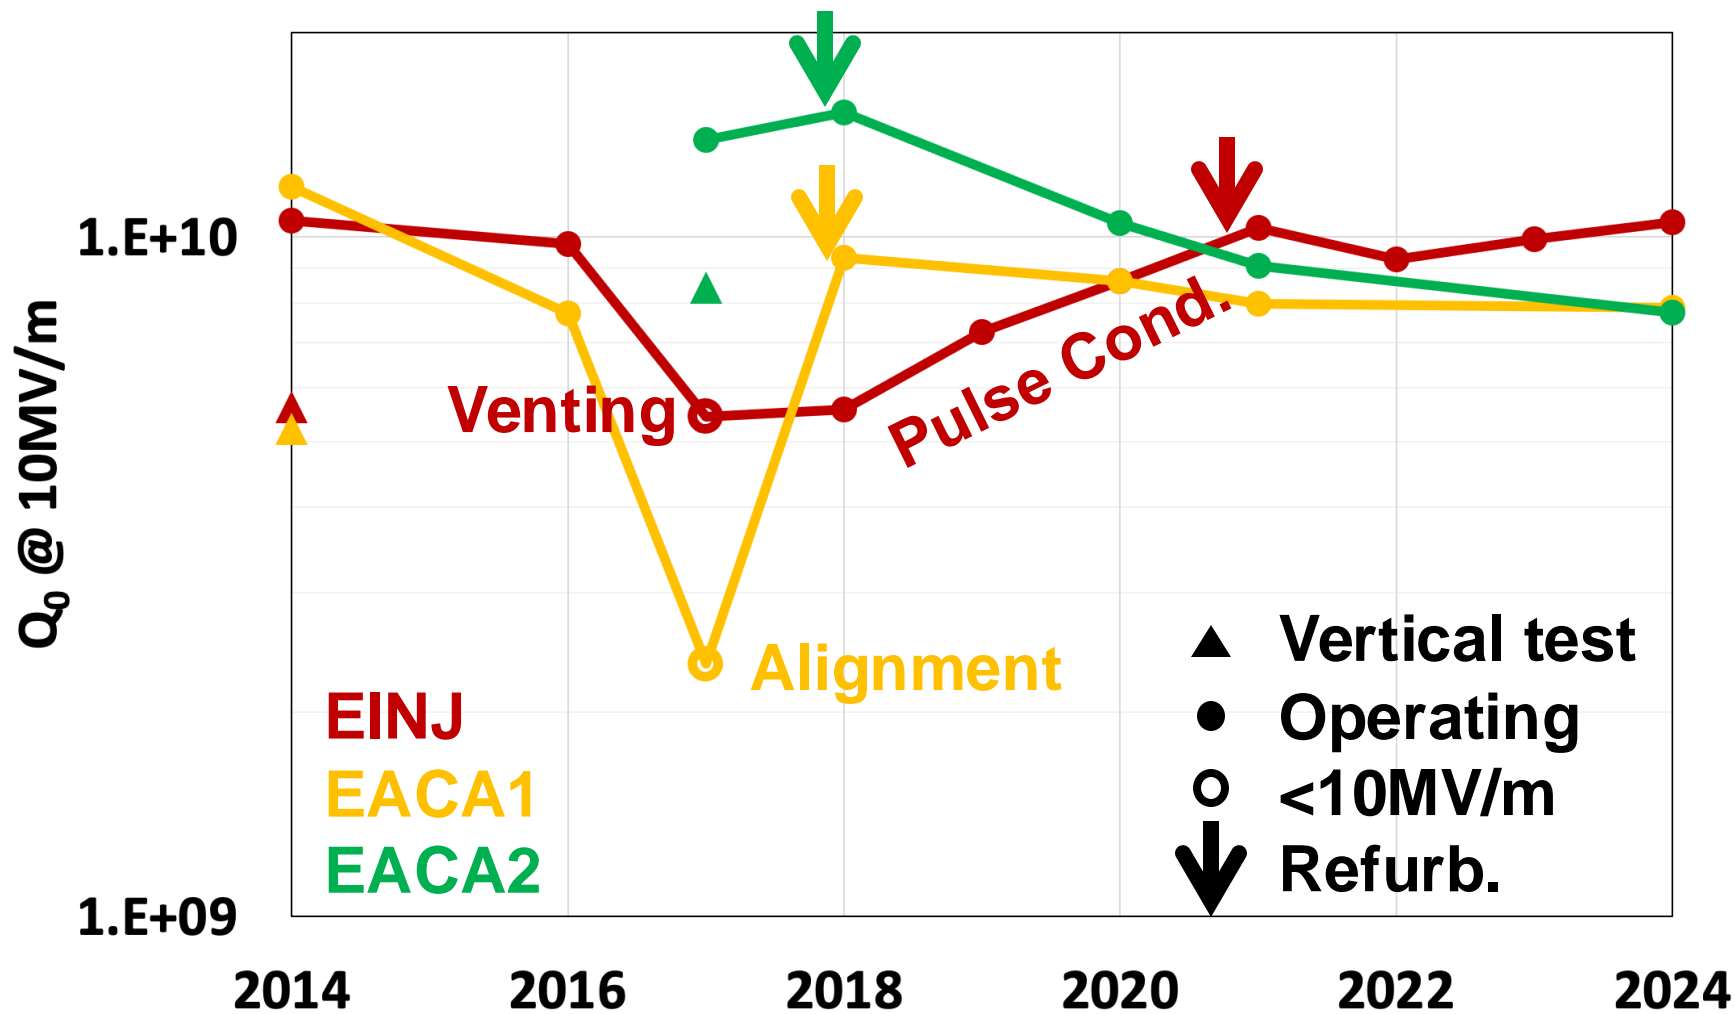
- Radiation from EINJ gradually increased
- Heat loads of EACA cavities gradually increased and consistent with radiation
