3D Imaging Dome Prototype

Second Round of Prototype Tests
And Some Modifications

SLAC MAGIS Group Meeting
Aug. 5th, 2021

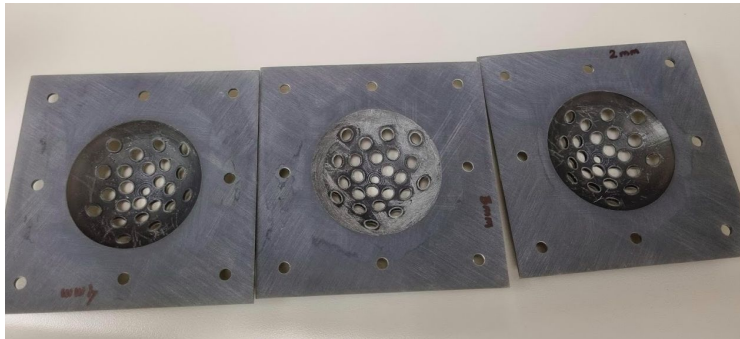
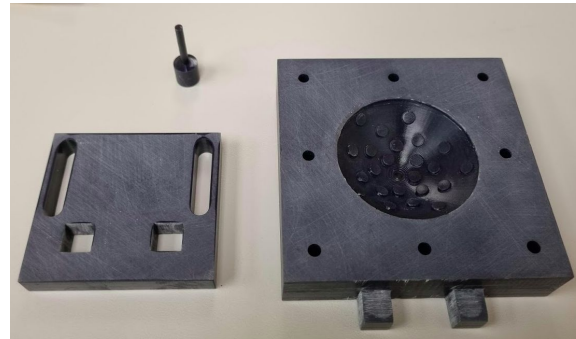
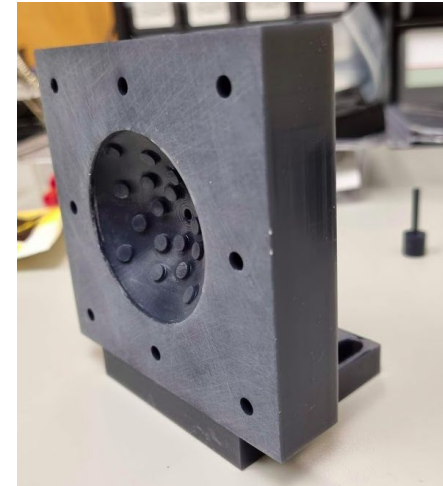
MDProto2: Products Arrived

- **Black opaque material**
 - Different material called “Somos Taurus”
 - “... I thought that you were in a rush for this part and that machine was open.”
 - Seems slightly tighter, but not a major issue
- Local support board
 - Seems to be better quality overall, particularly the “knobs”
 - **Printing orientation seems to have helped!**

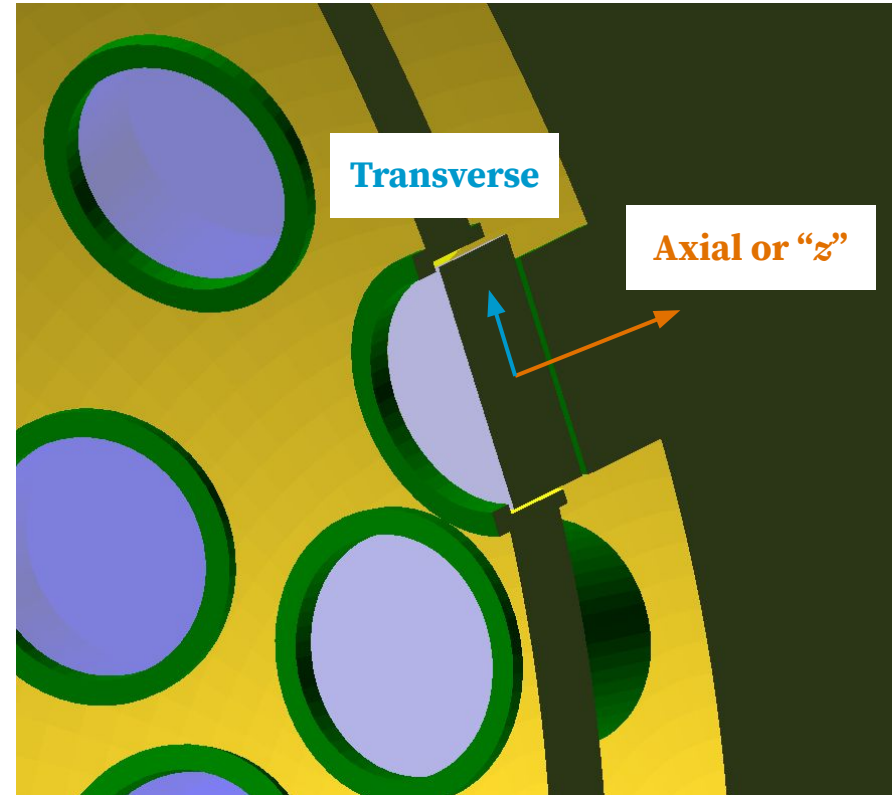
MDProto2: Mirror Loading Experience

- All 5.2mm holes, still **loose**
 - Transverse movement
 - Not a major issue by itself,
 - But, combined with axial movement
⇒ Can cause alignment errors
- **Visible axial movements**
 - Particularly among inner mirrors
 - Hints at back knobs not pushing in properly
 - In MDProto1, edge mirrors had loose axial pressures
 - Mainly attributed to back knob print quality

- Make the back knobs longer
- Two adjusted versions
 - +0.5mm back knobs at all locations
 - +0.5mm back knobs at inner 10 locations only

- Add a screw at the center for more even pressure
- Can use the existing hole (originally for object rod)
 - Current design: 3.2mm diameter hole
 - Use long M2.5-0.45 or M3-0.50 screw + nut
- No adjustment required for the print, just need some screws

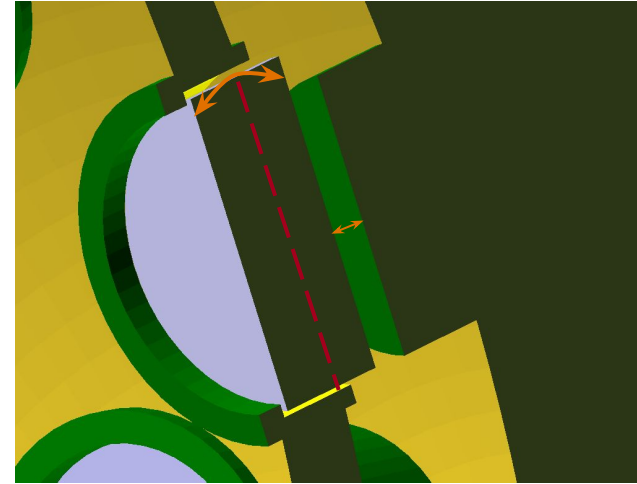
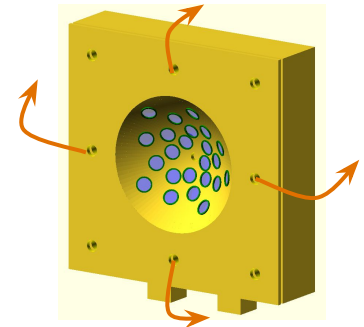
MDProto2: Debugging the Issue

- The back knobs are simply not long enough to push the mirrors actively
- Too much axial room

- Front & back boards are screwed only at the edges
- This could flex the board towards the edge
- Better contact at the outer mirrors, looser contact at the inner mirrors

Could be a combination of both (and more) causes
