Taking out Another Momentum Bifurcation

Cameron Bravo (SLAC)

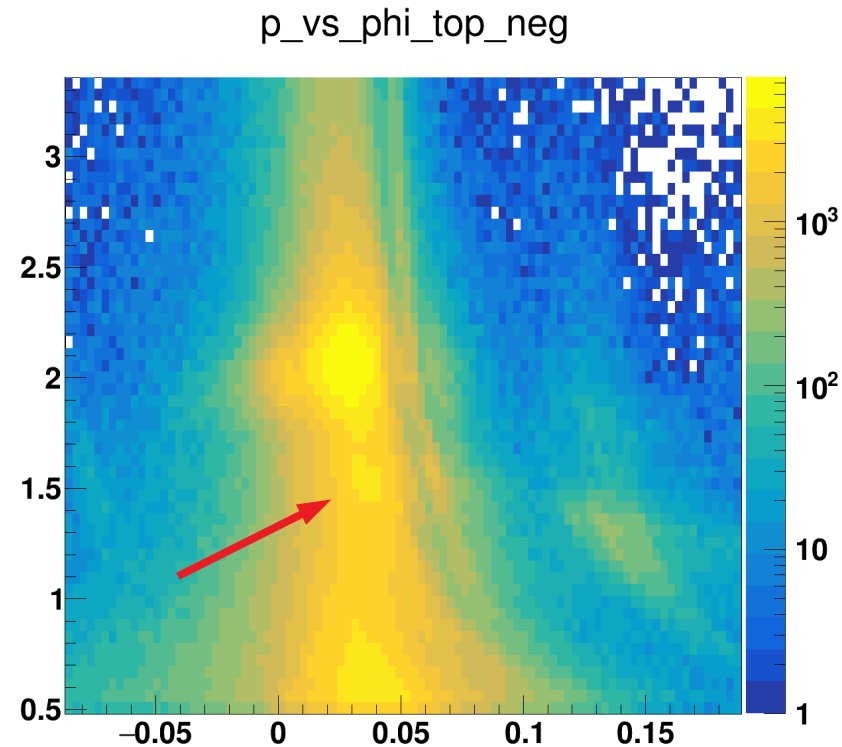
- Focus on momentum bifurcation
- In the top this time
- Seen in run 14654 which is a high lumi physics run at 1.92 GeV beam energy
- Accidental FEEs have extra peak at about 1.4 GeV
- Tracks are missing layer 7 hits in lower peak
- What do we need?
- Where are we going?
- How are we getting there?

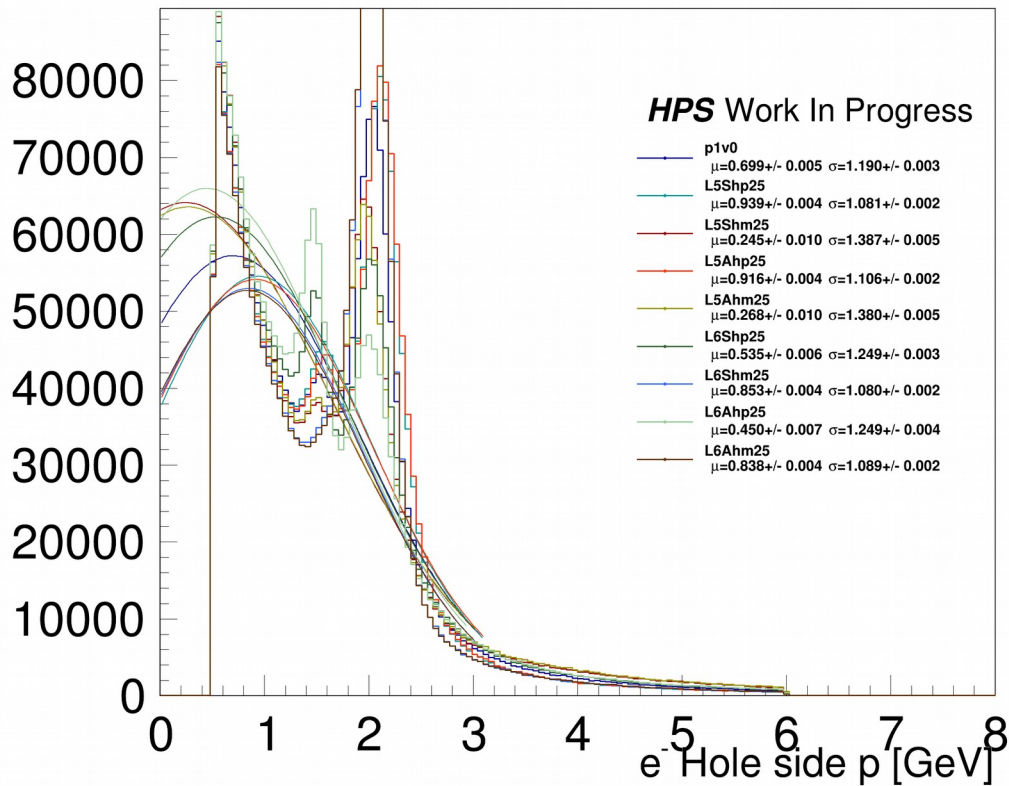
Determine which layer is misaligned

- Millipede does not fix this problem, it doesn't try to find missing hits
- Issue is x position of hits in layer 5 or 6 is way off, causing KF to sometimes miss the layer 7 hit and pulling the momentum down
- Systematically move layer 5 and 6 stereo sensors in Tu
- Move hits in x so KF doesn't miss the layer 7 hit
- Conclude here that it is layer 6 causing most of the issue, not layer 5

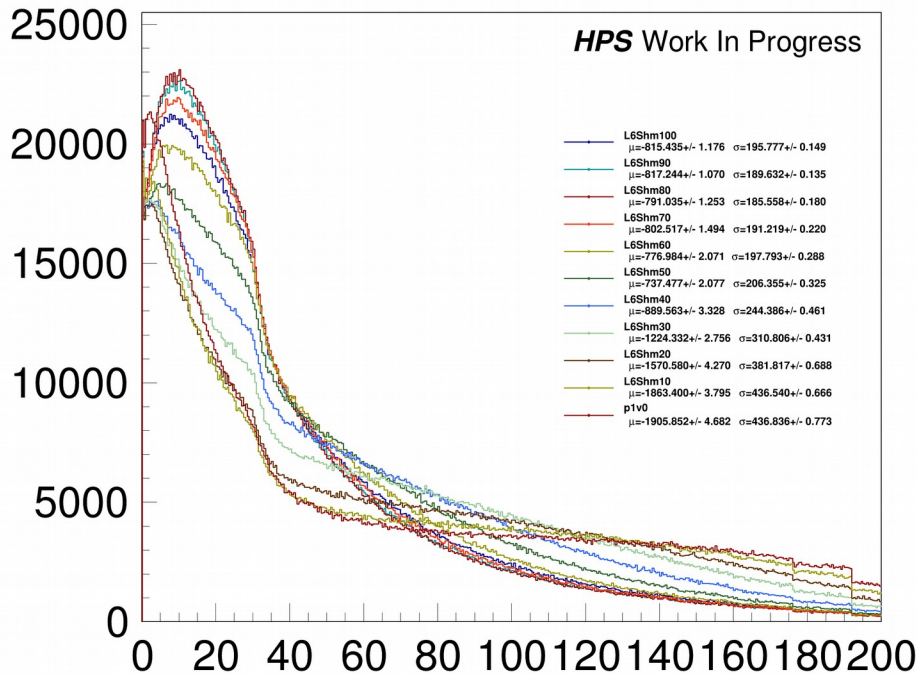
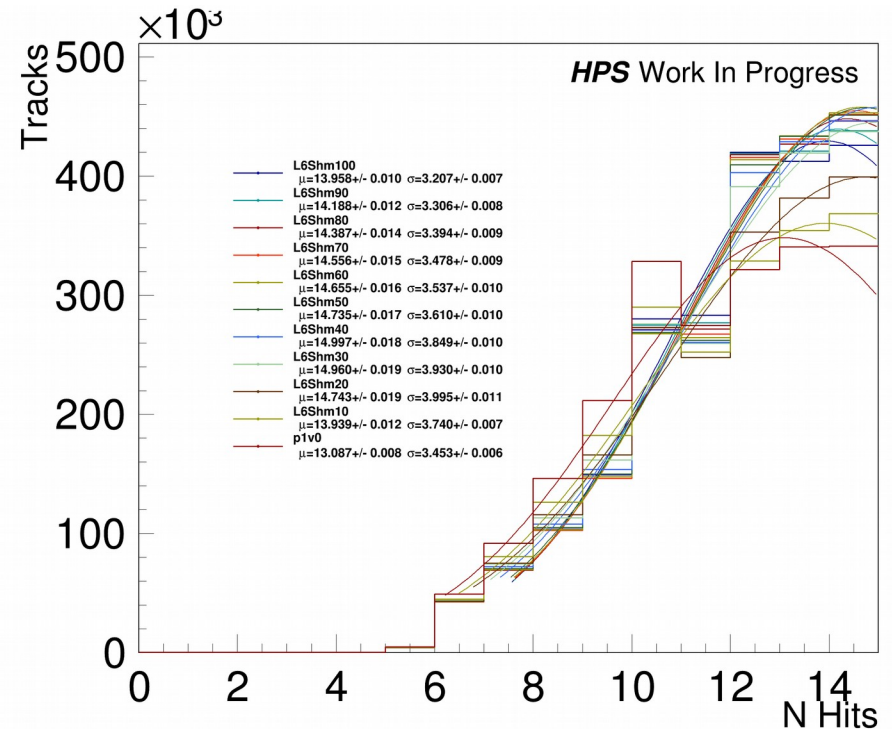
Determine how much to move Layer 6

- See improvement to chi2 distribution as L6 top stereo hole is moved in negative direction
- Starts getting worse again after 80 um
- Chi2 shape has a “cut off” feature at high end of hump around 30

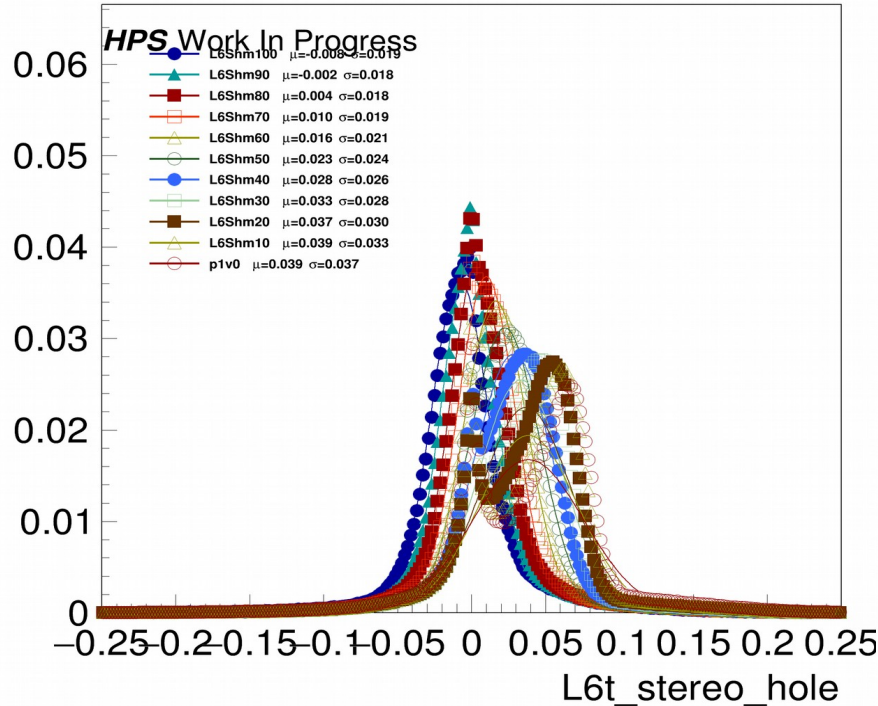
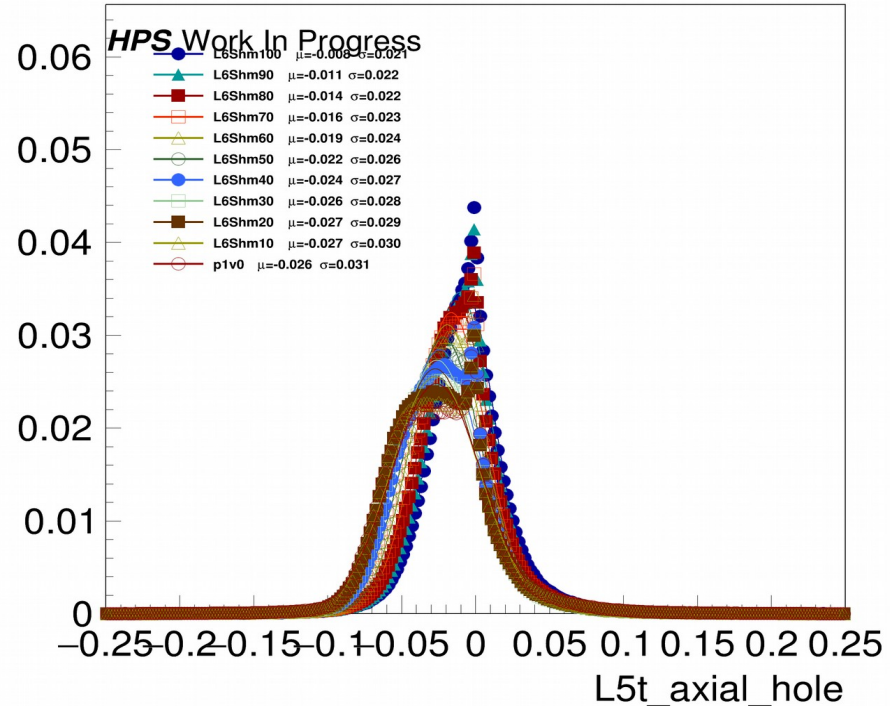
Determine how much to move Layer 6

- Large satellite peak in uresidual line up in both 5 and 6

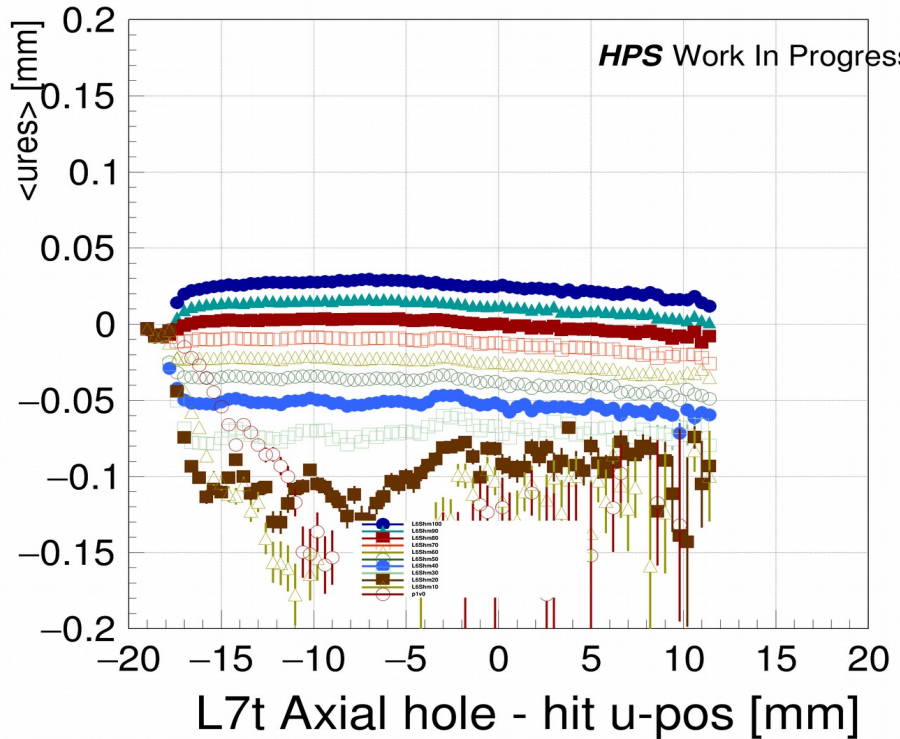
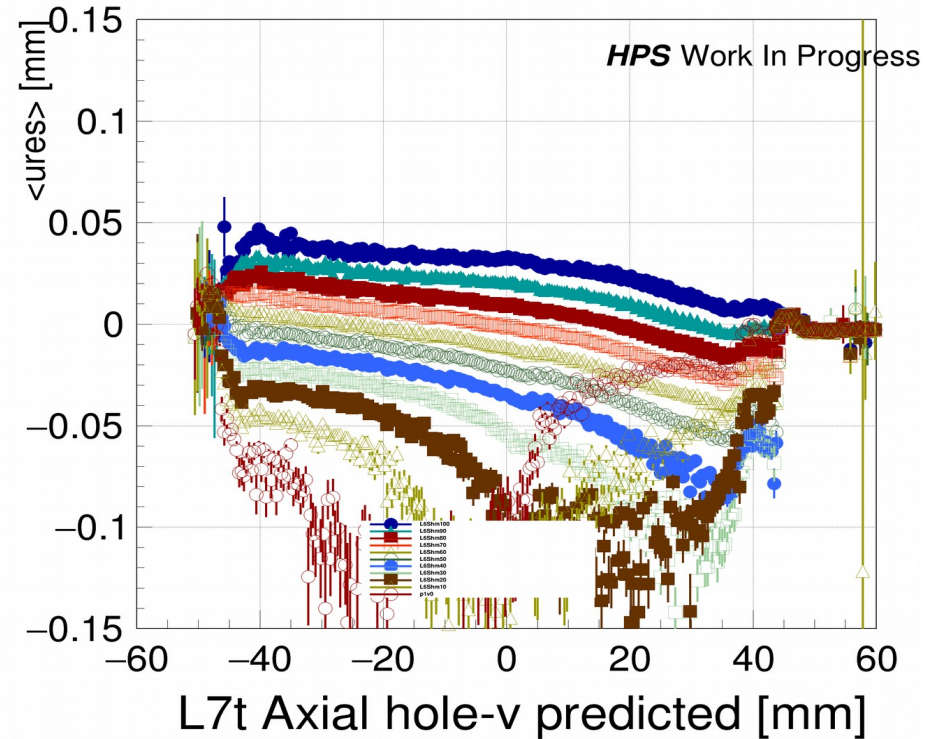
Determine how much to move Layer 6

- See significant improvement in residuals in layer 7
- Tracks have a layer 7 hit more often now with layer 6 aligned better
- Interesting we didn't see this issue in 3.74 GeV running

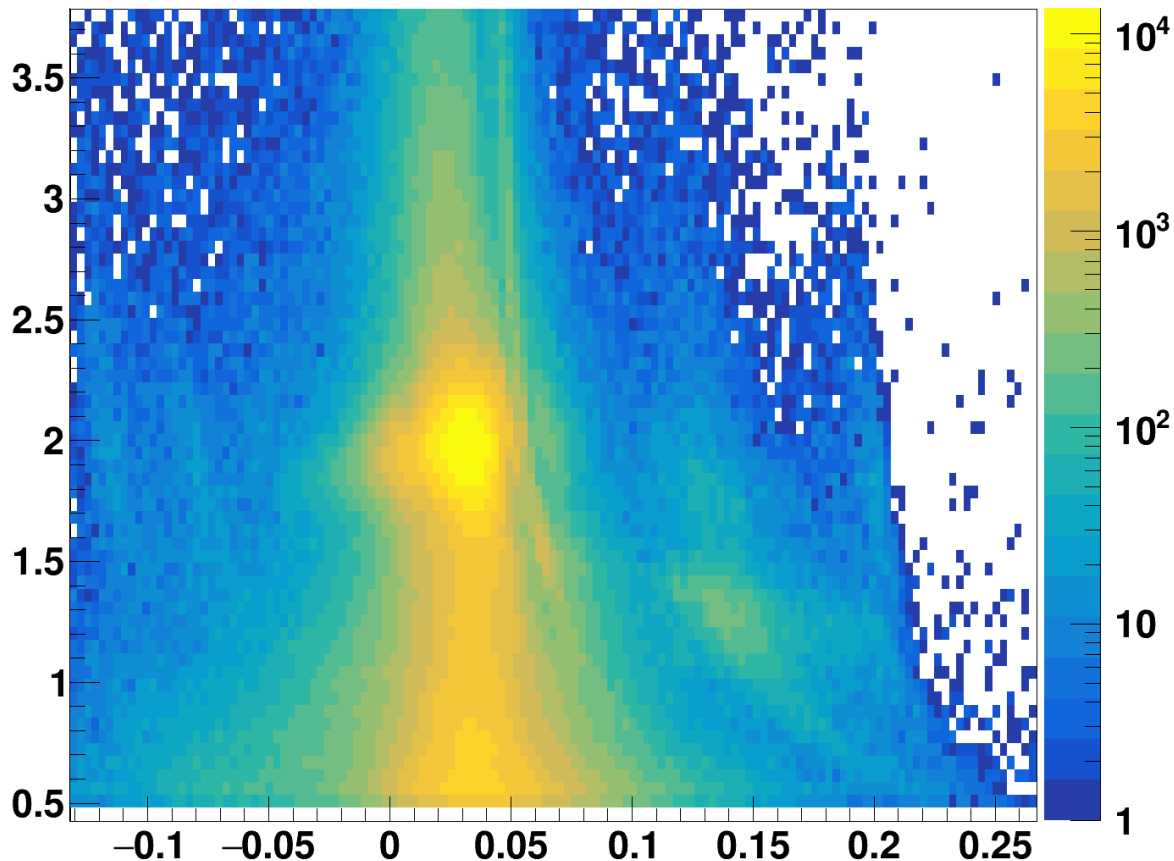
p_vs_phi_top_neg

- Bifurcation in hole side is gone
- Run 2016 like procedure to further minimize chi2
- Slot side momentum scale of FEEs is low
- Starting to study which sensors need to move
- Bowing of layers 5-7?
