Updates from the Lab: Some Testing with MHTestB

Some Preliminary Observations & Measurements

SLAC MAGIS Group Meeting

Jun. 24th, 2021

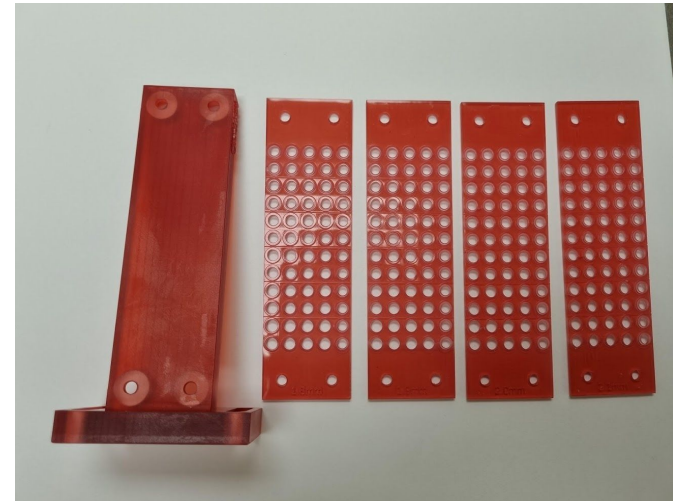
- MHTestB
 - 1 “local support” board
 - 1cm thick
 - 4 “front” boards
 - Thickness: {1.8, 1.9, 2.0, 2.1} mm
 - Boards screwed together by #8-32 screws
- Rubber sheets
 - Padding between the two boards
 - Thickness: {1/64”, 1/32”, 1/16”}
corresponding to {0.4mm, 0.8mm, 1.6mm}

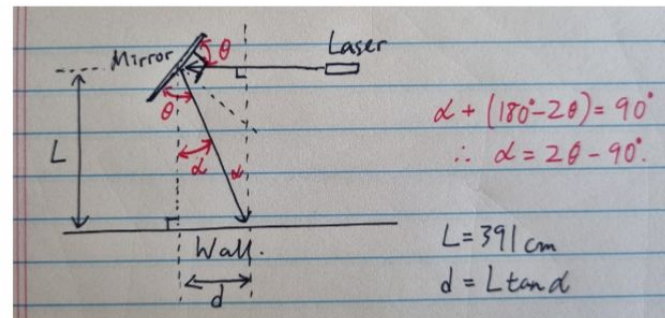
$$\Delta\theta = 0.1^\circ \implies \Delta d = 13.66 \text{ mm}$$

We want all our beamspots within ~10cm!

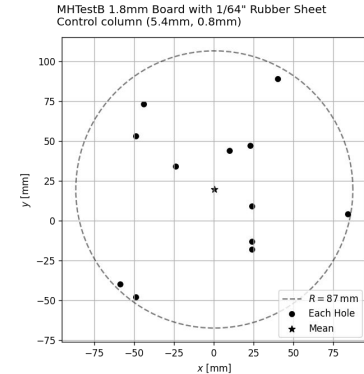
- Caveats
 - Our boards are not what we wanted/expected
 - In particular, the bend & the thickness variance
- **First successful demonstration** of push-in mounting
 - Within ± 0.64 deg span
 - Sensitivity to screw strength makes this hard to reproduce consistently
- It seems like the front-stop **overlap doesn't have to be very thick**
 - We should test lower values again next time (0.2mm to 0.5mm)
- Hard to test further before we get **more precise prints**
