3D Imaging Dome Prototype

Second Round of Prototype Tests
And Some Modifications

SLAC MAGIS Group Meeting
Aug. 5th, 2021

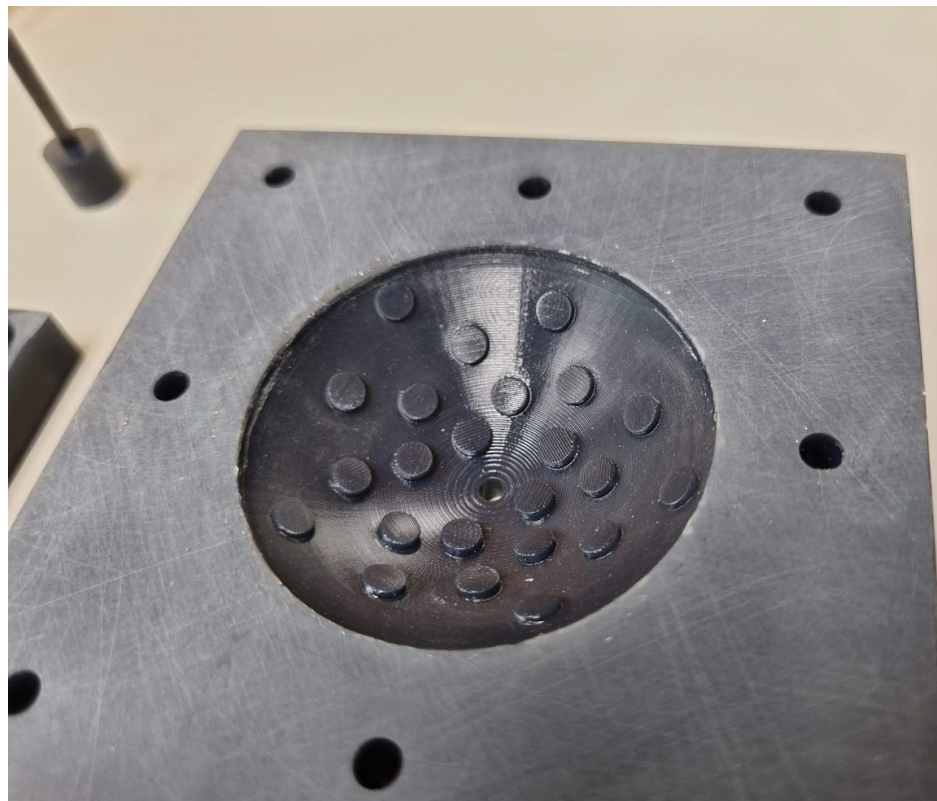
MDProto2: Local Support Board

- **Black opaque material**
 - Different material called “Somos Taurus”
 - “... I thought that you were in a rush for this part and that machine was open.”
 - Seems slightly tighter, but not a major issue
- Local support board
 - Seems to be better quality overall, particularly the “knobs”
 - **Printing orientation seems to have helped!**
