Safety Measures Taken in High-Gradient Accelerating-Structure Test Facility at KEK

Tetsuo ABE

KEK / Accelerator Laboratory

LCWS2023

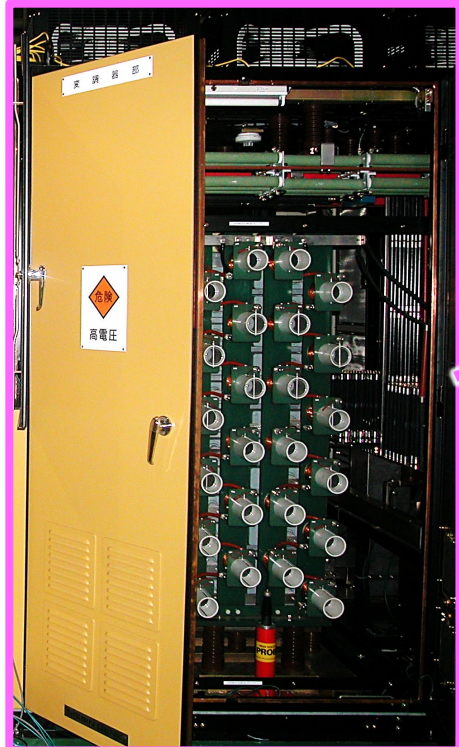
Smoke/Temperature sensors in the cubicle of the X-band modulator

These sensors cannot be helpful for fire prevention.

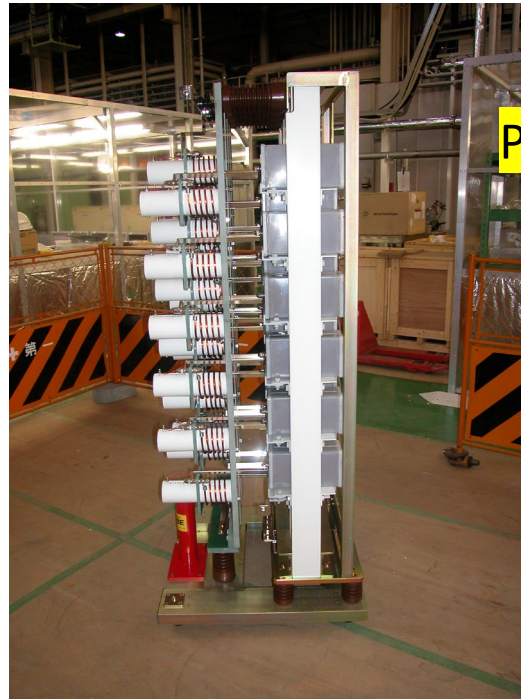
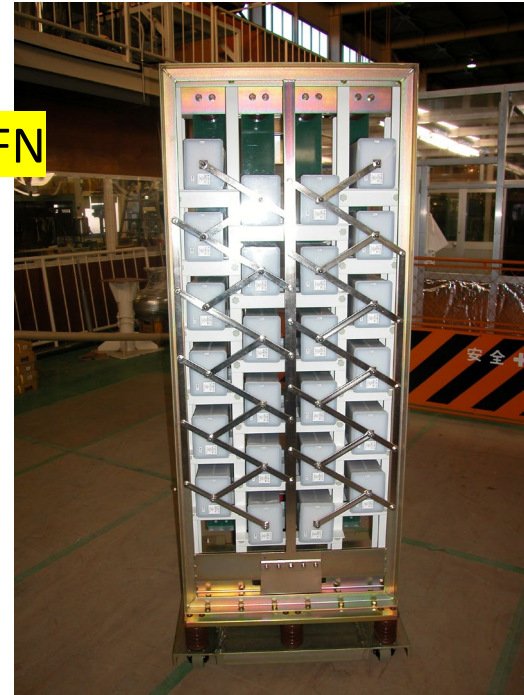
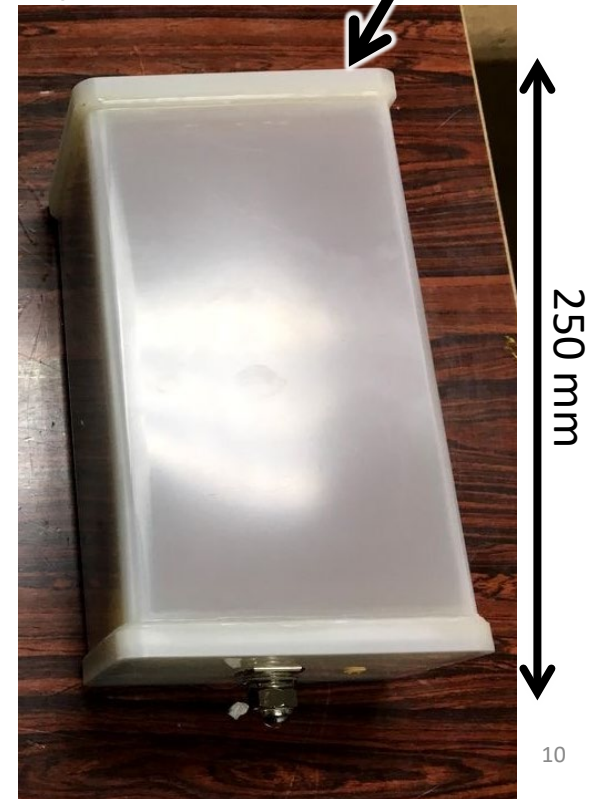
What is the cause of the fire?

- No deterioration of the modulator performance observed
- The most likely cause is puncture of the plastic-case capacitors (although there is no direct evidence).
 - Fire occurred at other facilities using modulators with plastic-case capacitors.
 - At Nextef, such puncture occurred twice.

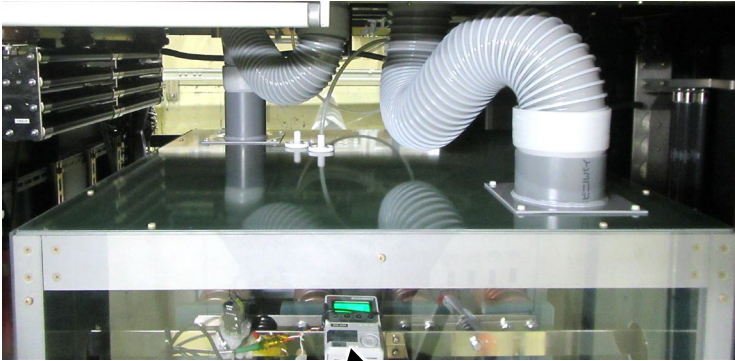
Measurement of the O2 level inside the modulator during/after the fire extinguishing gas injection (Aug. 25, 2022)

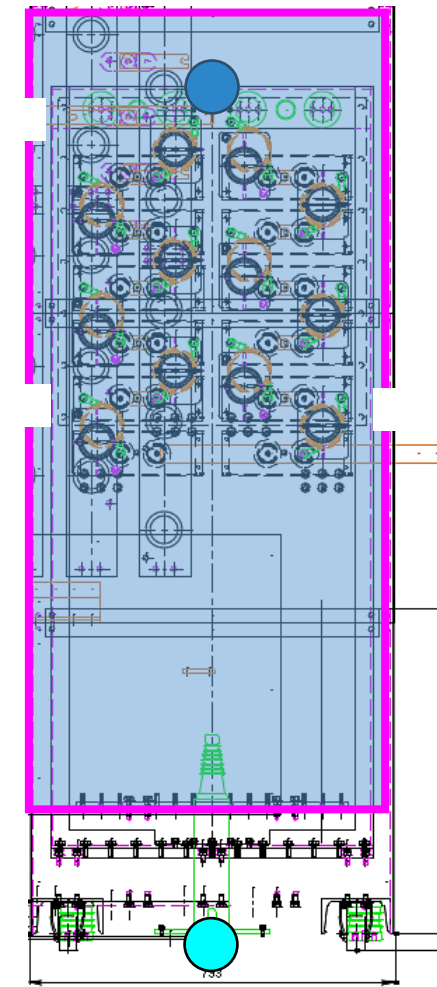
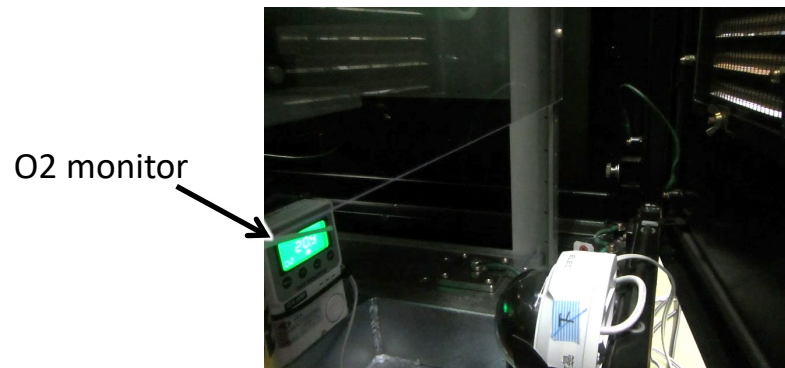
- ✓ O2 level dropped to 14.3vol% (15vol% is the threshold for fire to persist.)
- ✓ After 1 hour, the O2 levels returned to normal (20.9vol%)

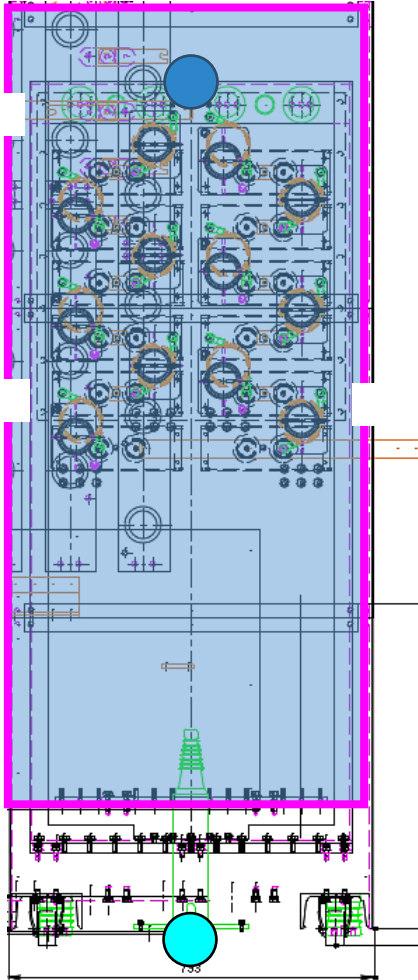
- Time during the O2 level below 15vol%
- At the PFN top : 63 sec
 - At the PFN bottom : 53 sec

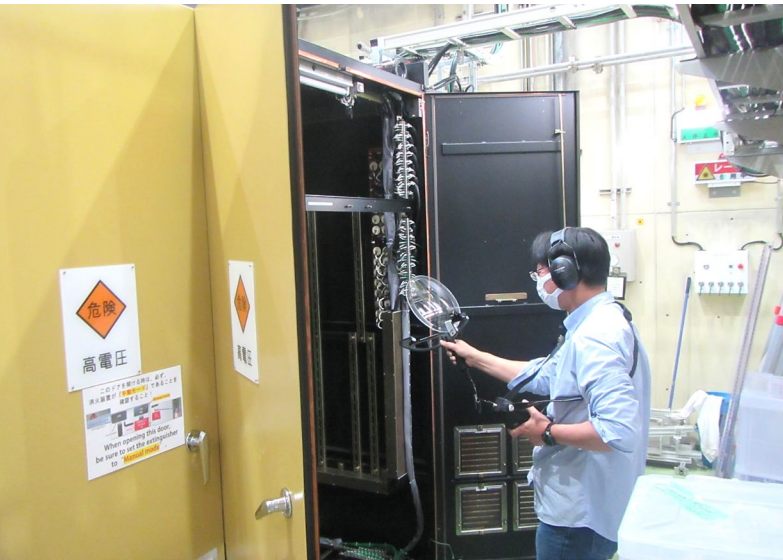
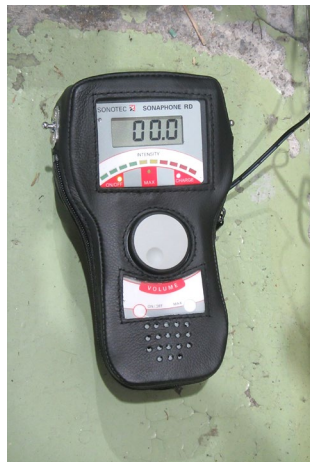
Listening to ultrasonic sounds from corona discharge

During operation with $E_s=36\text{kV}$

To be incorporated in our regular inspection
