Experience with Field Emission at TRIUMF

Zhongyuan Yao

RF/SRF, Accelerator, TRIUMF

CM01 Field Emission Workshop, Jan. 28-29, 2025

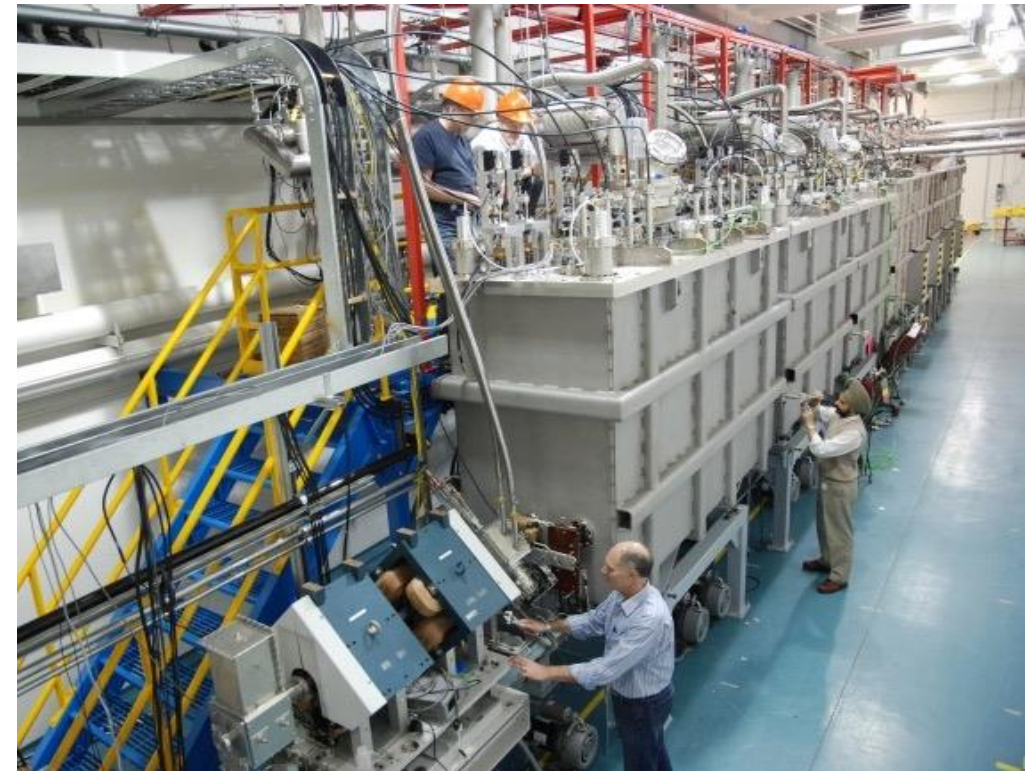
- Operating E_{acc} is generally stable over years unless known issues
- Small differences due to inconsistent pulse conditioning

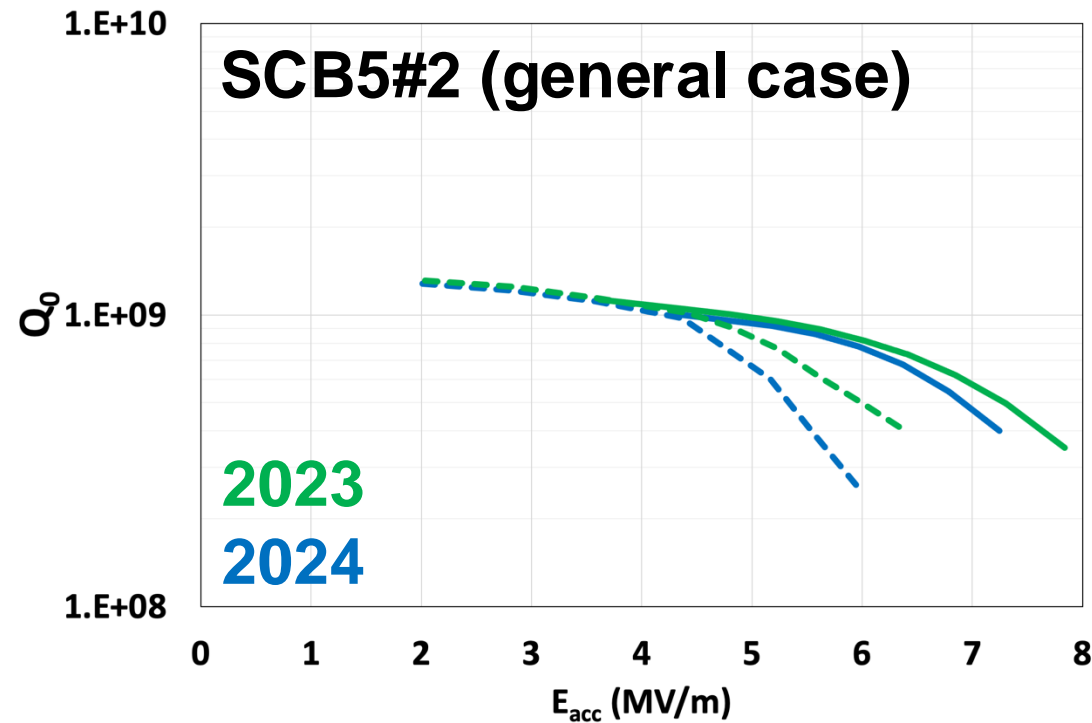
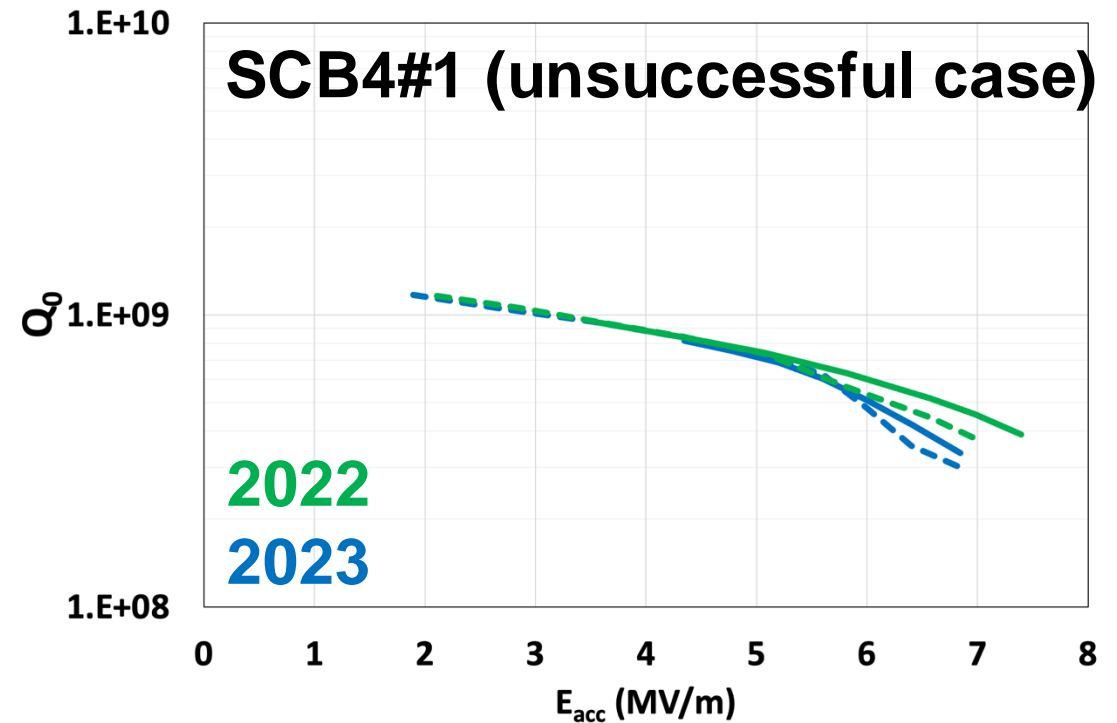
- 40~100ms pulse length, 1Hz repetition rate, up to 200W P_{FWD}
- Variable coupler, slightly over coupling $\beta \sim 10$, normal cavity decay $\sim 200\text{ms}$
- Pulse conditioning to 50% higher than the operating field
- Pursue 'electronic' quench to break through FE barriers

- Improvement in minutes w/ 'electronic' quench, while requires hours to days w/ 'thermal' quench or even no changes
- Effective to restore ISAC-II cavity performance

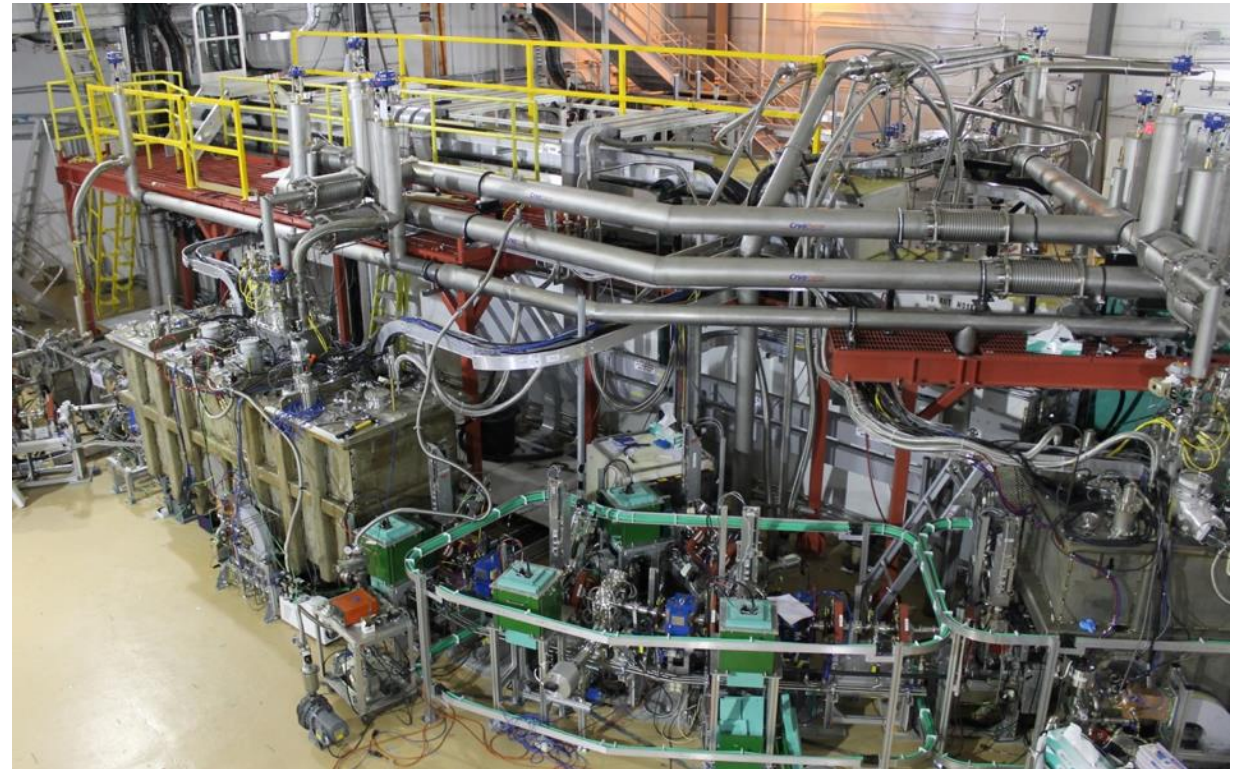
- 1.3GHz 9-cell cavities
- 1 in injector CM (EINJ), 2 in accelerator CM (EACA)
- Operate at 2K
- Operating E_{acc} 10MV/m
- Warm sections between CMs
- In commissioning stage since 2014
