HPS Detector Status/Plans

Tim Nelson
February 2, 2022

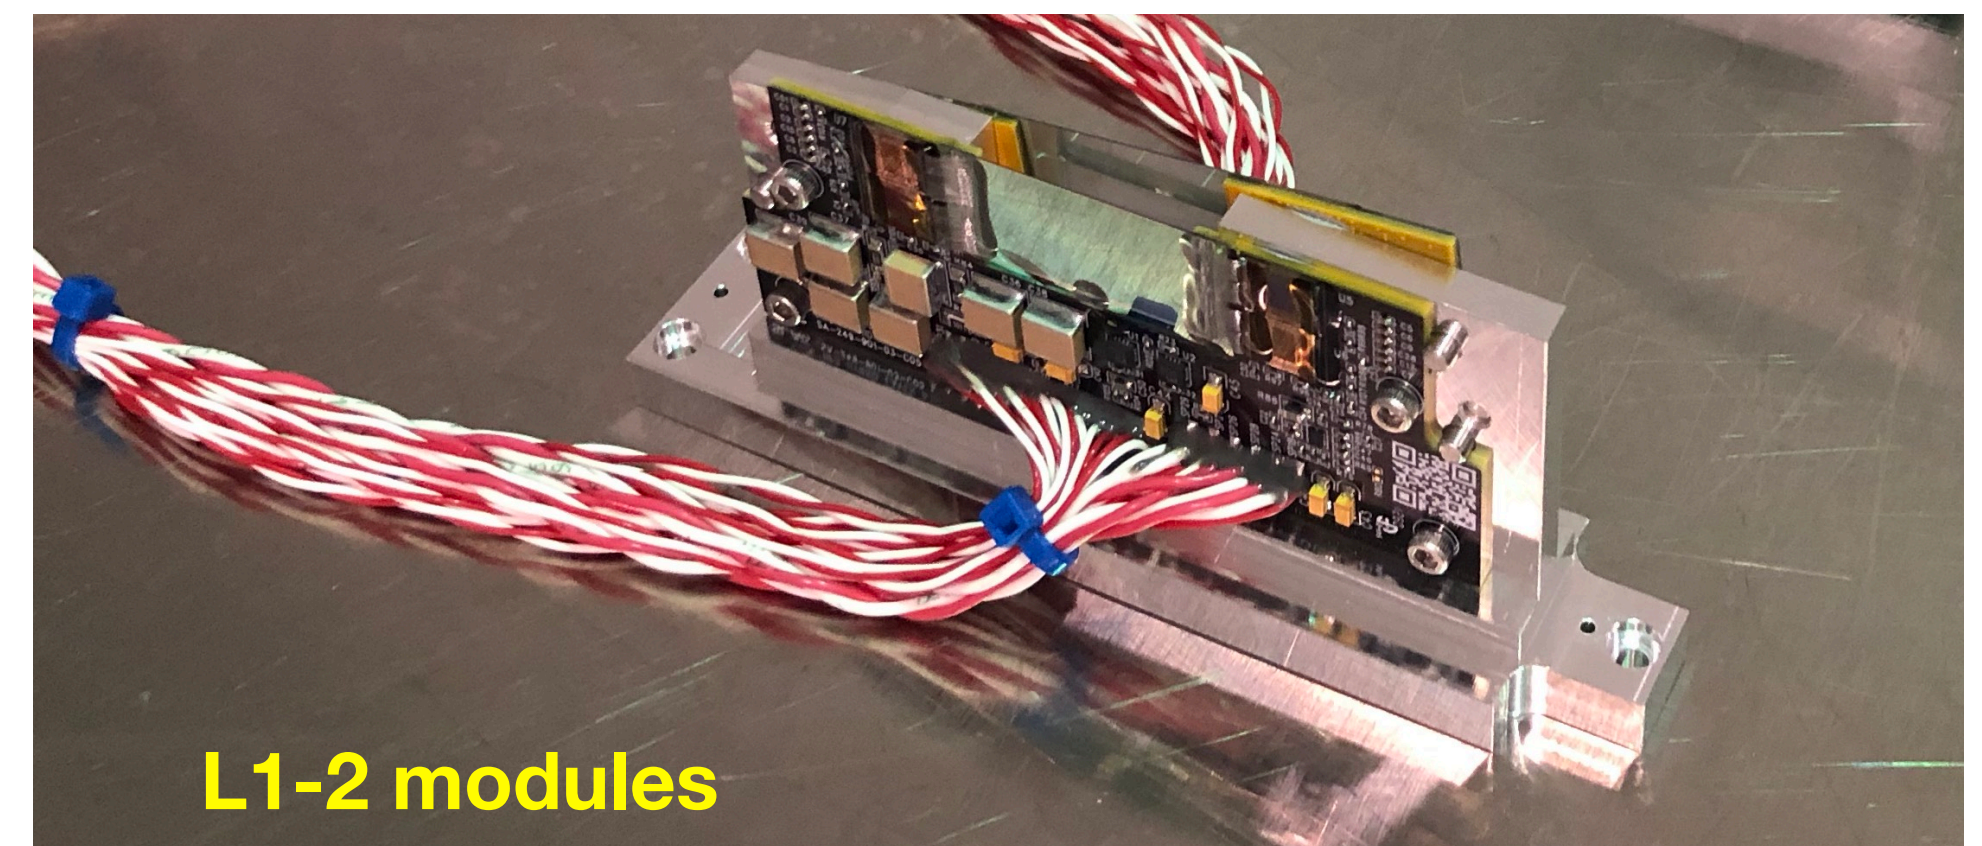
- Agreed on design changes with CNM to eliminate metallization, fabricate on lower resistivity silicon
- SLAC currently processing the order for 30 new sensors
- Wafers ordered by CNM before the holidays
- Hope to have sensors before end of CY2022

When sensors arrive, will plan out assembly and testing of the rest of half-modules with UCSC.

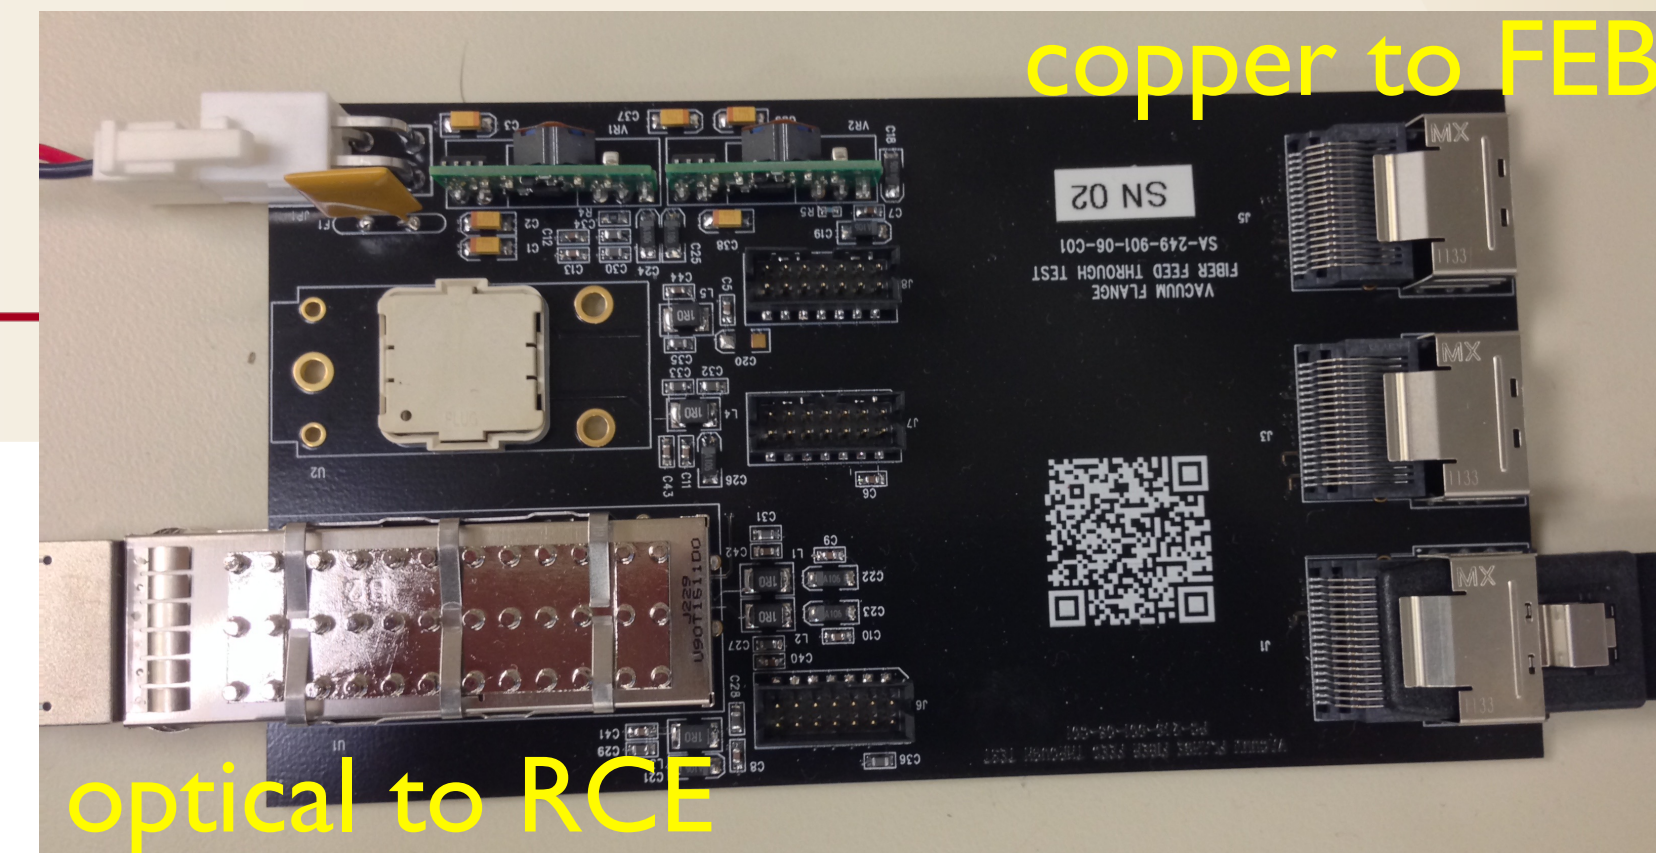
SVT Data Flange

SVT data flange converts FEB control+data on copper to optical connected to RCE back end.

- Four boards with 3 channels each (12 links total)
- Boards are potted through 6" vacuum flange on positron side of upstream vacuum box.
- Two flanges were built: the first no longer has 10 reliably working channels. Spare was used in 2021.
